Product Safety Recall

N202322230 Seat Belt May Not Be Properly Attached

Release Date: January 2021

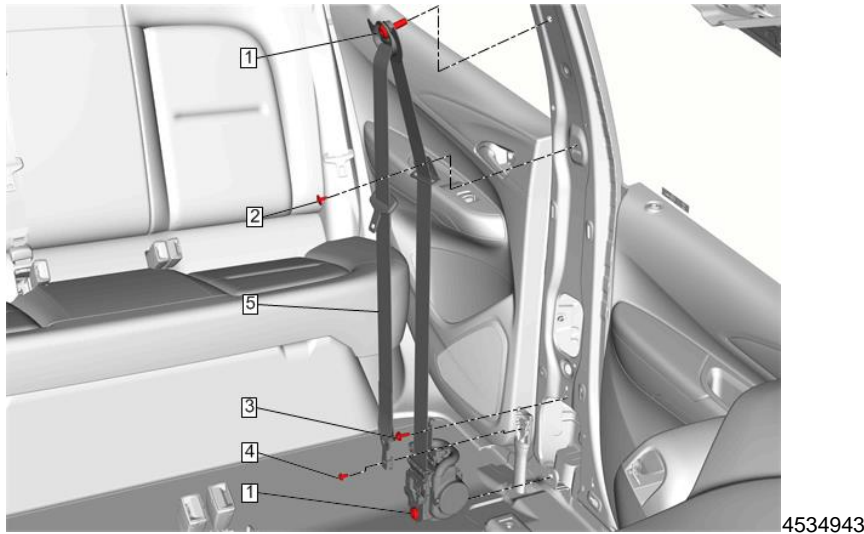
Note: The LH side is shown for reference purposes only.

2. Remove and discard the lower retractor bolt (1).
3. Install the new retractor mounting bolt. Refer to the note above for installation details. Tighten the new service bolt to 45 N.m (33 lb. ft).
4. Reinstall the center pillar lower trim panel. Refer to *Center Pillar Lower Trim Panel Replacement* in SI.

NOTE: The bolt being removed from the vehicle may not have cut the proper threads in the nut when the vehicle was manufactured. If this occurred, expect to feel resistance for the complete bolt length when removing the bolt. When the new bolt is being installed in an unthreaded nut, there will be resistance as the self-threading bolt threads the nut. There will be an initial resistance while the thread is being cut, followed by a reduction in

resistance. This is an expected condition. Continue tightening the bolt until the retractor or belt bracket is secured. To complete the installation, tighten the bolt to the proper torque specification.
