Tesla, Inc. Service Bulletin		<i>Readjust Hood Latch</i>	
SB-21-11-003 December 29, 2021			
Classification		Section/Group	Mobile Service
Recall Bulletin		11 - Closures	Can Perform (where permitted)
Model Year	Model	Country/Region	Version
2014 – 2021	Model S	All	All
<small>The model(s) and model year(s) listed are a general approximation of the affected VIN list. Refer to the VIN/Bulletin Tracker or Customer/Vehicle profile to determine applicability of this bulletin for a particular vehicle.</small>

Condition

On certain 2014 to 2021 Model S vehicles, the secondary hood latch may not latch to the frunk striker as designed.

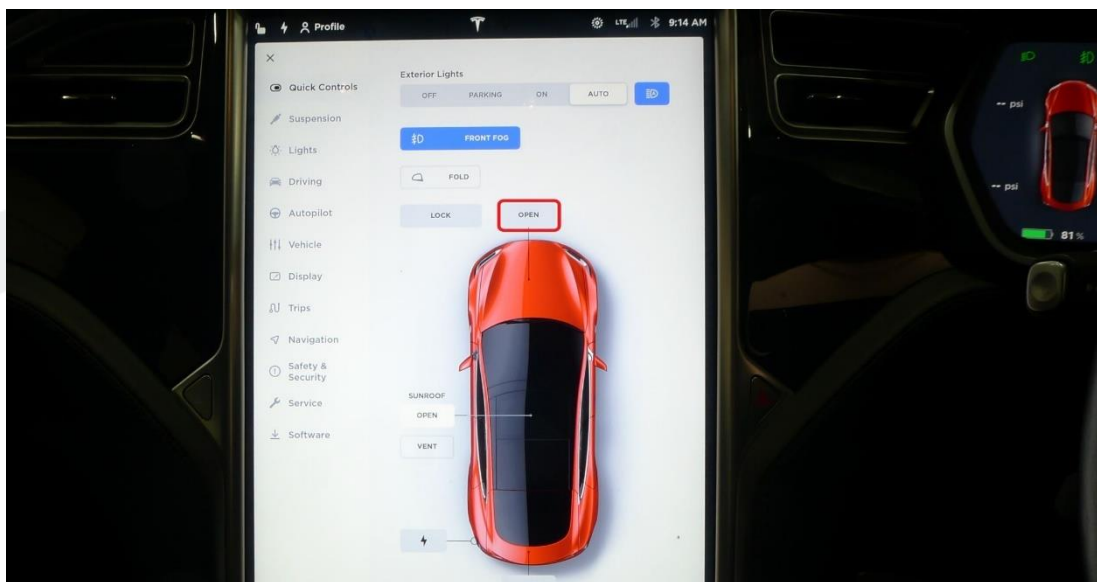
Figure 1

1. Open the LH front door and lower the LH front window.
2. Press the brake pedal to turn on the drive rails.
3. Open the hood through the touchscreen (Figure 1).

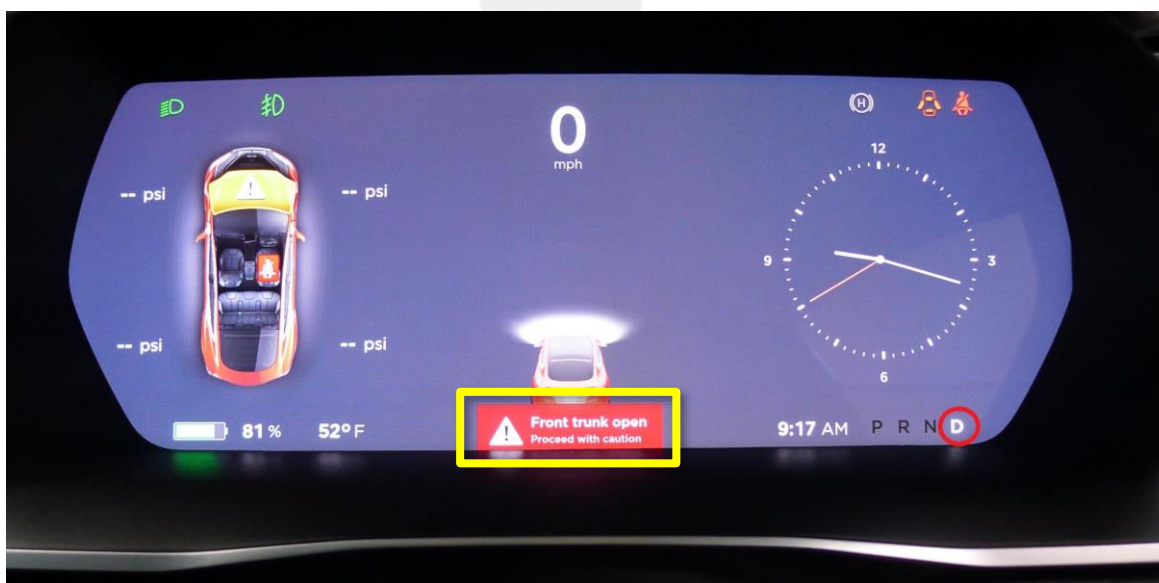
Figure 2

**NOTE:** The warning messages “Front trunk open” (Figure 2) in the instrument cluster and “Front Trunk Unlatched” (Figure 3) in the touchscreen should appear when the vehicle is in Drive.

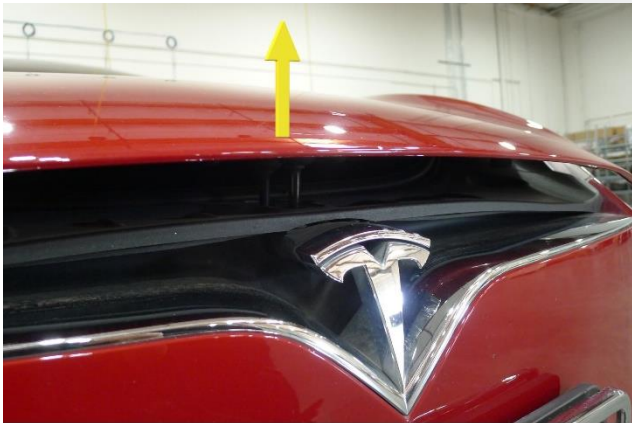
**Figure 4**

- If the secondary hood latch prevents the hood from opening fully (Figure 4), the hood latch is working as designed. Close the hood and discontinue this procedure.
- If the hood opens fully (Figure 5), the secondary hood latch is NOT working as designed. Continue with one of the procedures as follows:
 - [2014 to 2016 Front Fascia Applique Vehicles \(Nose Cone\)](#)
 - [2016 to 2021 Vehicles \(Refresh\)](#)
