# Safety Recall Y03 / NHTSA 21V-028

## Software Update

2018 – 2020(JL) Jeep® Wrangler  
2020 (JT) Jeep® Gladiator

## Subject

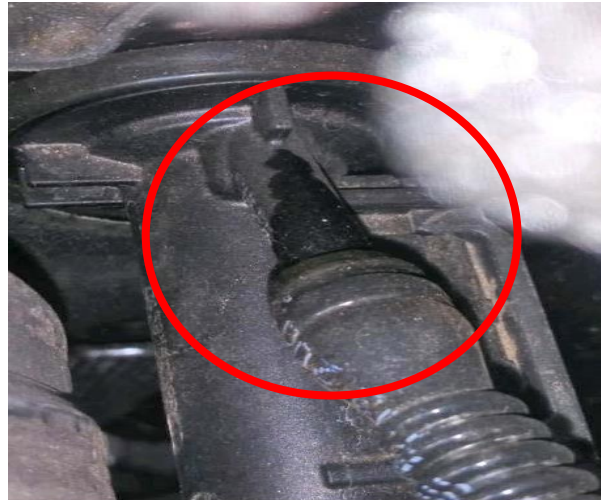
**SAMPLE of Leak/Seepage**

1. Locate and cut the clip holding the wire harness to the low pressure reservoir hose and **Discard** the clip (Figure 1).
2. Visually inspect the low pressure reservoir hose for any leaks/seepage (See Sample Pictures Below), if leak or seepage, deformation, or wear is found replace the reservoir hose (Figure 1).

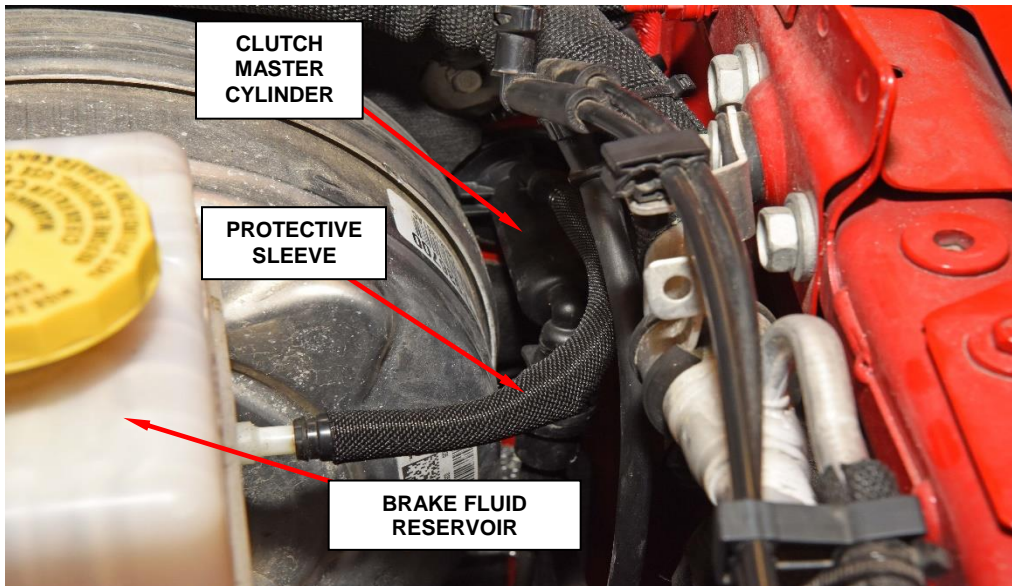
**Figure 2 – Hose Sleeve Installed**

3. Install the protective sleeve on the low pressure reservoir hose, **making sure it is installed close to the clutch master cylinder inlet tube** (Figure 2).

**NOTE: If the reservoir hose is replaced, actuate the clutch pedal 50 times, making sure the pedal is getting to the top of its return stroke each time (this may require that you lift the pedal to the top of the stroke).**
