# Safety Recall Y04 / NHTSA 21V-037

## Brake Clip

#### 2021 (DS) Ram 1500 Pickup

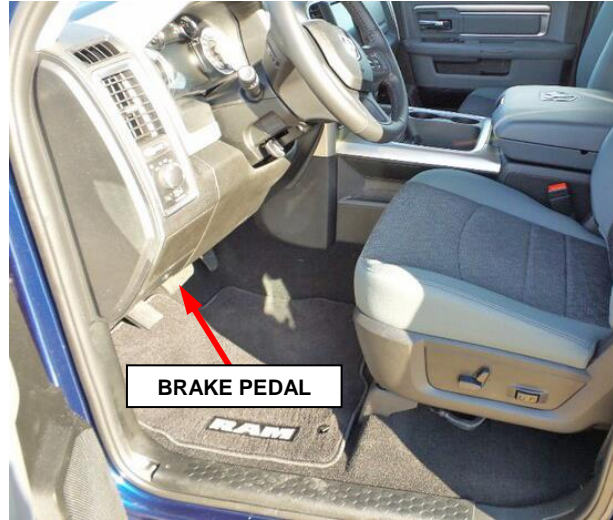
**Figure 1 – Gain Access to Brake Pedal**

1. Open the driver side front door.
2. As needed, position the driver seat rearward to gain access to the brake pedal below the instrument panel (Figure 1).

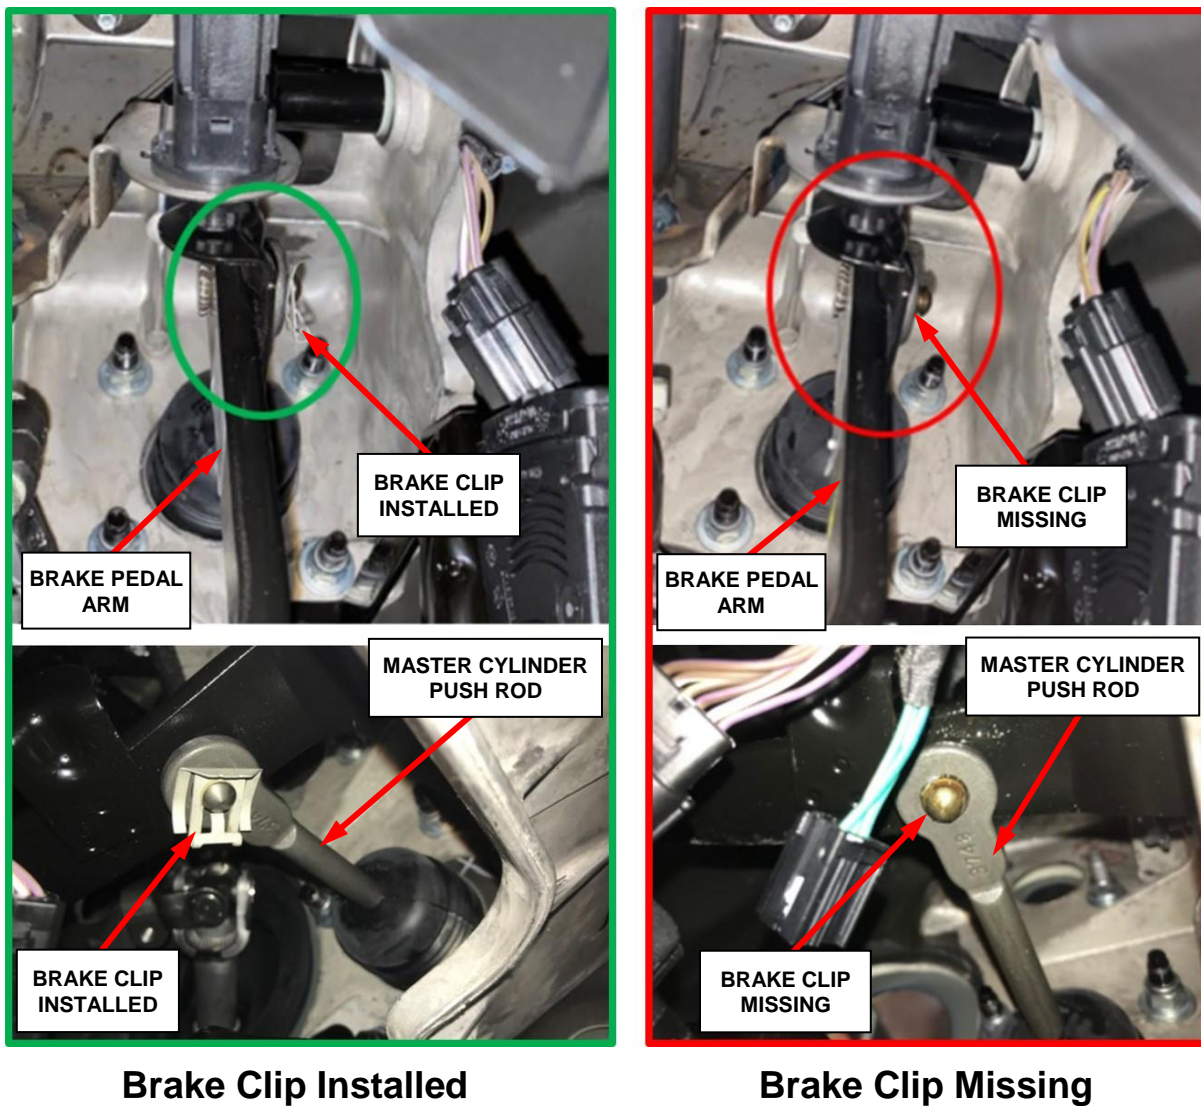
**Figure 3 – Inspect for a Clip Securing the Brake Master Cylinder Push Rod to the Brake Pedal Arm**

- 4. Is there a clip installed securing the master cylinder push rod to the brake pedal arm? (Figure 3).
  - **YES, clip installed:** There is no need to do anything. Claim the Inspection LOP to complete the recall on this vehicle.
  - **NO, clip is missing:** Proceed to **Step 5** of the procedure on **Page 5**.

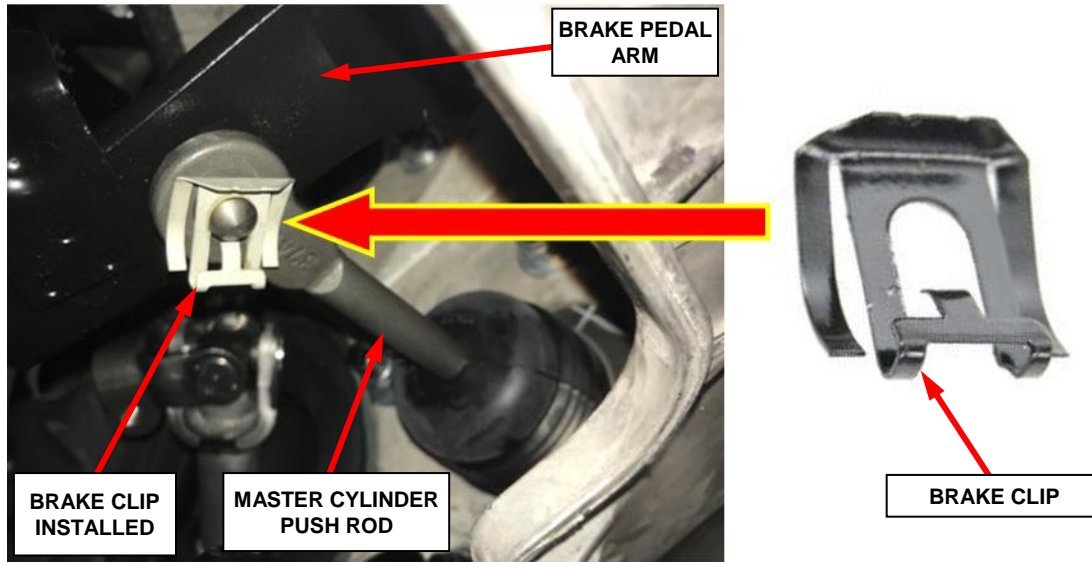
**Figure 4 – Install Clip Securing the Brake Master Cylinder Push Rod to the Brake Pedal Arm**

5. If clip is missing, install a clip onto the brake pedal pivot pin securing the master cylinder push rod to the brake pedal arm (Figure 4).
