iABS Sensor Visual Inspection Illustration

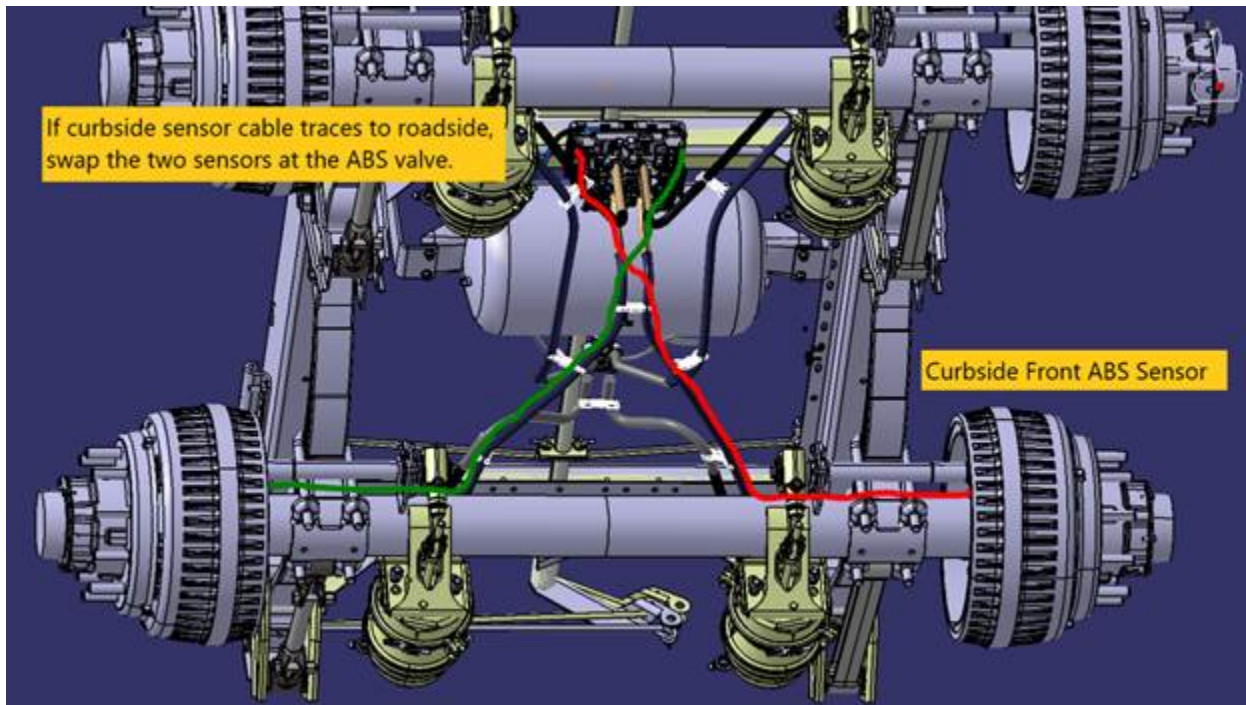
The view below shows what it would like if the sensor cables are installed incorrectly. The sensor cables should not cross side to side.
