Release Date: March 2021

Revision: 01

Product Safety Recall

N212329050 Tires Overcured

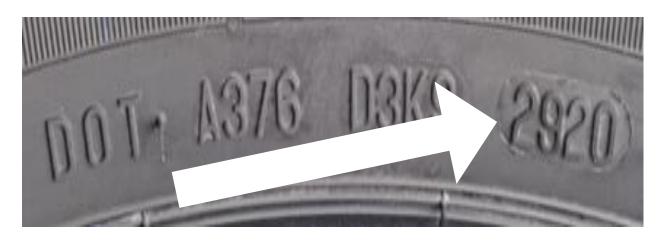
5672013

1. Take a picture of the DOT stamp (Date Code).
