Condition	General Motors has decided that a defect which relates to motor vehicle safety exists in certain
	Continental tires installed as original equipment on certain 2018-2021 model year Chevrolet Express and
	GMC Savana vehicles; certain 2018-2020 model year Chevrolet Blazer and Silverado 1500 and GMC
	Acadia and Sierra 1500 vehicles; and certain 2020 model year Buick Enclave, Cadillac Escalade,
	Escalade ESV, XT4, XT5, Chevrolet Suburban, Tahoe, Traverse, and GMC Yukon and Yukon XL
	vehicles; or sold into the aftermarket by GM dealers. According to the tire manufacturer, Continental
	Tires the Americas (CTA), the affected tires may have an overcure condition and CTA has initiated a
	safety recall for these tires. According to CTA, overcured tires may experience a carcass break in the
	sidewall with sudden air loss or could develop a belt edge separation which could lead to partial or full
	tread/belt loss. These conditions may increase the risk of a crash.

Correction	Dealers will inspect vehicles and replace tires that have DOT number and production mold number
	combinations identified by Continental.

N212329050 Tires Overcured

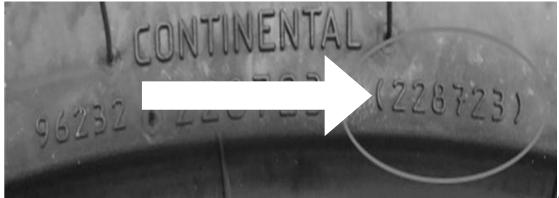
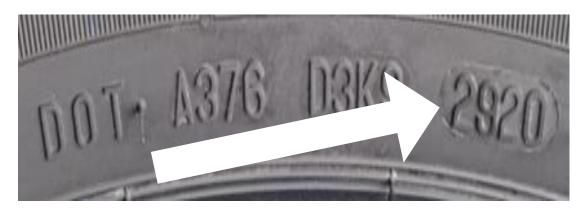
5672012

This procedure involves inspecting the tire sidewall for manufacturing information. The mold number, in parenthesis along with the last four numbers in the DOT stamp (Date Code) indicate if the tire is involved in this recall. See the examples in the photographs below.

The tires must contain the exact DOT week and mold number combination as specified in the chart above.

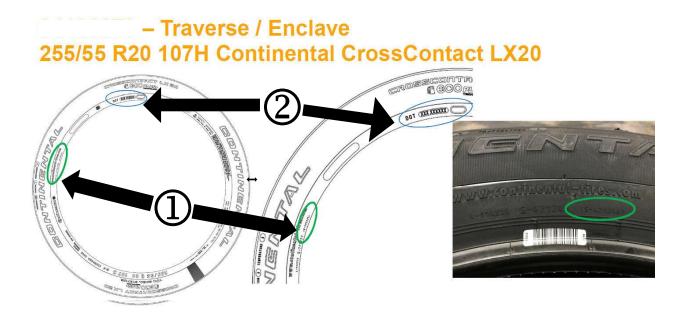
5668968

- 1. Inspect the tire sidewall as shown and verify the mold number (1) and DOT week (2).
- 2. If the mold number and DOT date match the Affected DOT wk(s) Mold # combination in the tire information chart, replace the tire.

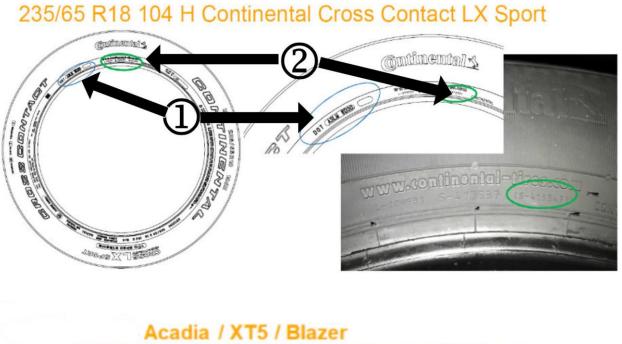
5669524

- 1. Inspect the tire sidewall as shown and verify the mold number (2) and DOT week (1).
- 2. If the mold number and DOT date match the Affected DOT wk(s) Mold # combination in the tire information chart, replace the tire.

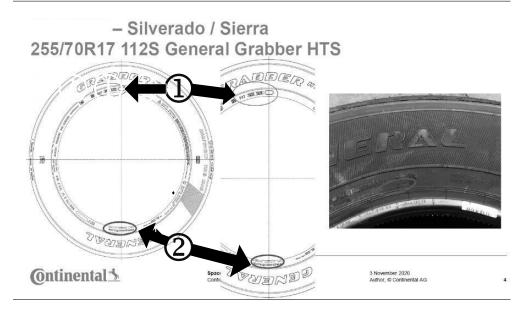
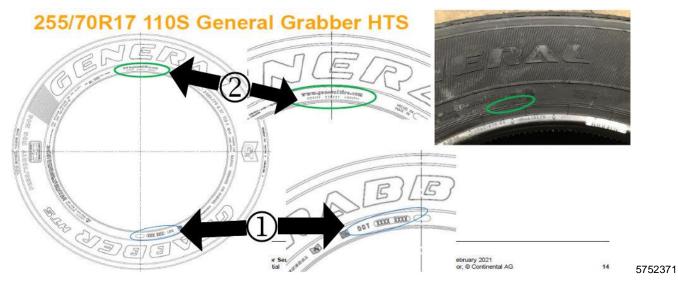
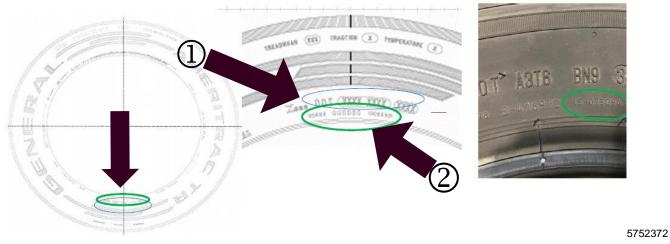
5668974

- Inspect the tire sidewall as shown and verify the mold number (2) and DOT week (1). 1.
- If the mold number and DOT date match the Affected DOT wk(s) Mold # combination in the tire information chart, 2. replace the tire.

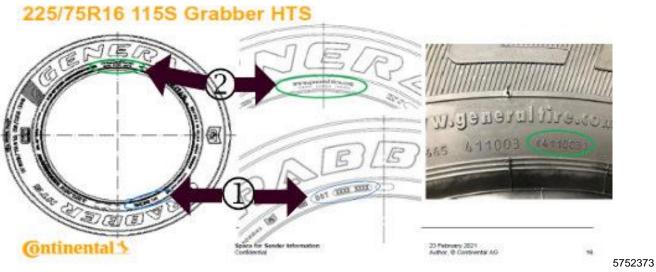
- 1. Inspect the tire sidewall as shown and verify the mold number (2) and the DOT week (1).
- If the mold number and DOT date match the Affected DOT wk(s) Mold # combination in the tire information chart, 2. replace the tire.

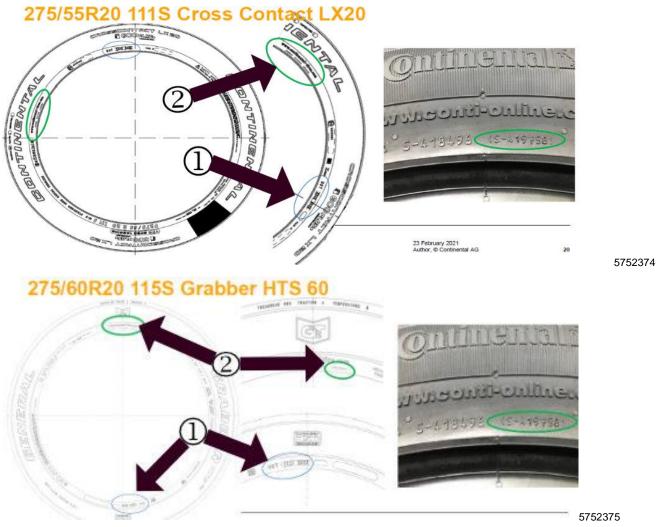
- Inspect the tire sidewall as shown and verify the mold number (2) and the DOT week (1).
   If the mold number and DOT date match the *Affected DOT wk(s) Mold # combination* in the tire information chart, replace the tire.

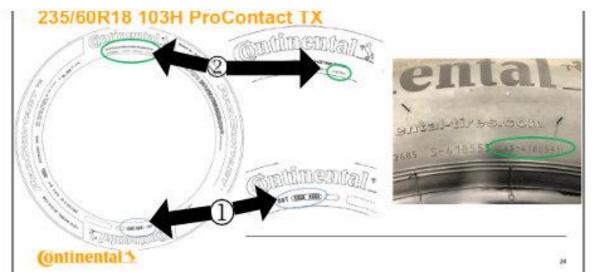
5752377

- 1. Inspect the tire sidewall as shown and verify the mold number (2) and the DOT week (1).
- If the mold number and DOT date match the Affected DOT wk(s) Mold # combination in the tire information chart, replace the tire.

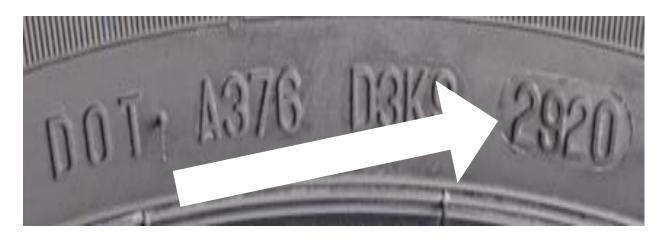
5672013

1. Take a picture of the DOT stamp (Date Code).

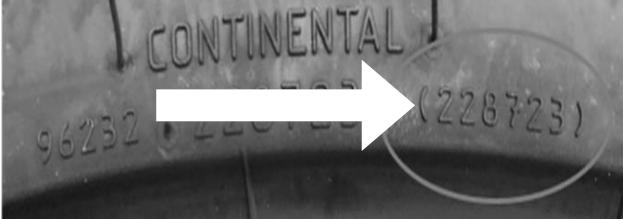
2. Take a picture of the mold number, in parenthesis.

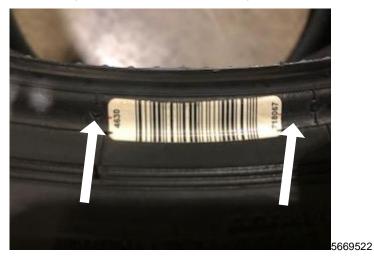
3. Take a picture of the bar code.

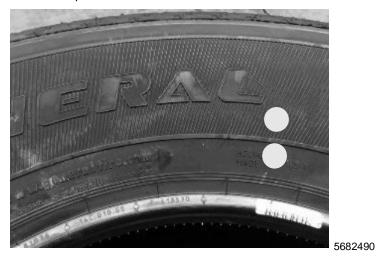
4. Drill two 13mm holes in the tire sidewall above the bar code label. Take a picture of the holes, including the barcode label.
