March 12, 2021

Version 3

Safety Recall: 2019–20 Passport, 2019–21 Pilot 20” Continental Tire

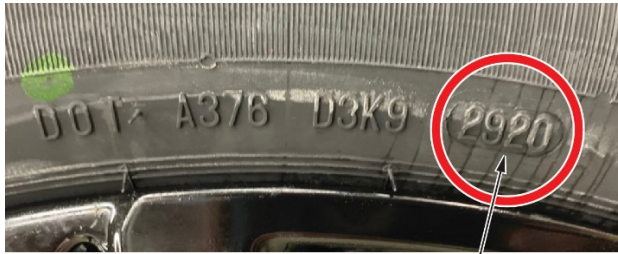
DOT NUMBER

1. Inspect the last 4 digits of the DOT number and the mold number on all 4 tires. The tire must display one of the pairs of DOT number and mold number listed below:
 - DOT number 1719 with mold number 412681 or 412688
 - DOT number 2719 with mold number 412689 or 408205
 - DOT number 2920 with mold number S - 421920 or S - 421921
 - DOT number 3119 with mold number 408204
 - DOT number 3319 with mold number 412692
 - DOT number 3819 with mold number 412692
 - DOT number 3919 with mold number 412692

- Above the DOT and mold number of each tire, mark its location on the vehicle. For example: Left Front: LF, Left Rear: LR, Right Front: RF, Right Rear: RR.
- Clear photos of the DOT, location, and mold numbers of all 4 tires must be submitted with the warranty claim.
- The number may or may not be preceded by "S -".

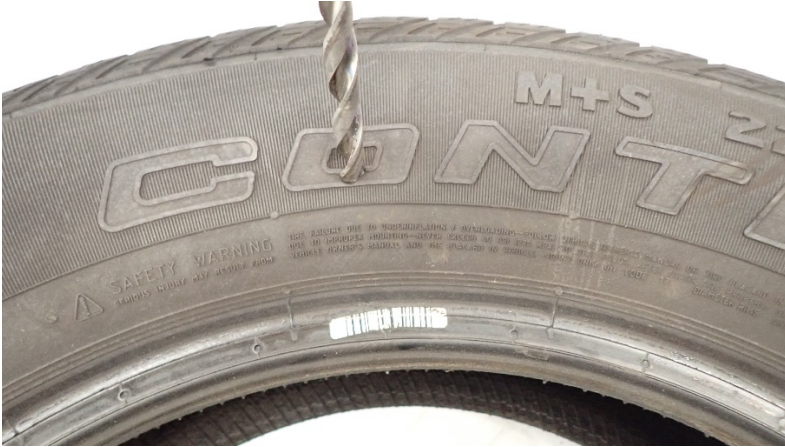
1. Replace any tire(s) that have the affected DOT and mold numbers.
1. Once the tire is removed, drill a 3/8" hole in the sidewall above the serial number.

2. Replaced tires are to be sent to AHM WPI for destruction. Ship tires to the address below.
