# RECALL CAMPAIGN BULLETIN

Classification: BR21-003B	Reference: NTB21-033B	Date: June 21, 2021
------------------------------	--------------------------	------------------------

## VOLUNTARY SAFETY RECALL CAMPAIGN 2021 ROGUE; REAR BRAKE CALIPER INSPECTION

**CAMPAIGN ID #:** PC804  
**APPLIED VEHICLES:** 2021 Rogue (T33)

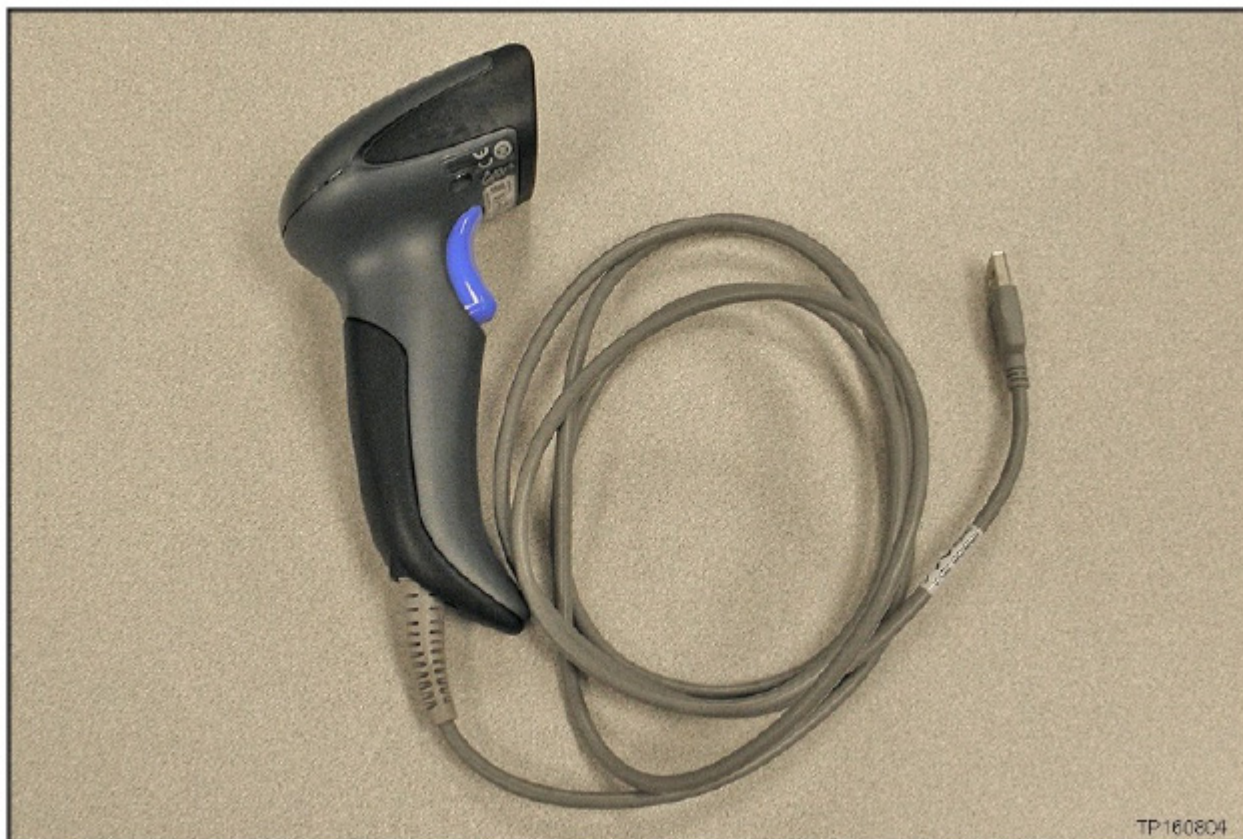
Figure 1

Each dealer has been shipped one Quick Scan Tool, special tool J-52352.

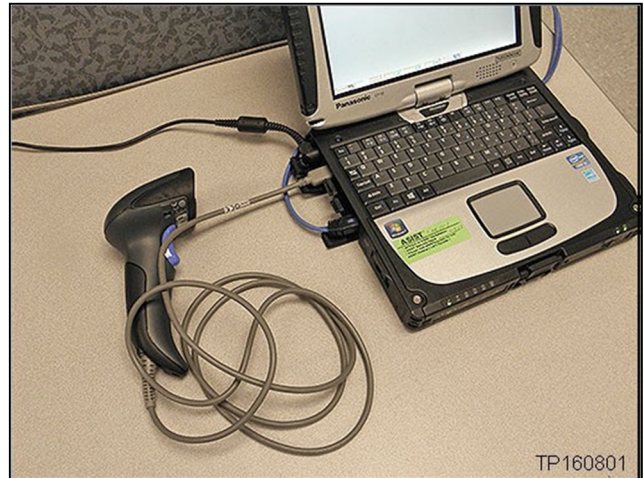
Figure 2

1. Connect the quick scan tool, J-52352, to a CONSULT PC USB port.

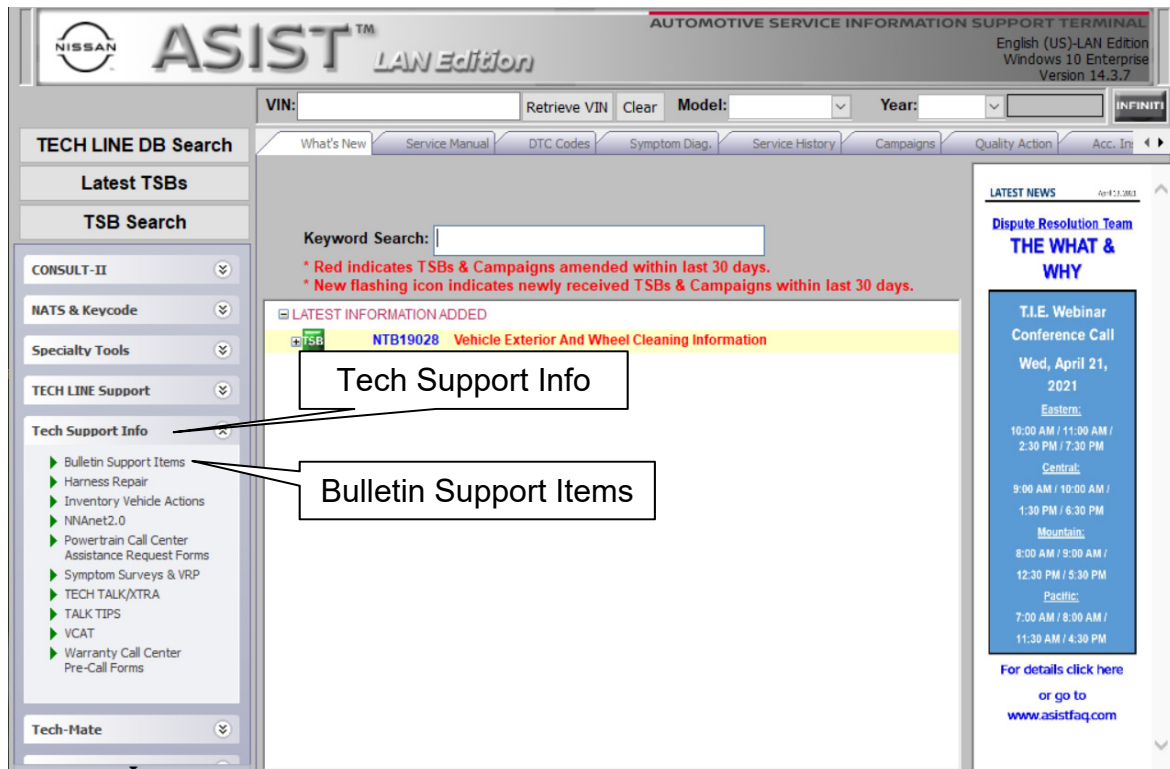
Figure 3

2. Open ASIST.
3. Select **Tech Support Info**, and then select **Bulletin Support Items**.

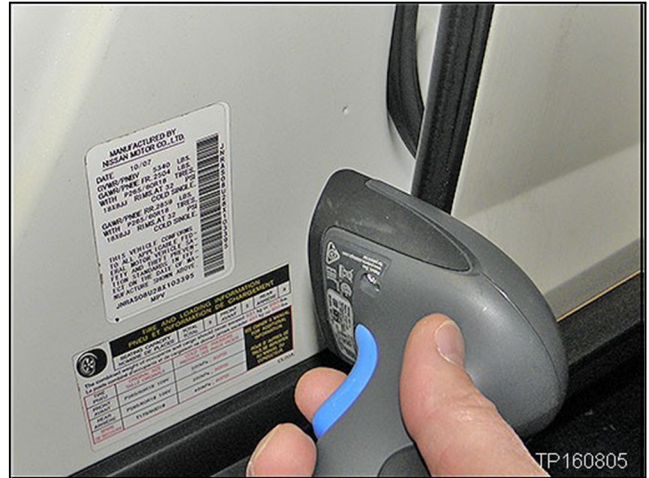
Figure 6

- Using the quick scan tool J-52352, scan the bar code on the VIN Certification Label located at the base of the B-Pillar.

- Make sure the VIN Certification Label is clean.
- Hold the quick scan tool J-52352 about 6 inches away from the label.
- Hold the trigger down until the quick scan tool J-52352 is finished scanning the label, an audible 'beep' sound will be heard.
- Some VIN Certification Labels may not scan quickly.
- Once the VIN automatically populates in the form, verify all 17 digits are correct (Figure 7).
- If needed, the VIN can be entered manually.

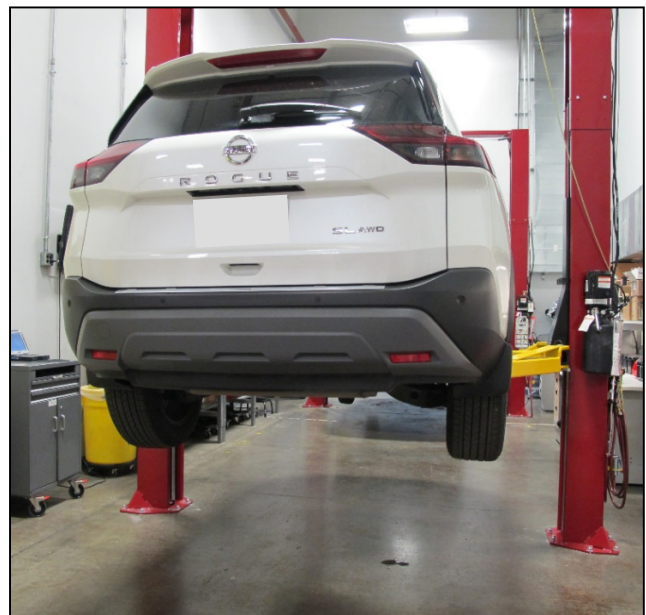
Figure 8

- Place the vehicle on a lift and raise to a suitable height to remove both rear wheel and tire assemblies from the vehicle.

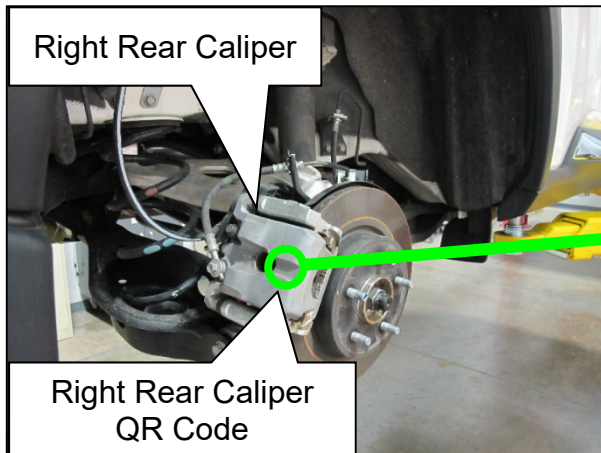
Figure 9

8. Locate the QR code on the right rear brake caliper (Figure 9 and Figure 10).

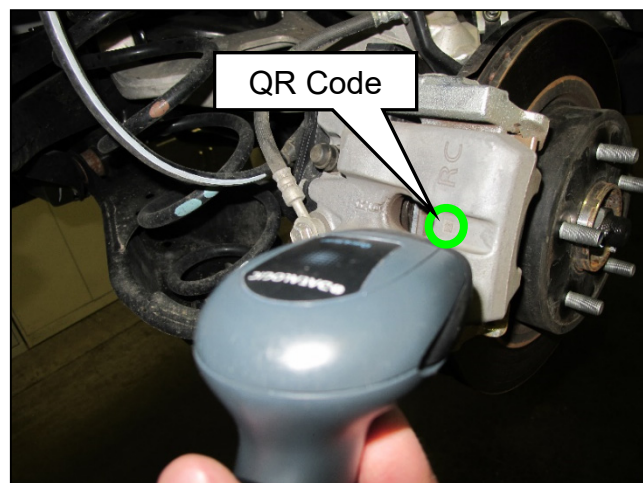
Figure 11

9. Using the quick scan tool J-52352, scan the right rear brake caliper QR code (Figure 11).

**NOTE:** If the QR code on the right rear brake caliper does not scan, the brake caliper will need to be replaced.

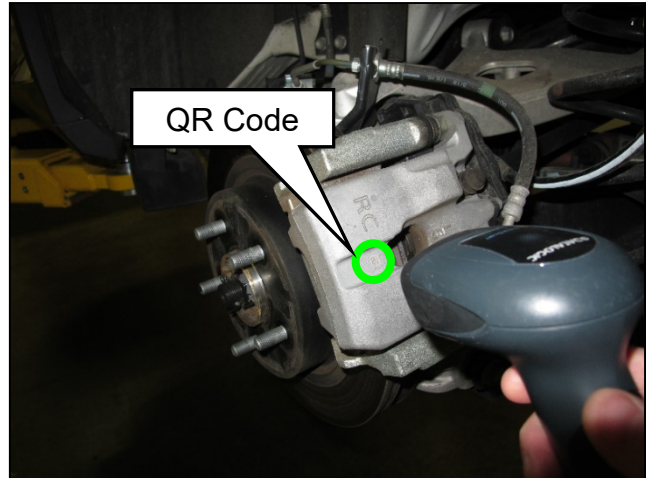
Figure 13

11. Using the quick scan tool J-52352, scan the left rear brake caliper QR code (Figure 13).

**NOTE:** If the QR code on the left rear brake caliper does not scan, the brake caliper will need to be replaced.
