Safety Recall Y24 / NHTSA 21V-309 ABS Hydraulic Control Unit

2020 - 2021 (GA) Alfa Romeo Giulia

2019 - 2021 (GU) Alfa Romeo Stelvio

Replace the Anti-Lock Brake System (ABS) Hydraulic Control Unit (HCU).

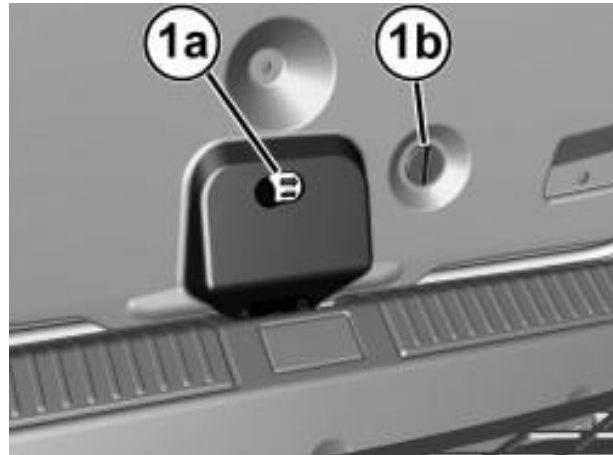
**Figure 1 – Lid Lock Release**

5. To be able to reopen the luggage compartment lid, even if it accidentally closes with the battery disconnected, before disconnecting the battery, it is necessary to unscrew the cap (1b), release the pull cord hooked onto it and leave it hanging out of the luggage compartment. Then, by working on the pull cord, an emergency luggage compartment lid lock release can be obtained. The pull cord operates on the lever (1a) inside (Figure 1).

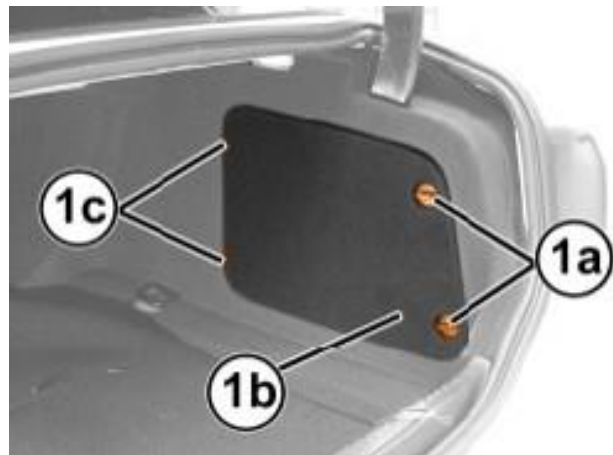
**Figure 2 – Battery Cover**

6. The ignition must be in the **OFF** position and the vehicle must remain powered down for at least 1 minute prior to proceeding.
7. Remove the battery cover (1b) by releasing retainers (1a) (Figure 2).

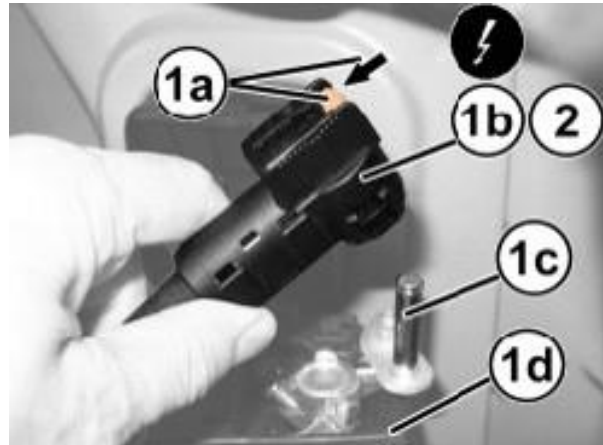
Figure 3 – Battery Negative Cable

9. Press the release button (1a) then disconnect and isolate the battery negative cable (1b) from the post (1c) (Figure 3).

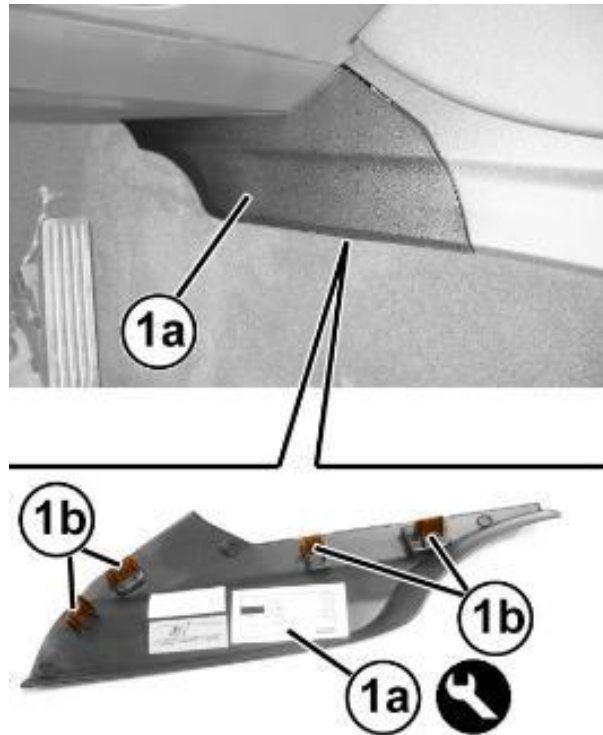
Figure 4 – Console Side Closure

10. Remove the console side closure (1a) by disengaging its inner retainers (1b) with the Trim Stick C-4829A (1823015000) (Figure 4).

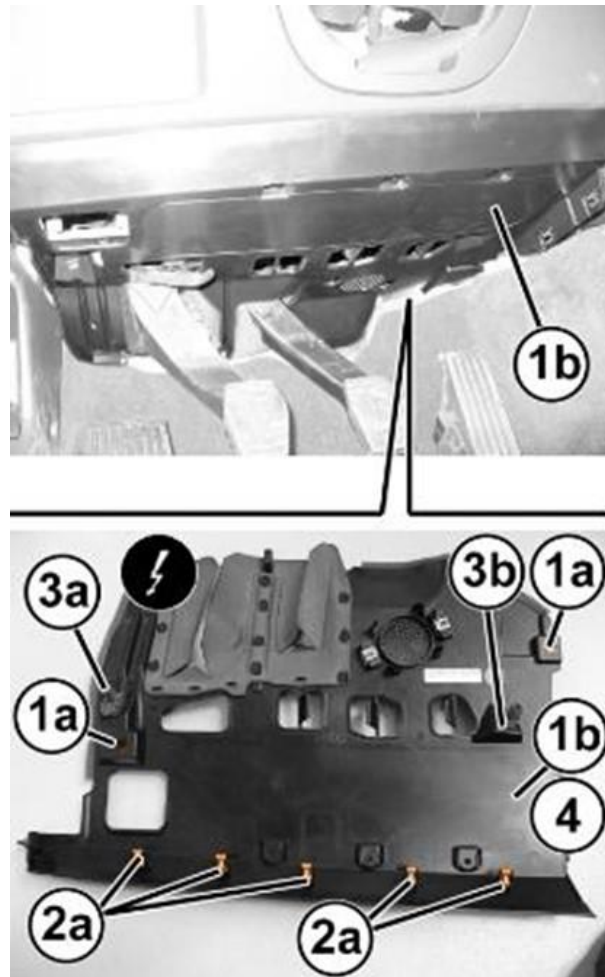
Figure 5 – Bottom Trim

14. Remove the bottom trim (1b) (Figure 5).

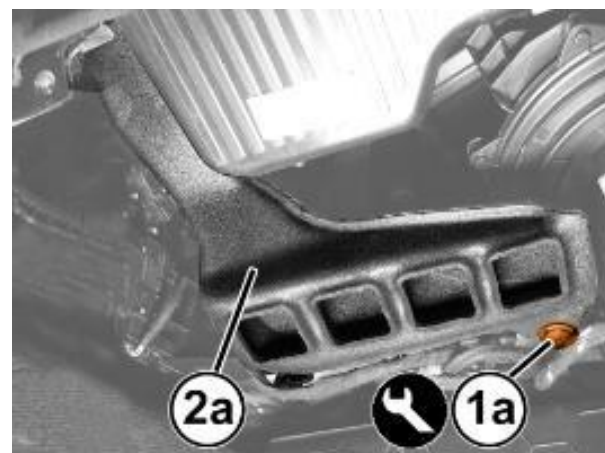
Figure 6 – Air Vent

15. Use tool Trim Stick C-4829A (1823015000) to disconnect the retaining pin with central pin (1a) and release the air vent (2a) (Figure 6).

CAUTION: Carefully move the air vent (2a) only when accessing the ABS module fasteners to avoid damaging it (Figure 6).

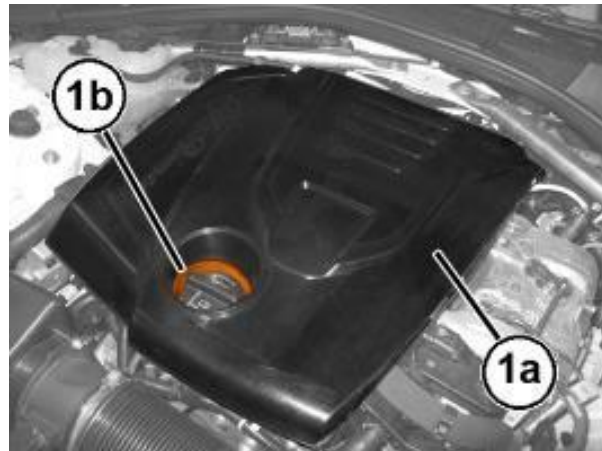
Figure 7 – Soundproofing Cover

16. Disengage from the retaining pins and remove the soundproofing cover (1a) complete with seal (1b) for the engine oil filler (Figure 7).

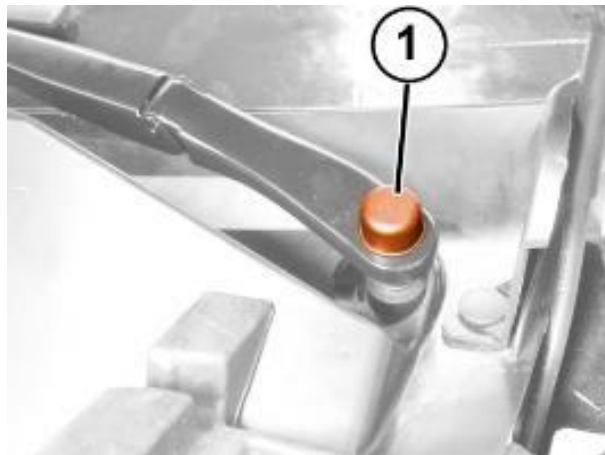
Figure 8 – Wiper Arm Nut Cover

17. Release the nut cover (1) at the base of the windshield wiper arm (Figure 8).

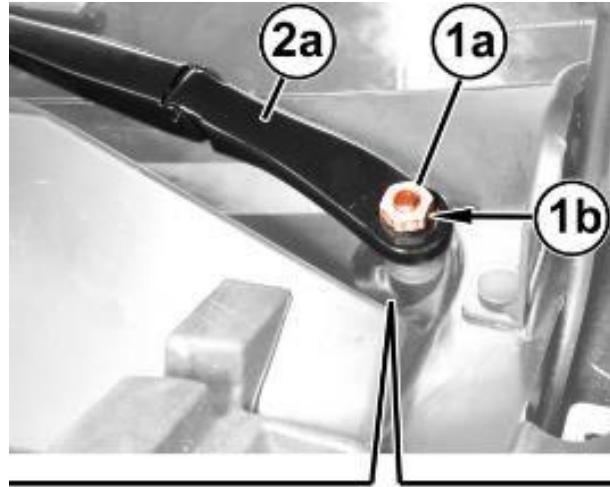
Figure 9 – Wiper Arm

NOTE: If necessary, remove the wiper arm using a suitable extractor to release the ribbed truncated cone coupling (3a) (Figure 9).

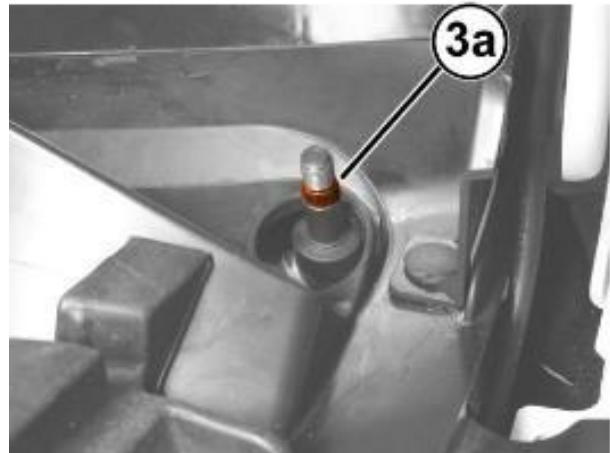
18. Remove the nut (1a) and keep the washer (1b) (Figure 9).
19. Remove the wiper arm (2a) (Figure 9).

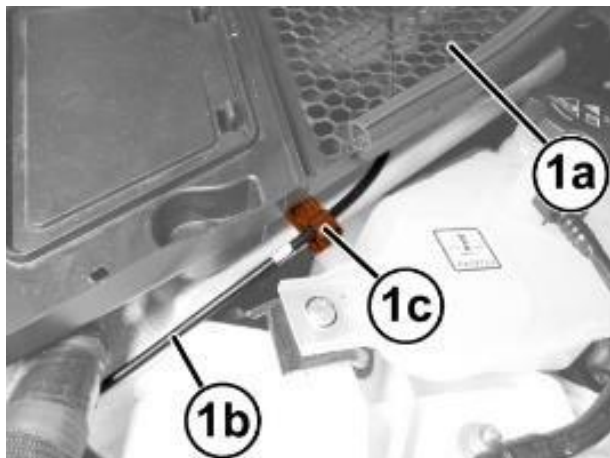
Figure 10 – Hood Opening Cable

20. Working on the front right side of the windshield base trim (1a), release the hood opening cable (1b) from the retainer (1c) (Figure 10).

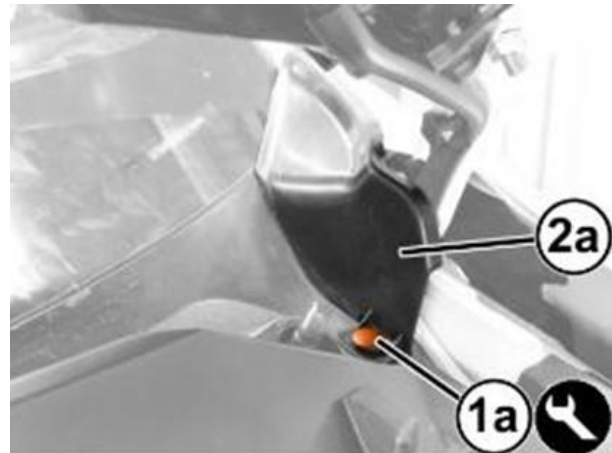
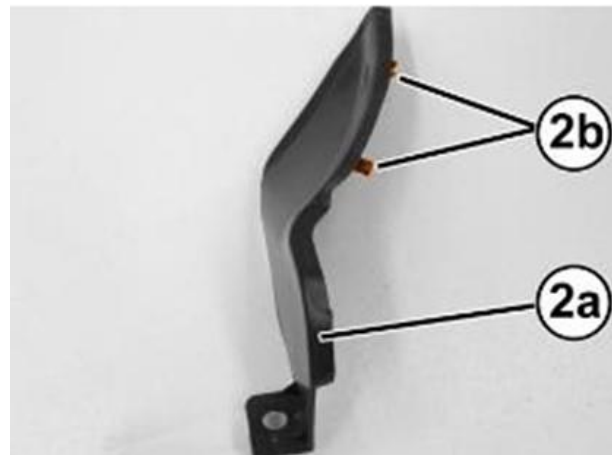
Figure 11 – Windshield Trim

21. Working on both sides of the windshield base trim, remove the retaining button (1a) after releasing its central pin using the appropriate tool Trim Stick C-4829A (1823015000) (Figure 11).

22. Remove the side moldings (2a) by releasing retainers (2b) (Figure 11).

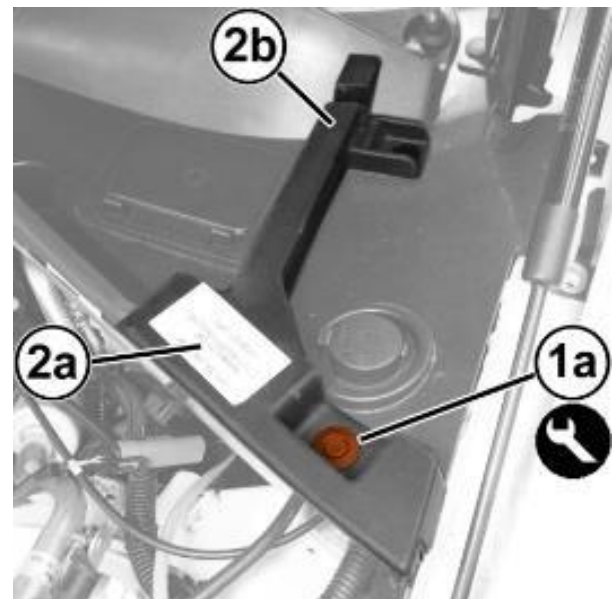
Figure 12 – Side Profile

23. Working on both sides of the windshield base trim, remove the retaining button (1a) after releasing its central pin using the appropriate tool Trim Stick C-4829A (1823015000) (Figure 12).

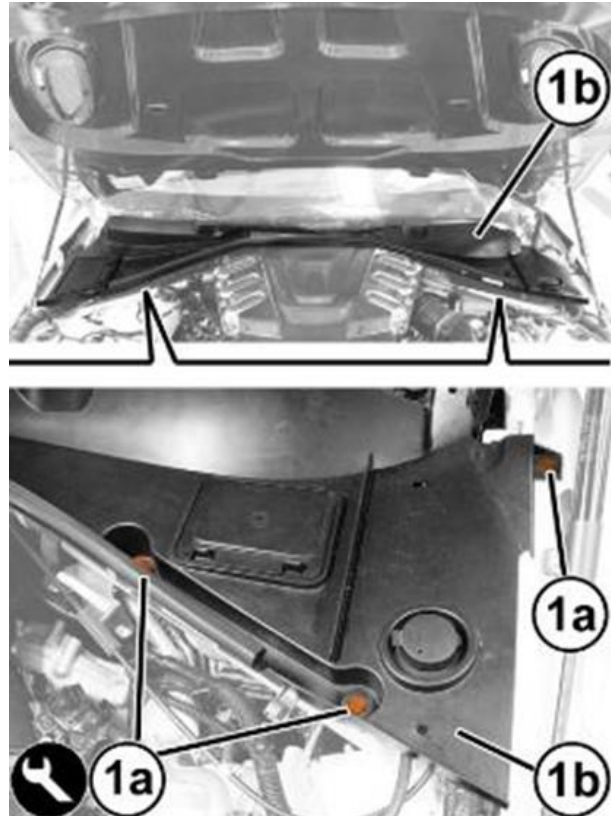
Figure 13 – Windshield Trim

25. Remove the retaining buttons (1a) from the windshield trim (1b), after releasing their central pins using the appropriate tool Trim Stick C-4829A (1823015000) (Figure 13).

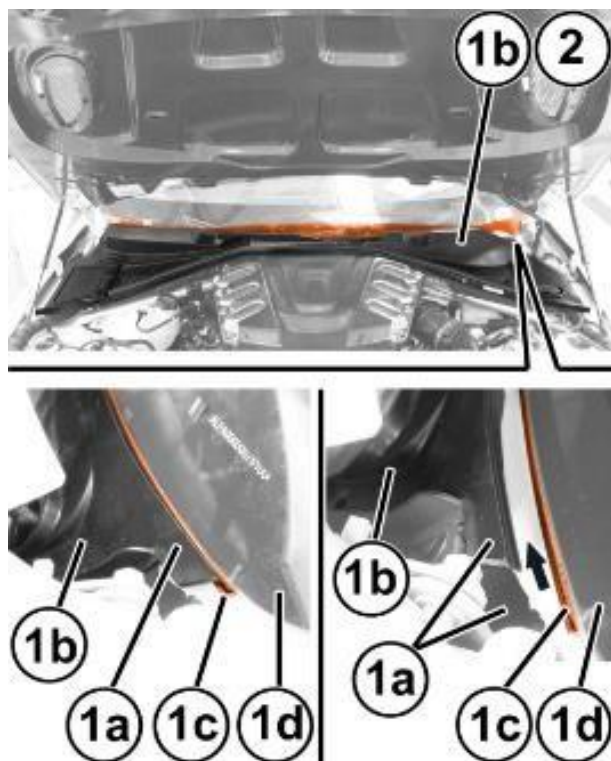
Figure 14 – Windshield Trim

27. Keep the windshield base trim (1b) (Figure 14).

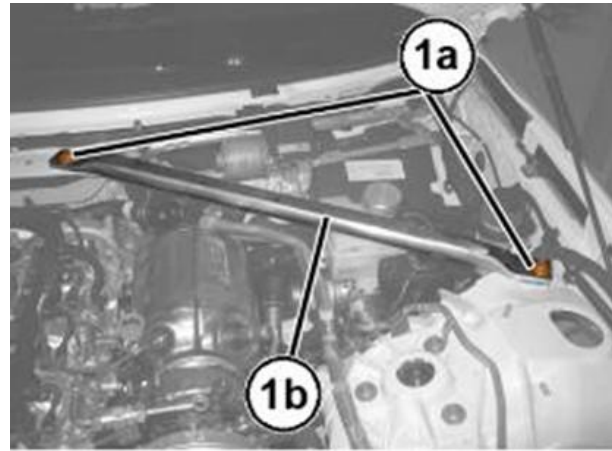
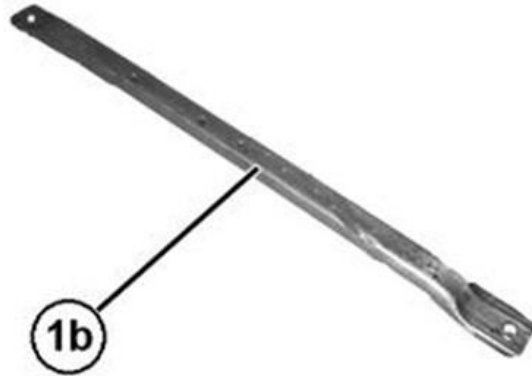
Figure 15 – Body Reinforcement

28. Remove the screws (1a) and remove the left body reinforcement (1b) (Figure 15).

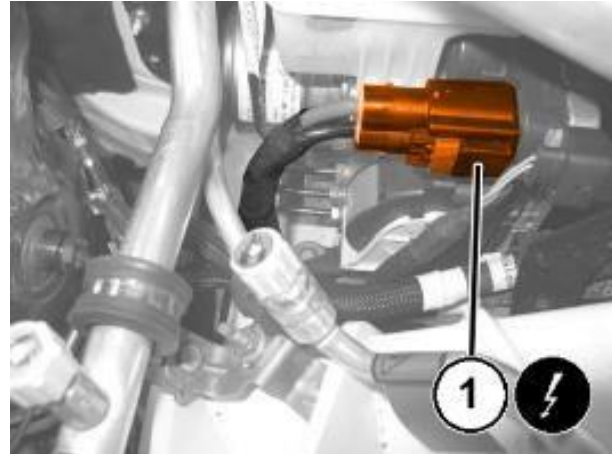
Figure 16 – ABS Electrical Connector

30. Disconnect the electrical connection (1) for the ABS module (Figure 16).

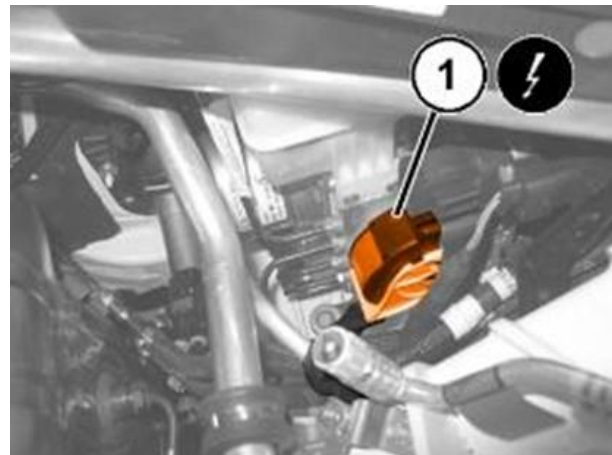
Figure 17 – ABS Electrical Connector

31. Disconnect the electrical connection (1) for the ABS module (Figure 17).

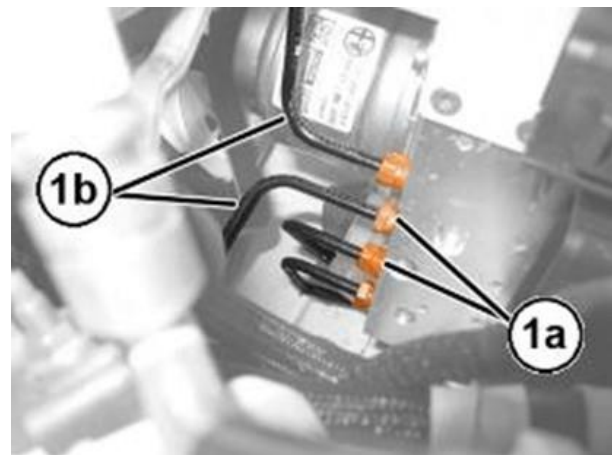
Figure 18 – Brake Fluid Pipes

32. Remove the connectors (1a) and disconnect the brake fluid pipes (1b) from the ABS module (Figure 18).

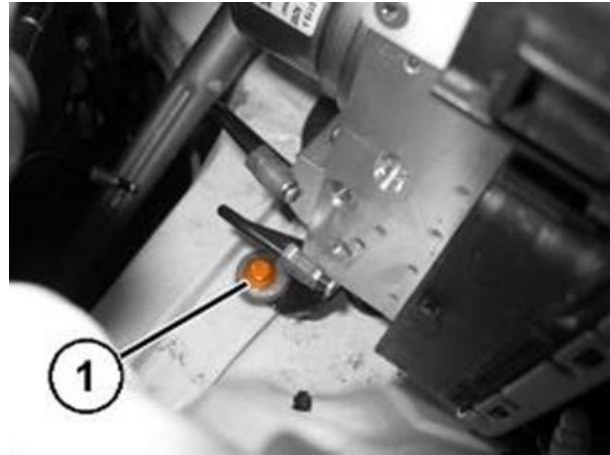
Figure 19 – ABS Mounting Bracket

NOTE: To facilitate the subsequent removal of the ABS control module, we advise loosening the screws attaching the aforementioned bracket to the ABS module first.

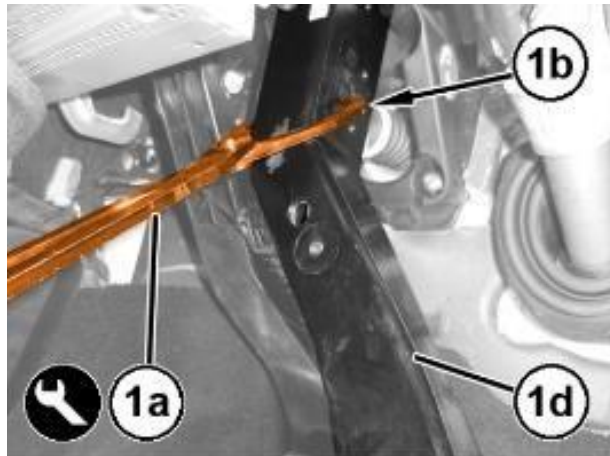
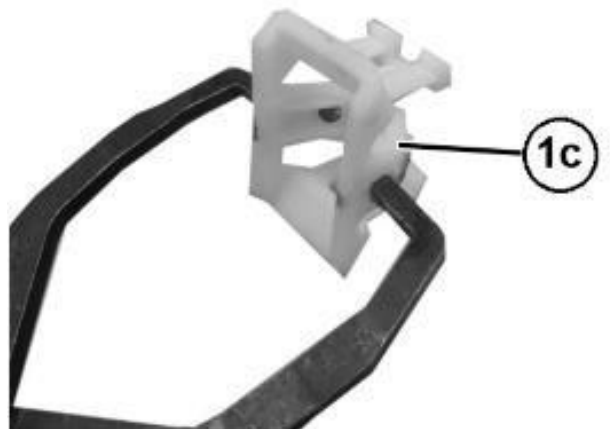
Figure 20 – Brake Pedal Retainer

34. Using the brake switch pliers 2000010500 (1a) positioned on the rear part of the holes (1b) of the brake pedal, compress the retaining device (1c) and retract the brake pedal (1d) at the same time in order to release the pedal from the ABS module push rod (Figure 20).

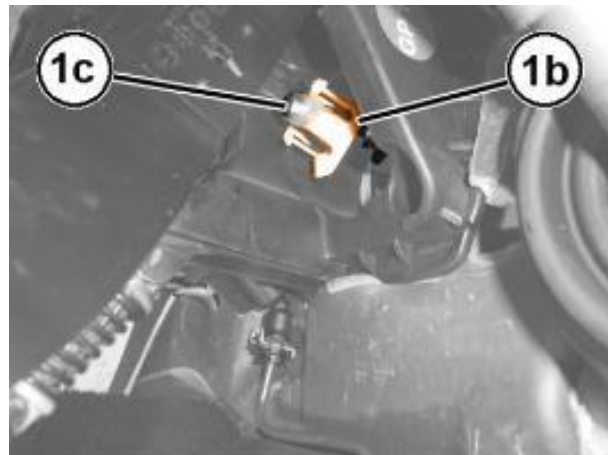
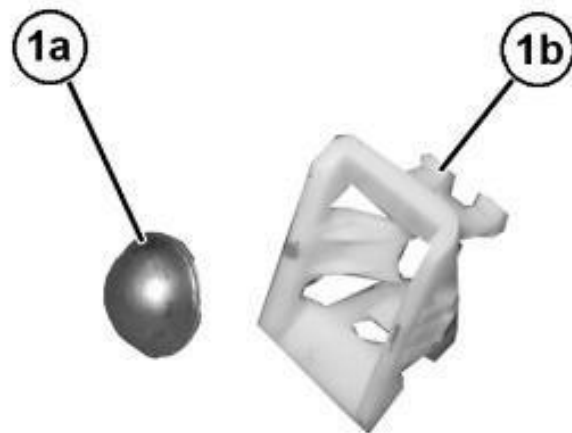
Figure 21 – Brake Pedal Retainer

NOTE: The retaining device must be replaced whenever the push rod is disconnected.

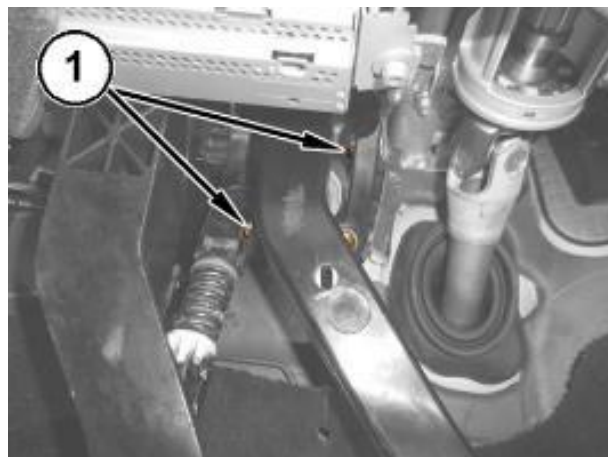
Figure 22 – ABS Module Nuts

36. Remove the nuts (1) attaching the ABS module to the pedal unit mounting (Figure 22).

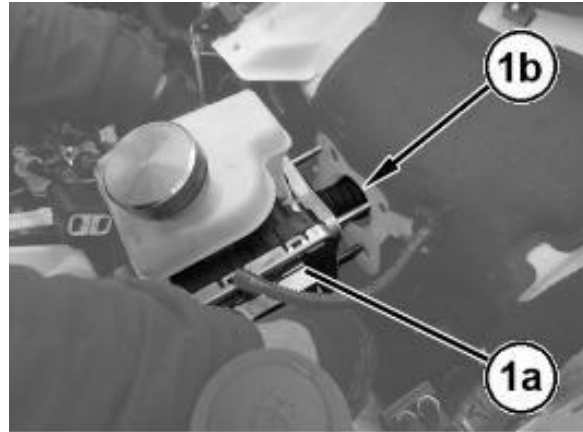
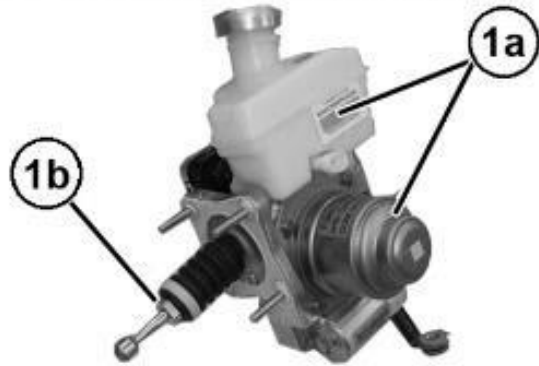
Figure 23 – ABS Module

37. Retract the ABS module (1a) and remove it releasing the push rod (1b) from the firewall (Figure 23).

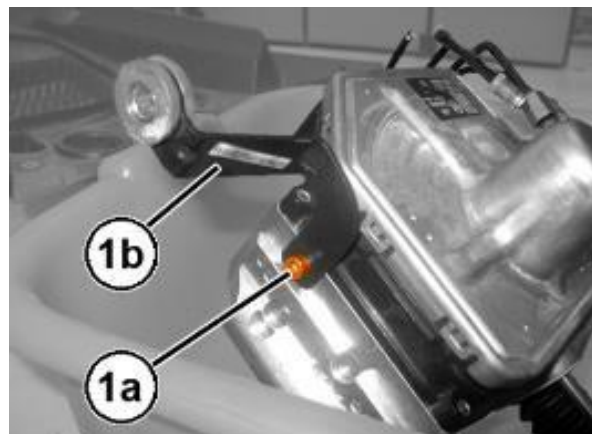
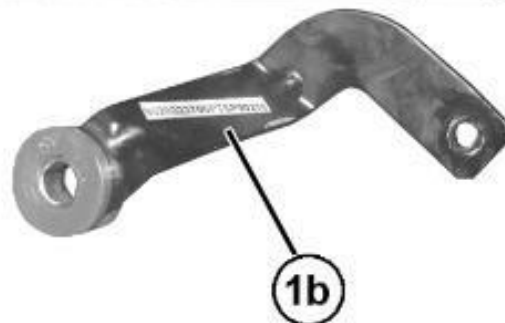
Figure 24 – ABS Module Support

38. Remove the screw (1a) and remove the ABS control module support bracket (1b) (Figure 24).

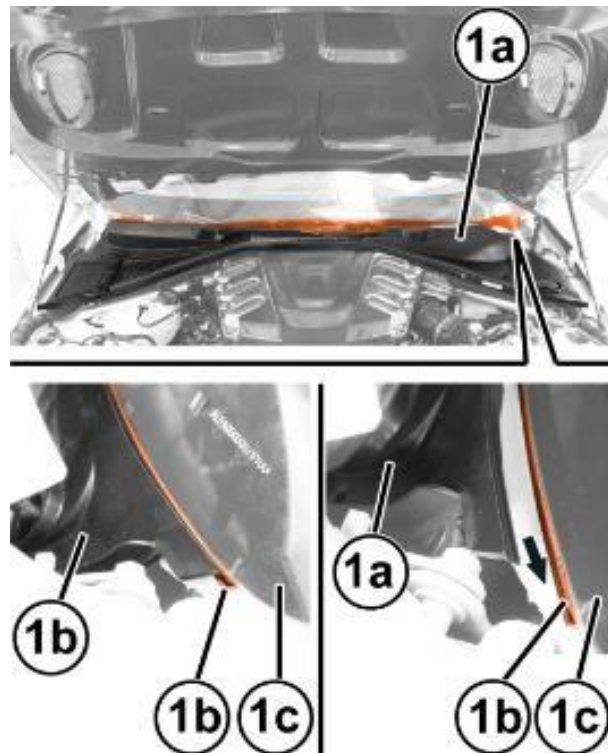
Figure 25 – Windshield Trim

CAUTION: Do not press the trim (1a) excessively into the retaining profile (1b) to avoid damaging the windshield.

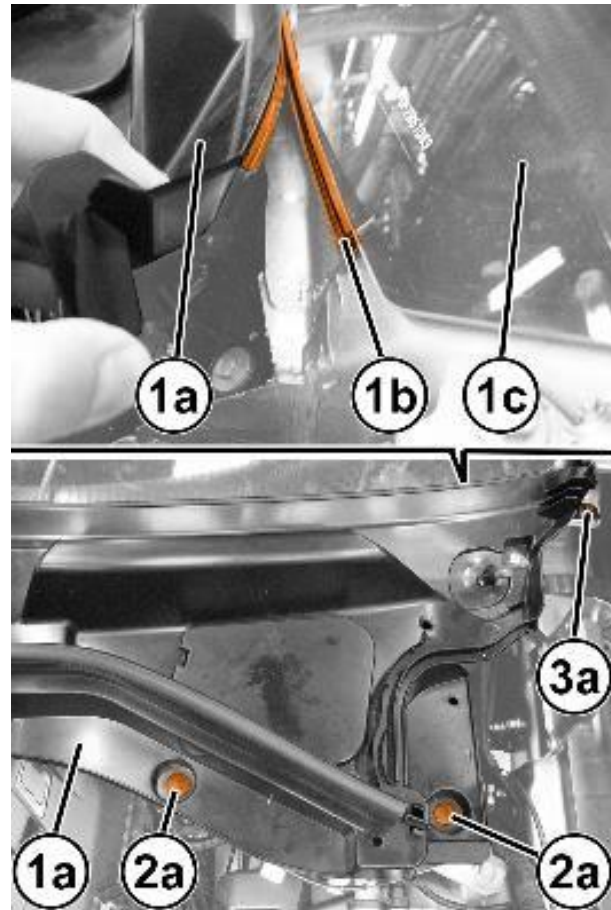
Figure 26 – Windshield Trim

55. Apply the retaining buttons (2a) with central pin (Figure 26).
56. Tighten the screw (3a) (Figure 26).
57. Working on the right side of the windshield frame trim, tighten the attaching screws.

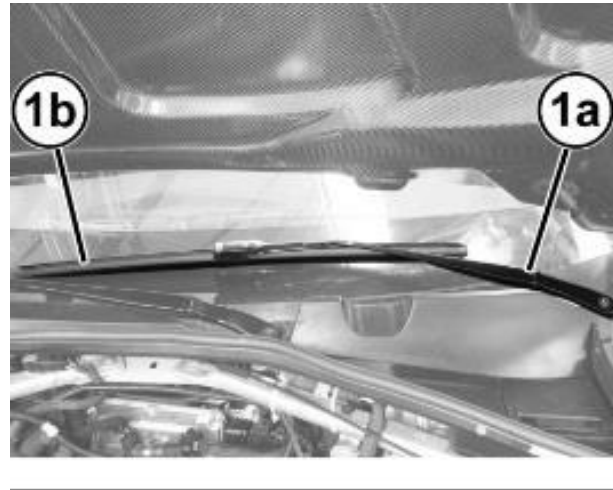
Figure 27 – Wiper Arm

61. Place the windshield wiper arm (1a) in position aligning the blade (1b) with the references (1c) etched on the windshield (Figure 27).

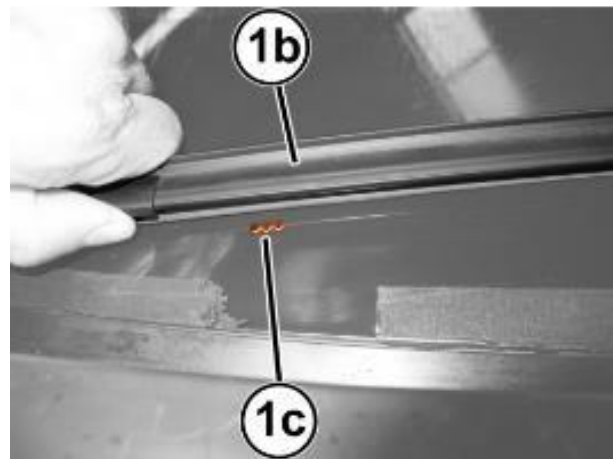
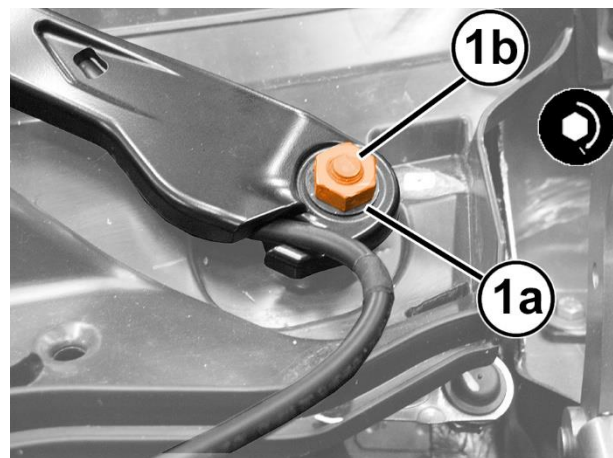
Figure 28 – Wiper Arm

62. Insert the washer (1a) and tighten the nut (1b) to the prescribed torque of 29 N·m (21 ft. lbs.) (Figure 28).

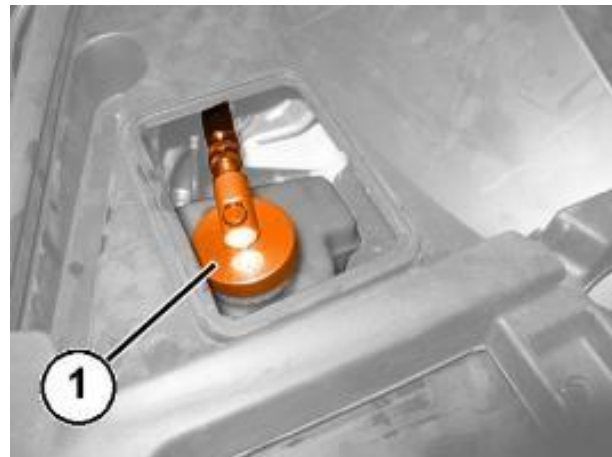
Figure 29 – Bleeding Equipment

70. Connect the bleeding equipment (1) to the brake fluid reservoir and pressurize the system (Figure 29).

NOTE: The operating pressure must be kept at 2 - 3 bar (29 - 43 psi) during the “First stage” and “Second stage” described below.

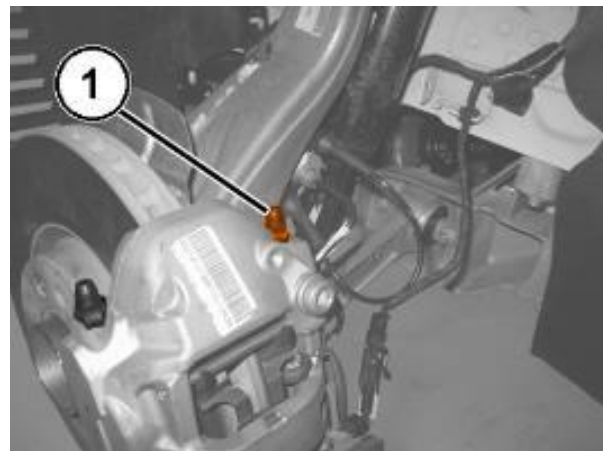
Figure 30 – Brake Bleeder Valve

71. Working at the right front caliper, position the brake fluid recovery hose to the INNER bleeder screw (1) and to the recovery container. Open the INNER bleeder screw (1) and without applying any pedal pressure on the system, allow a small amount of brake fluid to drain into the recovery container. Then tighten the bleeder screw and remove the recovery hose (Figure 30).

74. Repeat the procedure for the left rear caliper.
75. Working at the left front caliper, position the brake fluid recovery hose to the INNER bleeder screw (1) and to the recovery container. Open the bleeder screw and slowly press the brake pedal down fully three or more times, until there are no more air bubbles in the recovery hose. Then tighten the bleed valve to the prescribed torque of 10 N·m (89 In. lbs.) (Figure 30).

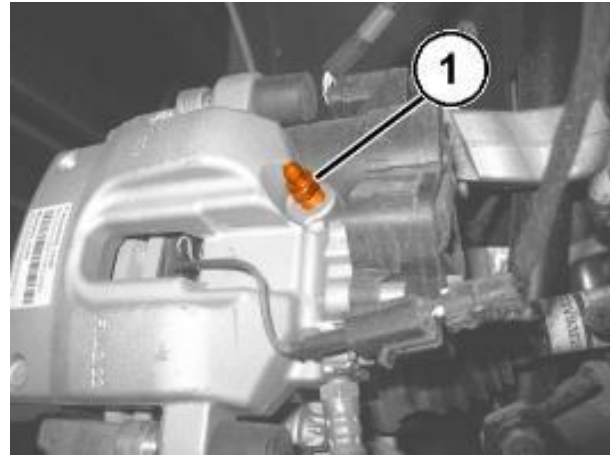
Figure 31 – Brake Bleeder Valve

73. Working at the right rear caliper, position the brake fluid recovery hose to the bleeder screw (1) and to the recovery container. Open the bleeder screw (1) and without applying any pedal pressure on the system, allow a small amount of brake fluid to drain into the recovery container. Then tighten the bleeder screw and remove the recovery hose (Figure 31).

76. Repeat the bleed procedure on the OUTER bleeder screw of the left front caliper.
77. Repeat the above operation on the left front brake caliper.
78. Connect the pipe to the valve of the rear right brake caliper. Open the valve, slowly press the brake pedal down fully three or more times, until there are no more air bubbles in the hose through which the oil flows into the container. Tighten the bleed valve to the prescribed torque of 10 N·m (89 In. lbs.) (Figure 31).

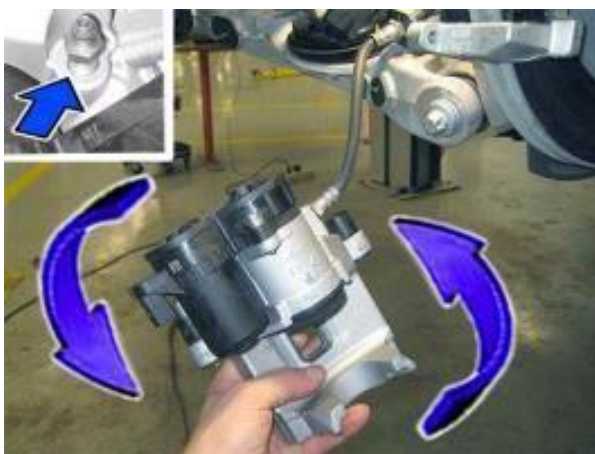
Figure 32 – Rotate Caliper

- 85. Find the out of tolerance caliper and remove it without disconnecting the hose.
- 86. Turn the brake caliper very slowly several times to the various possible positions, stop the motion and keep the bleed valve pointing upwards for a few minutes.

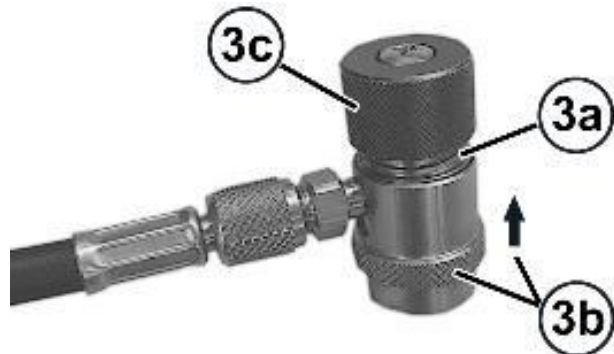
Figure 33 – Climate Control System

7. Connect the high pressure connecting pipe (**HIGH**) of the device to the corresponding quick coupling valve (1b) (Figure 33).

NOTE: To engage the connectors (3a) on the quick coupling valves, move the knurled ring nut (3b) upward. Fasten the ring nuts (3c) after insertion (Figure 33).

8. Connect the low pressure connecting pipe (**LOW**) to the corresponding quick coupling valve (1c) (Figure 33).

NOTE: To improve safety the quick couplings (3a) for the equipment connecting pipes have different diameters: the low pressure side is larger, while the high pressure side is smaller (Figure 33).

3. Drain the refrigerant using an R-1234yf refrigerant recovery recycling charging station that meets SAE standard J2843.
4. Let the engine run with the climate control system on for 10 - 15 minutes.
5. Depending on the vehicle engine type, remove/move any parts that hinder connection of the pipes of the refrigerant recovery recycling charging station (1a) to the corresponding climate control system re-pressurizing valves (1b) and (1c) (Figure 33).
6. Unscrew the re-pressurizing valve caps (1b) and (1c) (Figure 33).

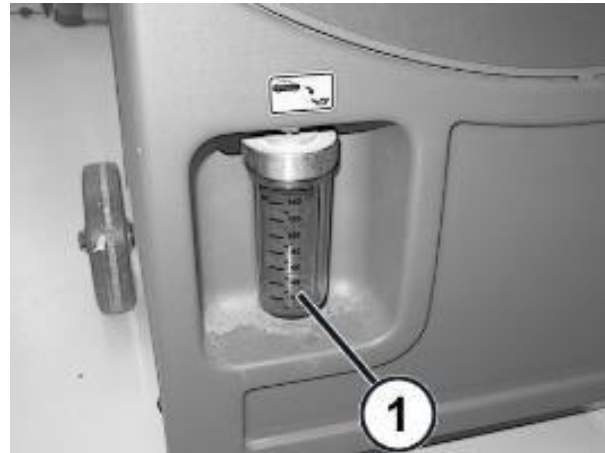
Figure 34 – Compressor Oil

10. When draining the system, the compressor oil extracted collects in a special container (1) (Figure 34).

CAUTION: The oil is very hygroscopic: do not leave the containers open.

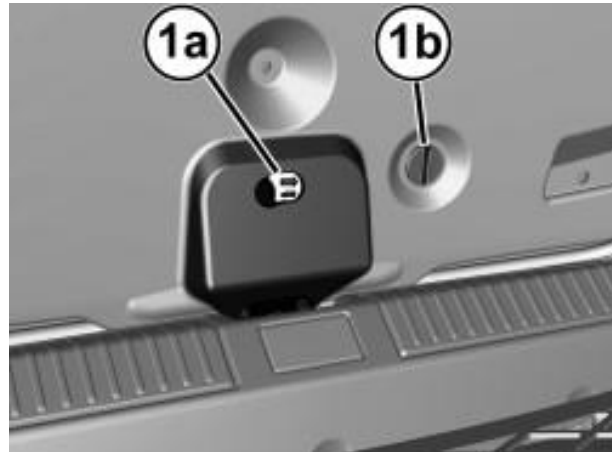
Figure 35 – Lid Lock Release

13. To be able to reopen the luggage compartment lid, even if it accidentally closes with the battery disconnected, before disconnecting the battery, it is necessary to unscrew the cap (1b), release the pull cord hooked onto it and leave it hanging out of the luggage compartment. Then, by working on the pull cord, an emergency luggage compartment lid lock release can be obtained. The pull cord operates on the lever (1a) inside (Figure 35).

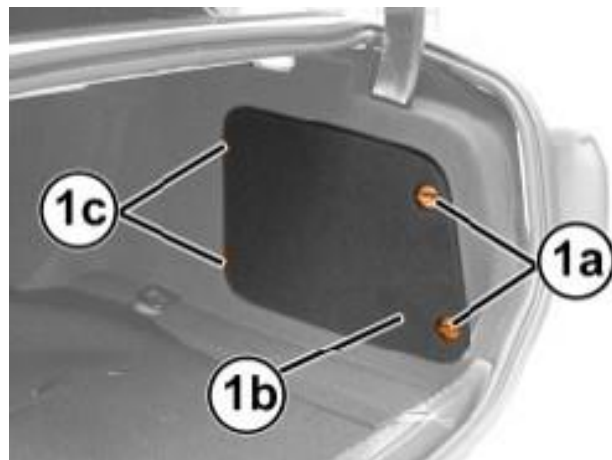
Figure 36 – Battery Cover

15. Remove the battery cover (1b) by releasing retainers (1a) (Figure 36).

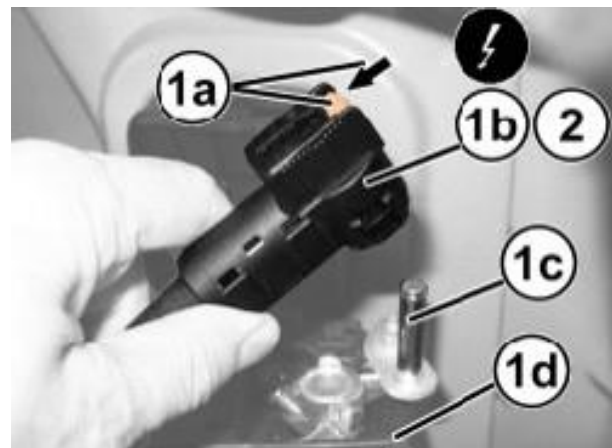
Figure 37 – Battery Negative Cable

17. Press the retainer (1a) and disconnect the terminal (1b) from the “negative dummy terminal” (1c) of the battery (1d) (Figure 37).

18. Move the terminal out of the way and isolate it (1b) (Figure 37).

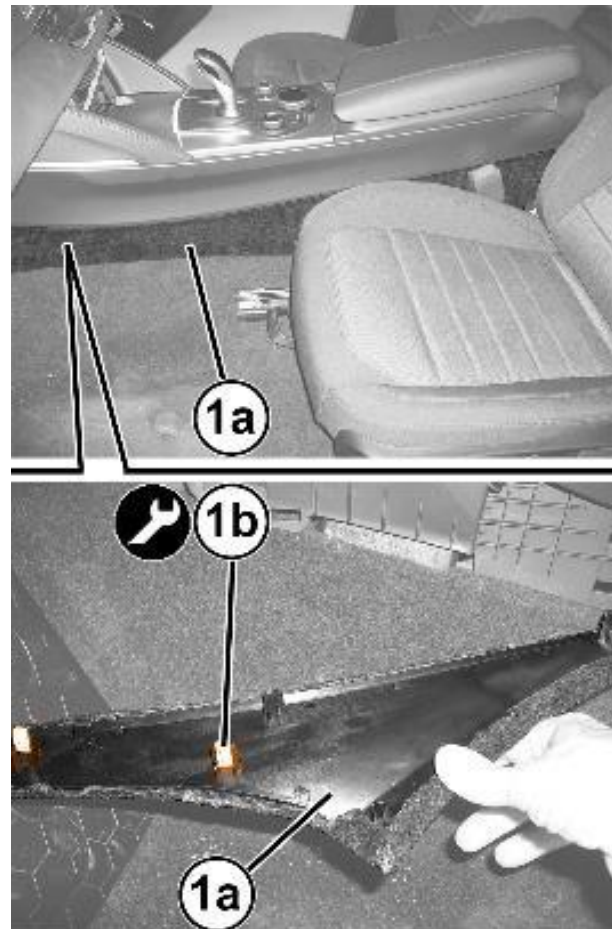
Figure 38 – Console Side Closure

19. Remove the console side closure (1a), by disengaging the various inner retainers (1b) using the appropriate tool Trim Stick C-4829A (1823015000) (Figure 38).

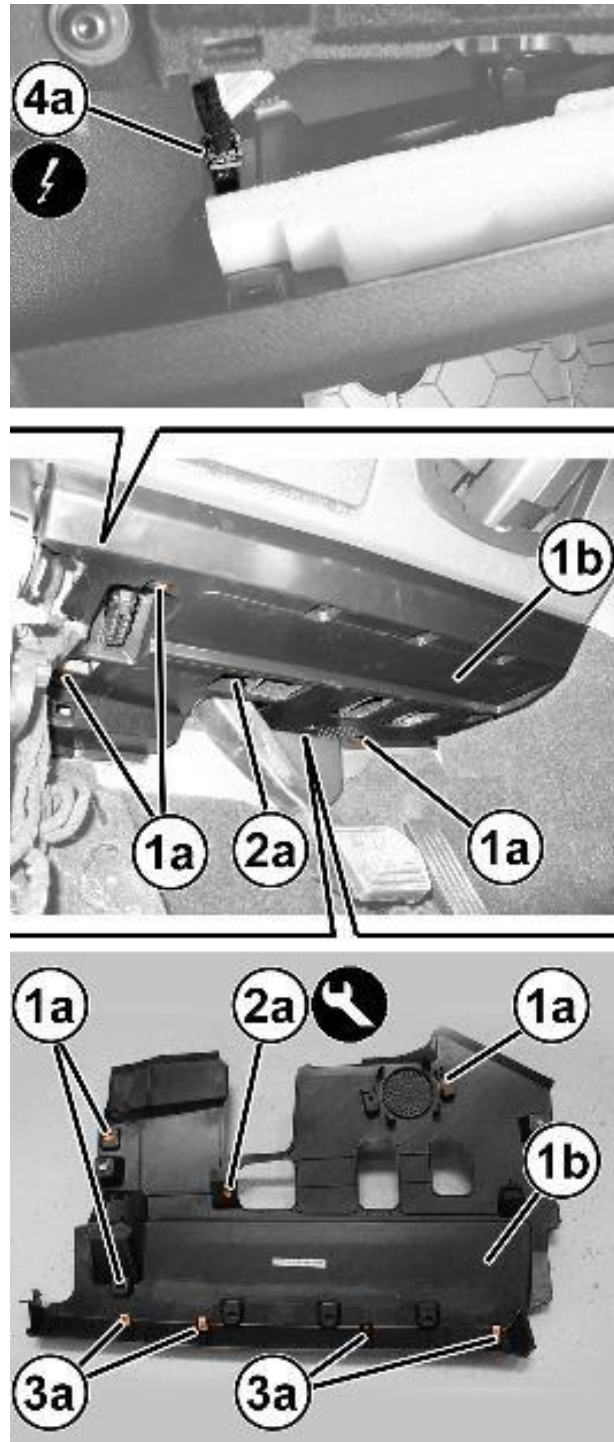
Figure 39 – Bottom Trim

23. Disconnect the electrical connection (4a) for the courtesy lights on the bottom trim (Figure 39).

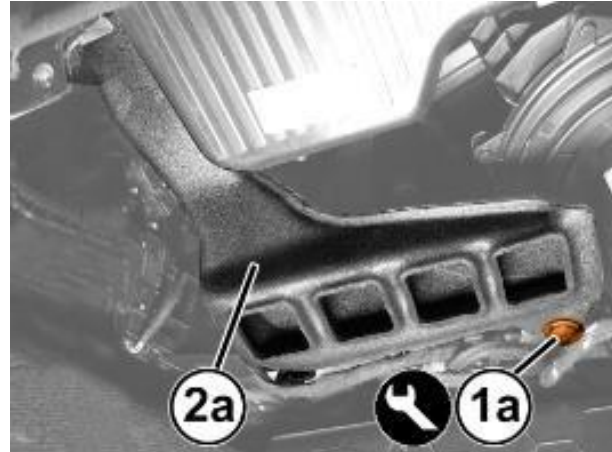
Figure 40 – Air Vent

24. Use tool Trim Stick C-4829A (1823015000) to disconnect the retaining pin with central pin (1a) and release the air vent (2a) (Figure 40).

CAUTION: Carefully move the air vent (2a) only when accessing the ABS module fasteners to avoid damaging it (Figure 40).

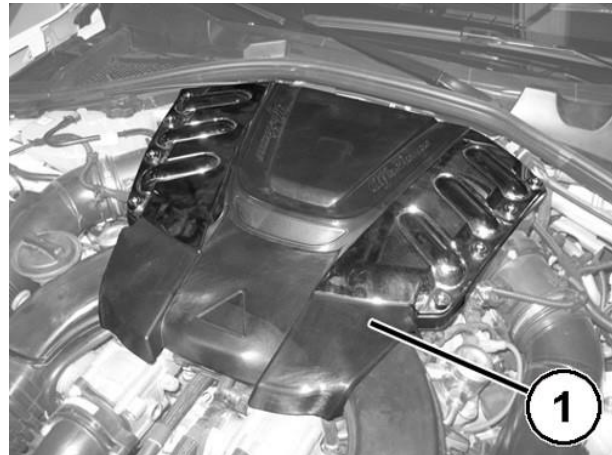
Figure 41 – Soundproofing Cover

25. Release the soundproofing cover (1) from the retaining pins and remove it (Figure 41).

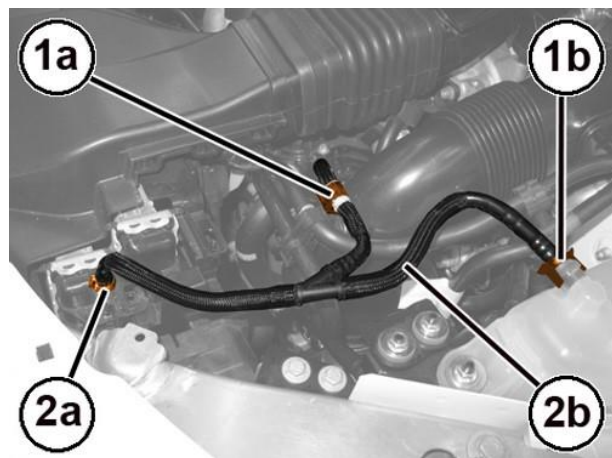
Figure 42 – Degassing Pipe

26. Open the clip (1a) and disconnect the quick coupling of the degassing pipe (1b) (Figure 42).
27. Loosen the clamp (2a) and disconnect the degassing pipe (2b) (Figure 42).

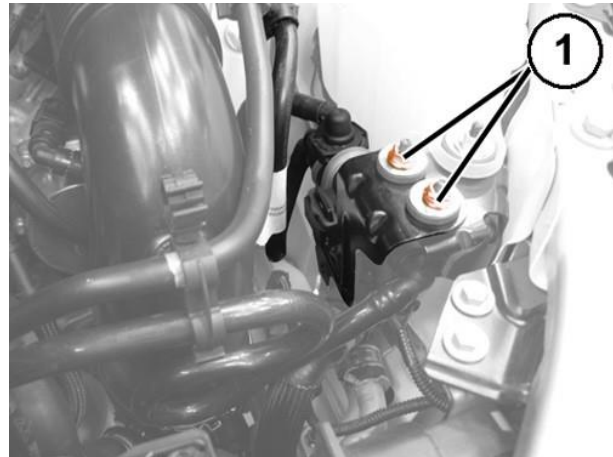
Figure 43 – Solenoid Support Bracket

28. Remove the attaching nuts (1) of the solenoid valve support bracket (Figure 43).

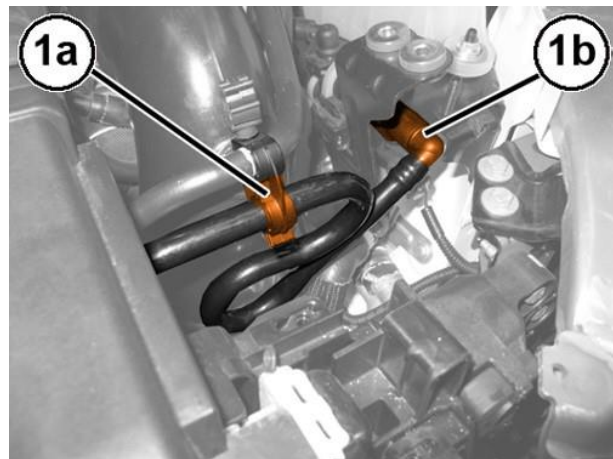
Figure 44 – Fuel Vapor Supply Pipe

29. Open the clip (1a) and disconnect the quick coupling (1b) of the fuel vapor supply pipe to the solenoid valve (Figure 44).

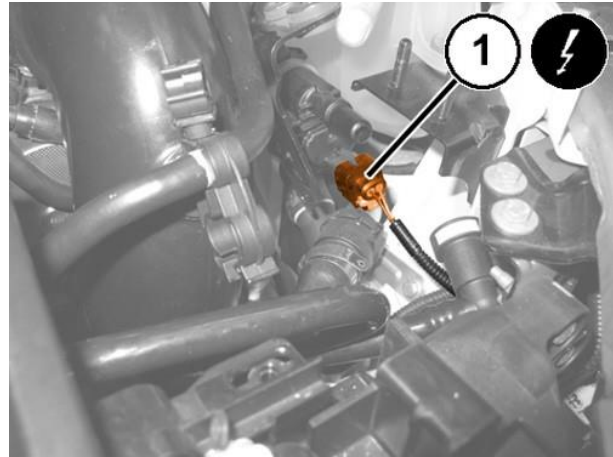
Figure 45 – Solenoid Valve Connector

30. Disconnect the electrical connection (1) for the solenoid valve (Figure 45).

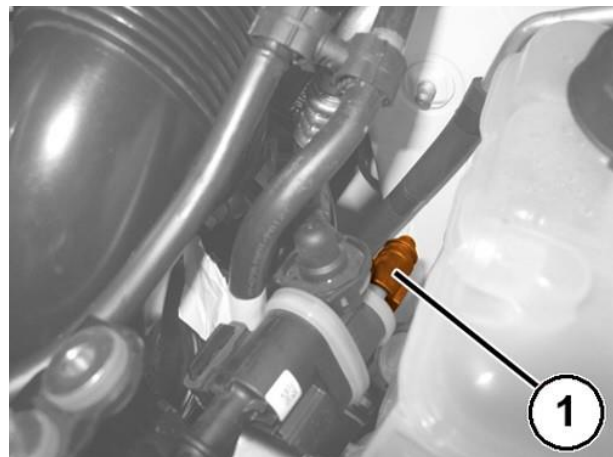
Figure 46 – Fuel Vapor Supply Pipe

31. Disconnect the quick coupling (1) of the fuel vapor supply pipe to the air sleeve between air flow meter and heat exchanger (Figure 46).

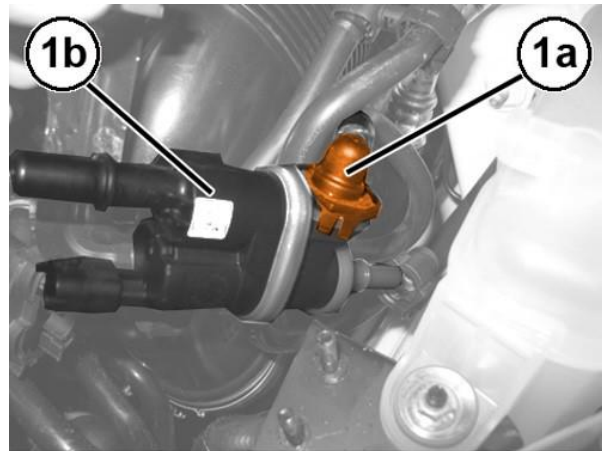
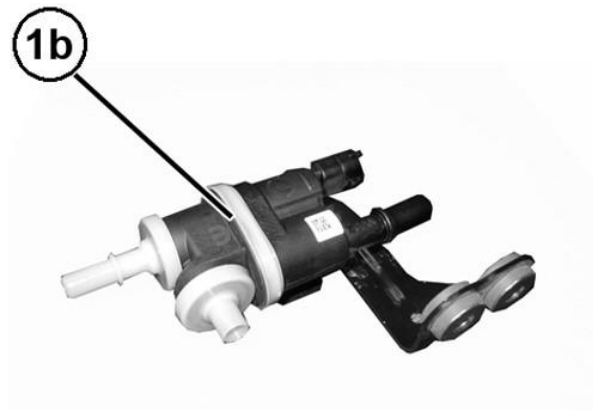
Figure 47 – Solenoid Valve

32. Work on the clips to disconnect the fuel vapor supply pipe to the intake manifold (1a) and remove the solenoid valve for consent of the fuel vapor passage to the intake (1b) (Figure 47).

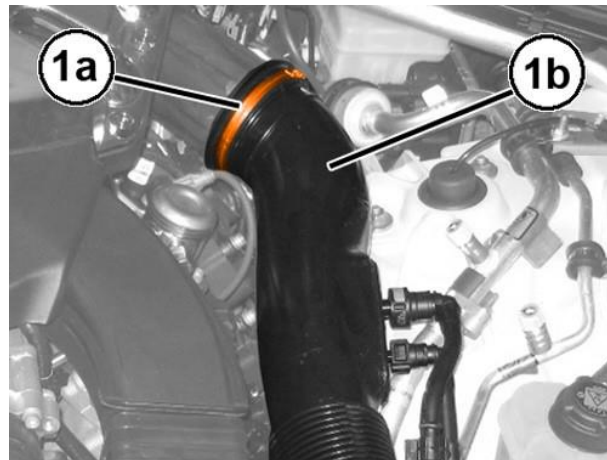
Figure 48 – Air Cleaner Outlet Tube

33. Loosen the clamp (1a) and disconnect the outlet tube (1b) from the air cleaner (Figure 48).

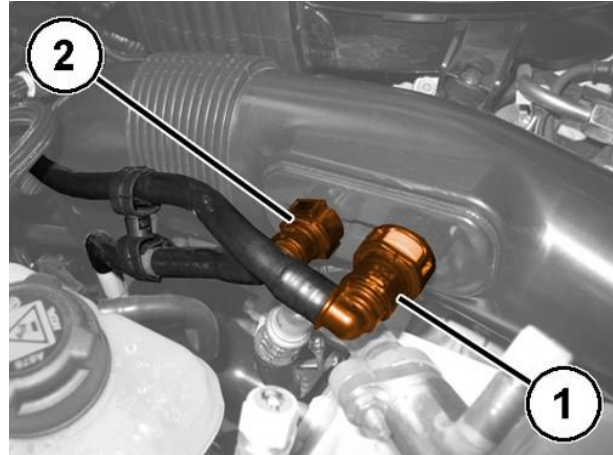
Figure 49 – Air Pipes Coupling

34. Disconnect the air piping quick coupling (1) between heat exchanger and left turbocharger intake (Figure 49).

35. Disconnect the fuel vapor supply pipe quick coupling (2) to the left turbocharger intake (Figure 49).

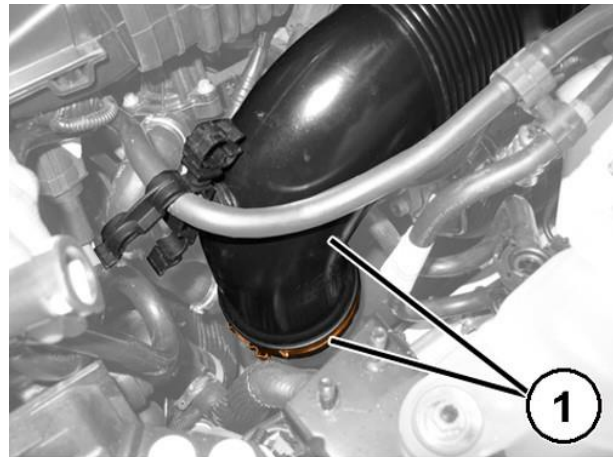
Figure 50 – Air Cleaner Outlet Tube

36. Loosen the clamp (1) and remove the outlet tube from air cleaner to left turbocharger air inlet pipe (Figure 50).

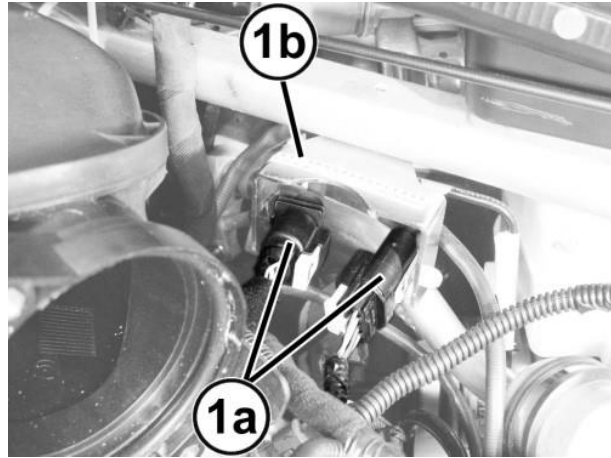
Figure 51 – Electrical Connectors

37. Release the electrical connections (1a) from the bracket (1b) and move it out of the way (Figure 51).

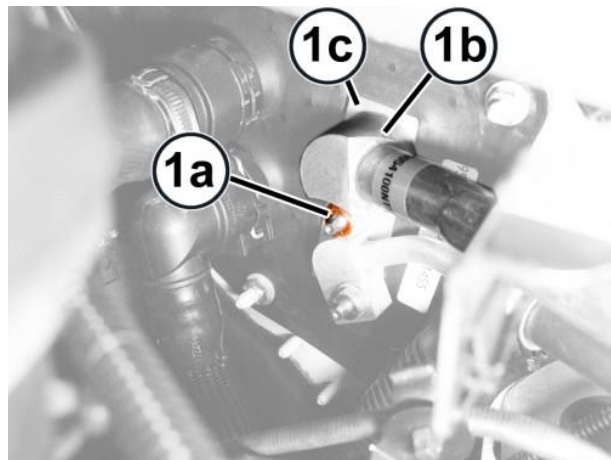
Figure 52 – Refrigerant Pipe

38. Remove the nut (1a) and disconnect the connector (1b) for the pipe from the expansion valve (1c) (Figure 52).

CAUTION: Seal the disconnected unions with suitable plugs to prevent moisture and impurities from entering the system.

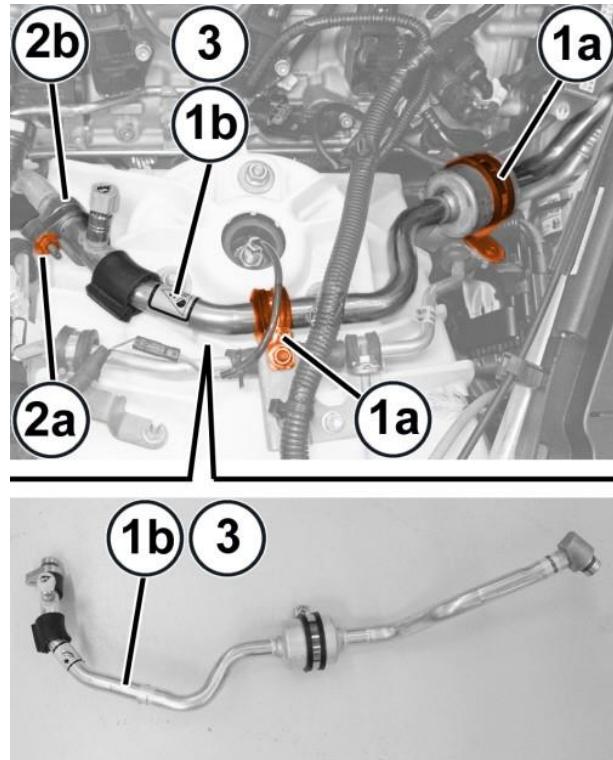
Figure 53 – Refrigerant Pipe

41. Remove the pipe (1b) (Figure 53).
