Safety Recall Y24 / NHTSA 21V-309 ABS Hydraulic Control Unit

2020 - 2021 (GA) Alfa Romeo Giulia

2019 - 2021 (GU) Alfa Romeo Stelvio

Replace the Anti-Lock Brake System (ABS) Hydraulic Control Unit (HCU).

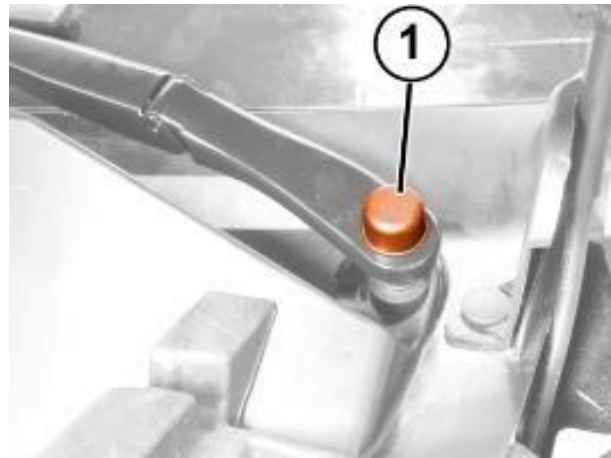
Figure 54 – Wiper Arm Nut Cover

42. Release the nut cover (1) at the base of the windshield wiper arm (Figure 54).

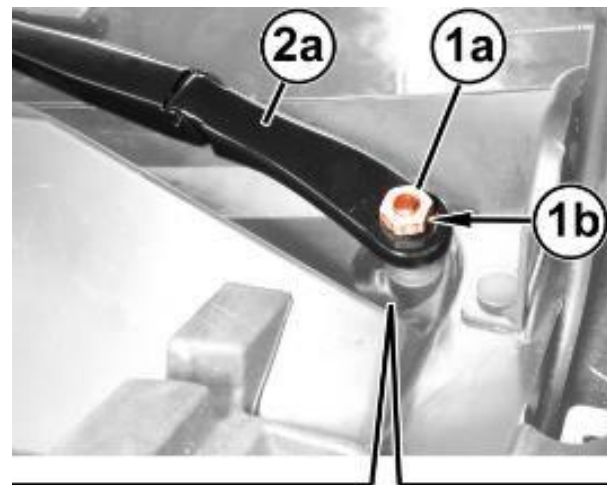
43. Remove the nut (1a) and keep the washer (1b) (Figure 55).
44. Remove the wiper arm (2a) (Figure 55).

NOTE: If necessary, remove the wiper arm using a suitable extractor to release the ribbed truncated cone coupling (3a) (Figure 55).

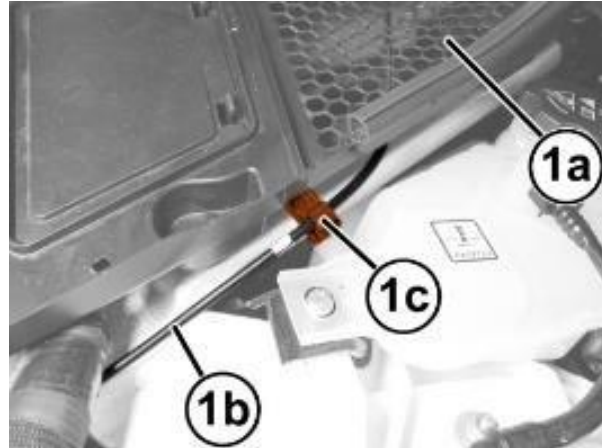
Figure 56 – Hood Opening Cable

- 45. Working on the front right side of the windshield base trim (1a), release the hood opening cable (1b) from the retainer (1c) (Figure 56).

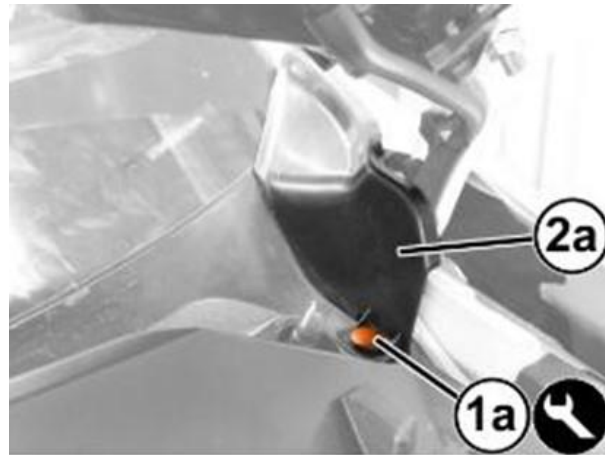
Figure 57 – Windshield Base Trim

- 46. Working on both sides of the windshield base trim, remove the retaining button (1a) after releasing its central pin using the appropriate tool Trim Stick C-4829A (1823015000) (Figure 57).

- 47. Remove the side moldings (2a) by releasing retainers (2b) (Figure 57).

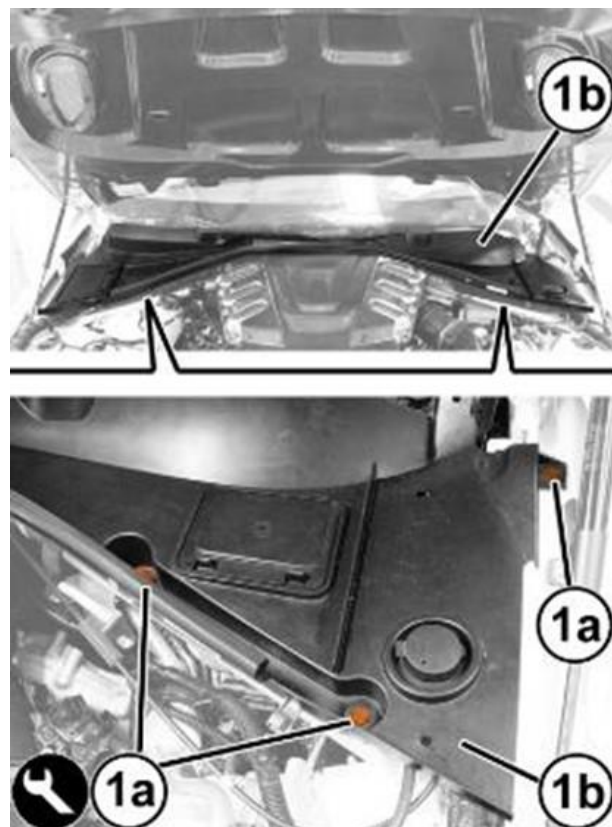
Figure 59 – Windshield Trim

50. Remove the retaining buttons (1a) from the windshield trim (1b), after releasing their central pins using the appropriate tool Trim Stick C-4829A (1823015000) (Figure 59).

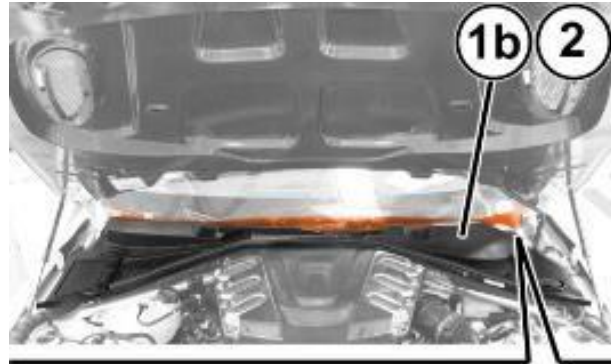
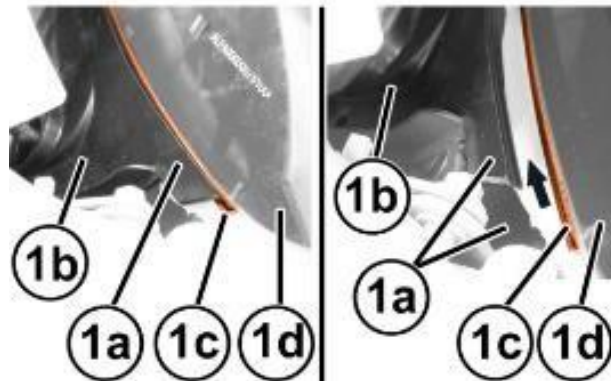
Figure 60 – Windshield Trim

51. Starting from one end (1a) gradually release the windshield base trim (1b) from the retainer profile (1c) along the windshield base (1d) (Figure 60).

CAUTION: Work carefully to avoid damaging the windshield (1d) and the profile (1c) (Figure 60).

52. Keep the windshield base trim (1b) (Figure 60).

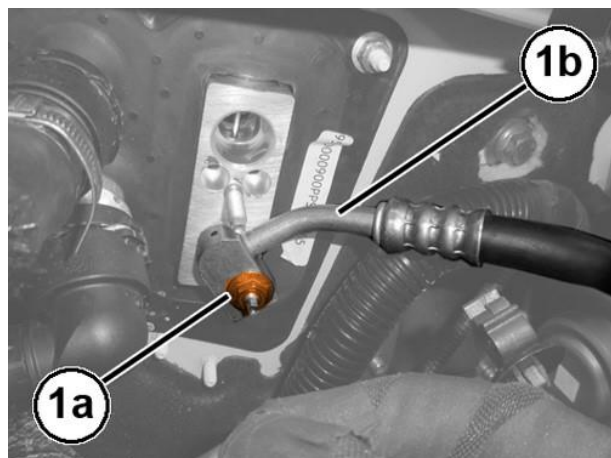
Figure 61 – Refrigerant Pipe

53. Remove the nut (1a) attaching the delivery pipe union (1b) to the condenser (Figure 61).

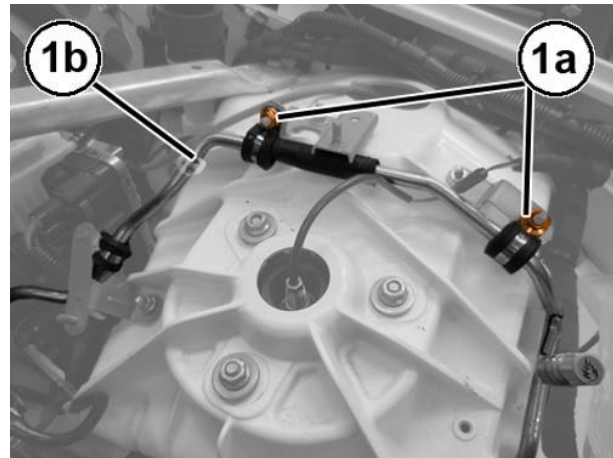
Figure 62 – Refrigerant Pipe

54. Remove the nut (1a) and move the supply pipe to the evaporator (1b) aside (Figure 62).

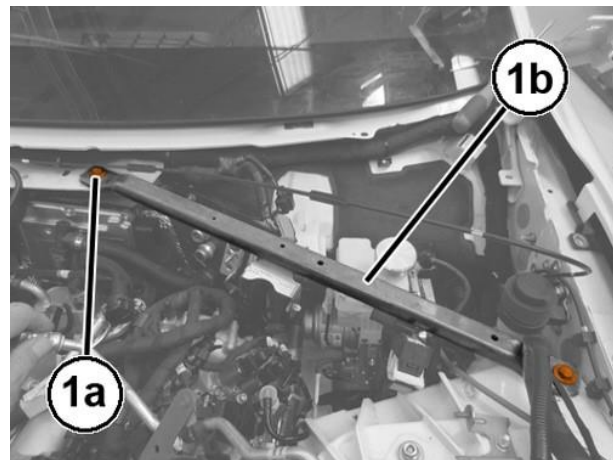
Figure 63 – Body Reinforcement

55. Remove the screws (1a) and remove the body reinforcement (1b) (Figure 63).

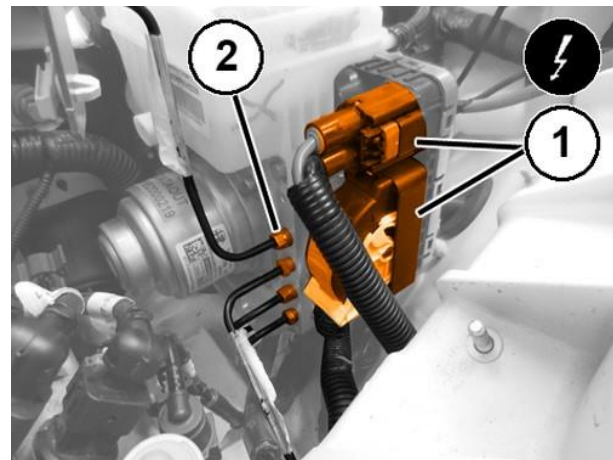
Figure 64 – ABS Module

57. Disconnect the electrical connections (1) of the ABS module (Figure 64).

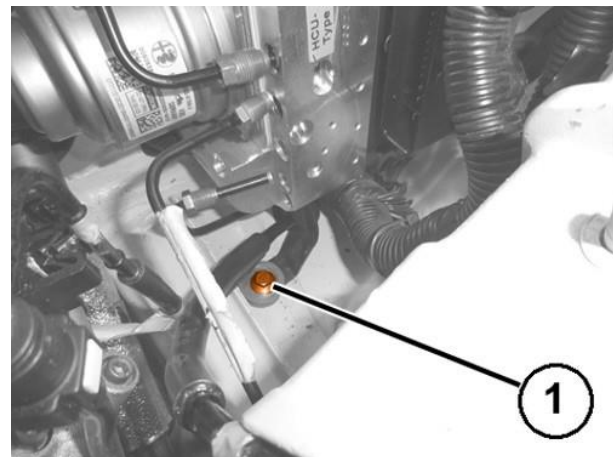
Figure 65 – Mounting Bracket

60. Remove the screw (1) attaching the ABS module mounting bracket to the body (Figure 65).

NOTE: To facilitate the subsequent removal of the ABS control module, we advise loosening the screws attaching the aforementioned bracket to the ABS control module.

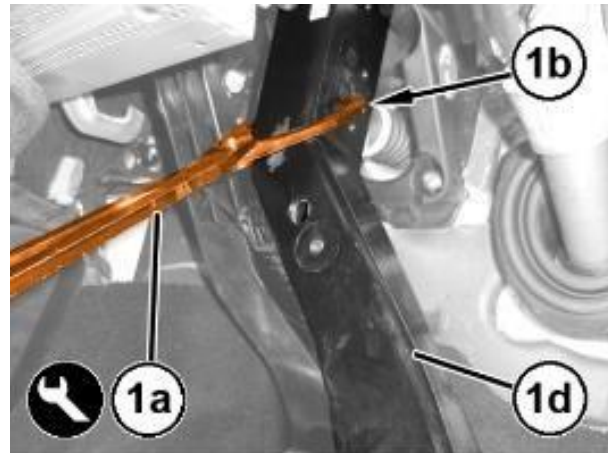
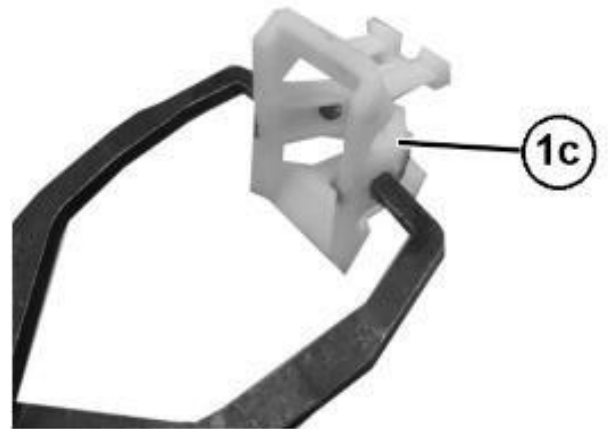
Figure 66 – Brake Pedal Retainer

61. Using the brake switch pliers 2000010500 (1a) positioned on the rear part of the holes (1b) of the brake pedal, compress the retaining device (1c) and retract the brake pedal (1d) at the same time in order to release the pedal from the ABS module push rod (Figure 66).

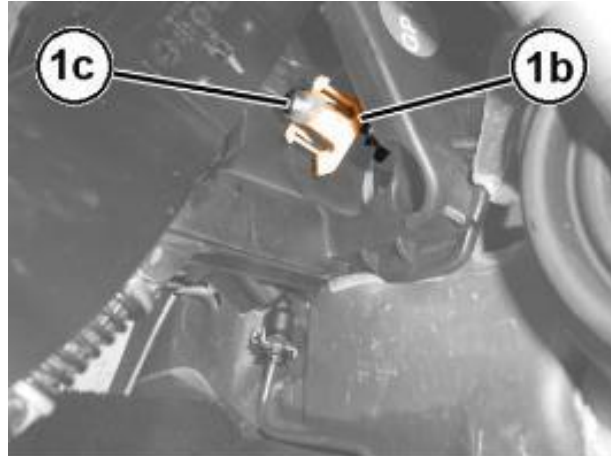
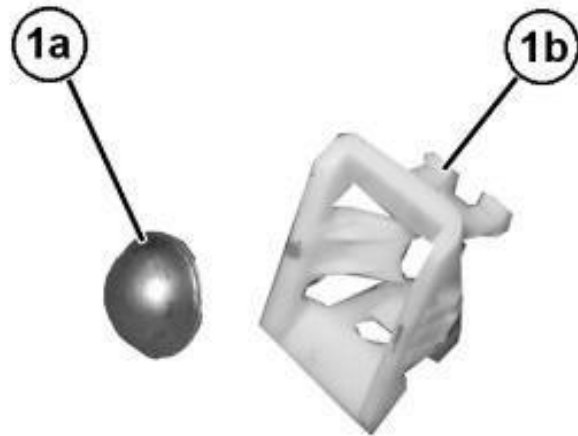
Figure 67 – Brake Pedal Retainer

NOTE: The retaining device must be replaced whenever the push rod is disconnected.

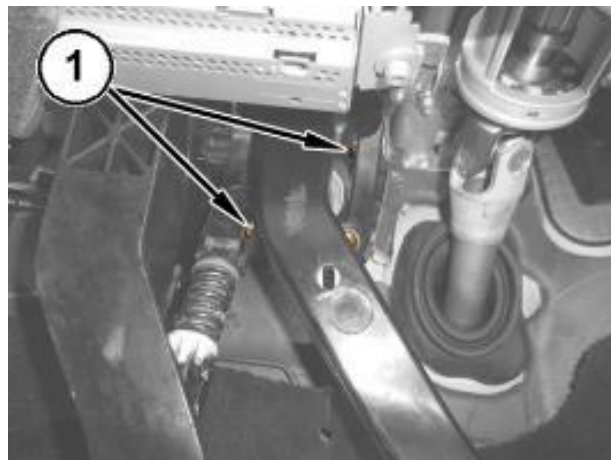
Figure 68 – ABS Module Nuts

- 63. Remove the nuts (1) attaching the ABS module to the pedal unit mounting (Figure 68).

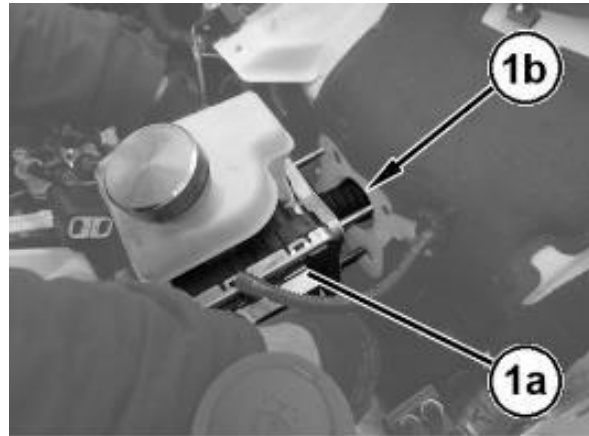
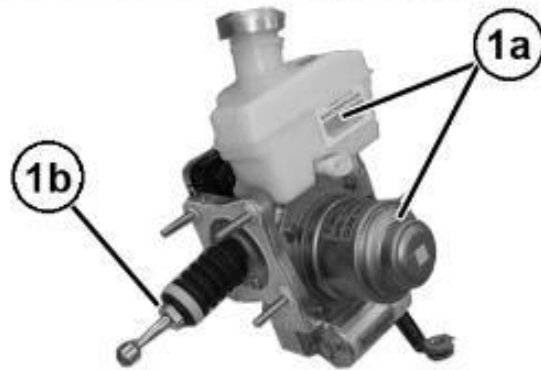
Figure 69 – ABS Module

- 64. Retract the ABS module (1a) and remove it releasing the push rod (1b) from the firewall (Figure 69).

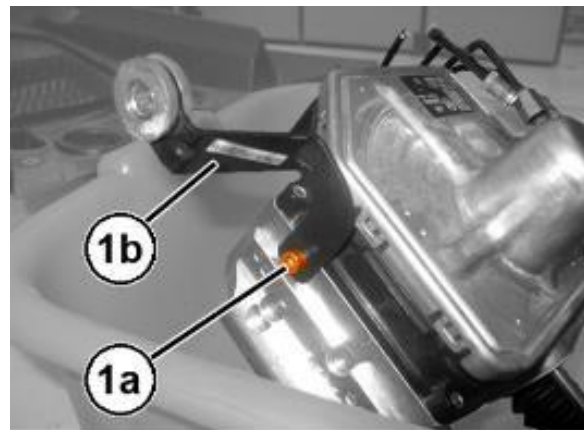
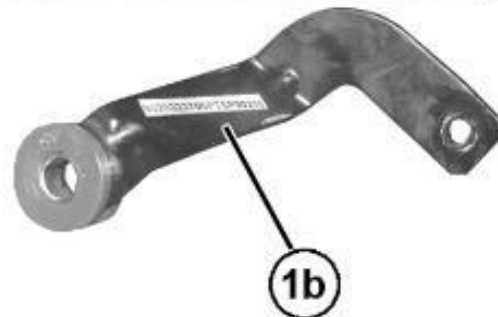
Figure 70 – ABS Module Support

- 65. Remove the screw (1a) and remove the ABS control module support bracket (1b) (Figure 70).

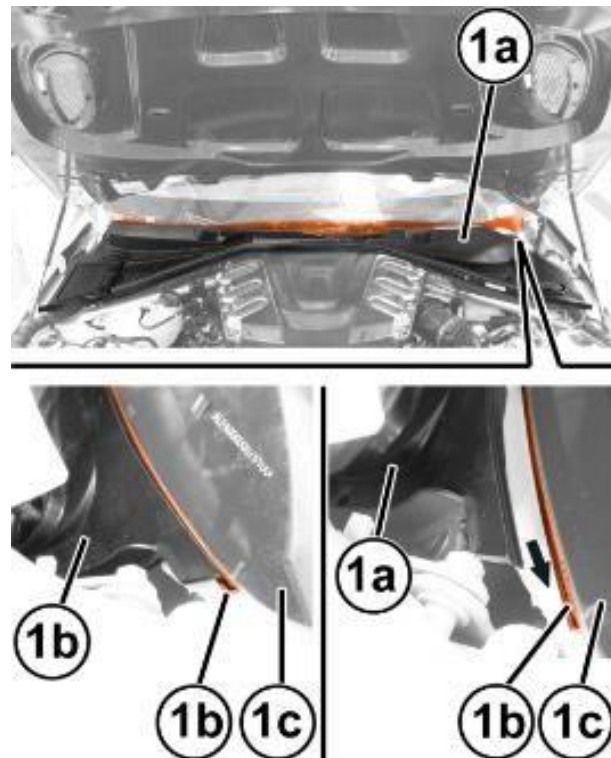
Figure 71 – Windshield Trim

CAUTION: Do not press the trim (1a) excessively into the retaining profile (1b) to avoid damaging the windshield (Figure 71).

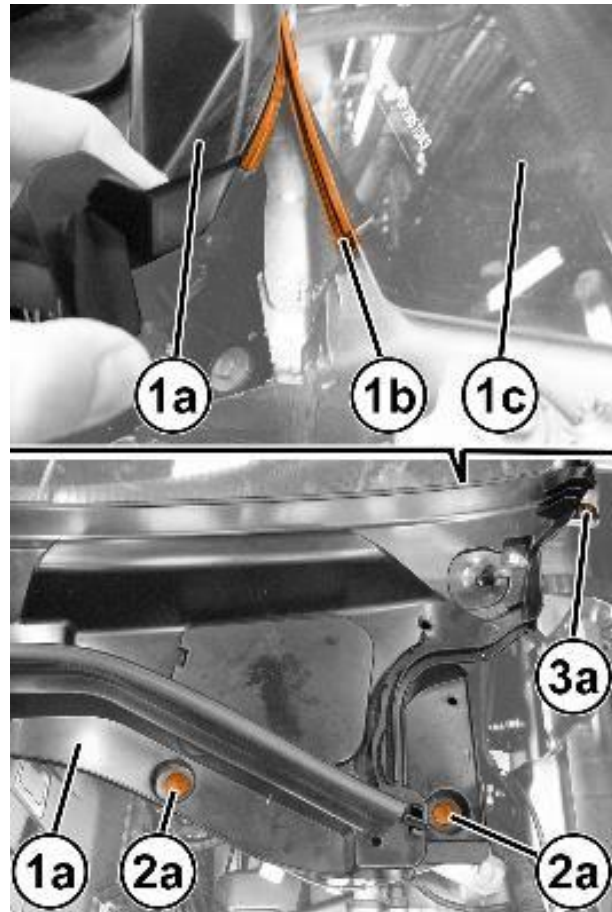
Figure 72 – Windshield Trim

97. Position the windshield base trim (1a) in position and engage the retaining profile (1b) along the entire windshield base (1c) (Figure 72).

NOTE: If necessary, use soapy water to facilitate inserting the trim (1a) into the retaining profile (1b) (Figure 72).

CAUTION: Do not press the trim (1a) excessively into the retaining profile (1b) to avoid damaging the windshield (Figure 72).

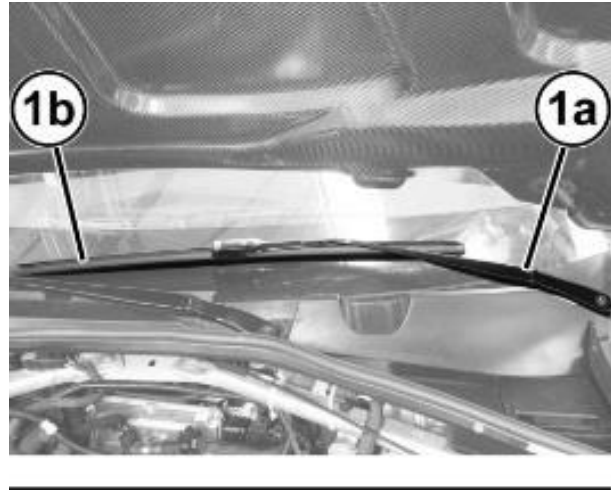
Figure 73 – Wiper Arm

102. Place the windshield wiper arm (1a) in position aligning the blade (1b) with the references (1c) etched on the windshield (Figure 73).

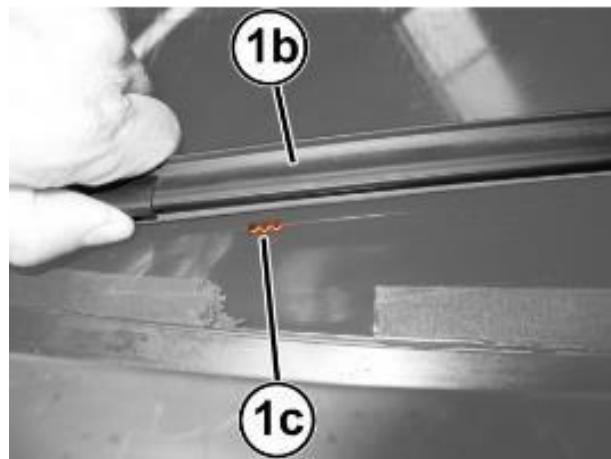
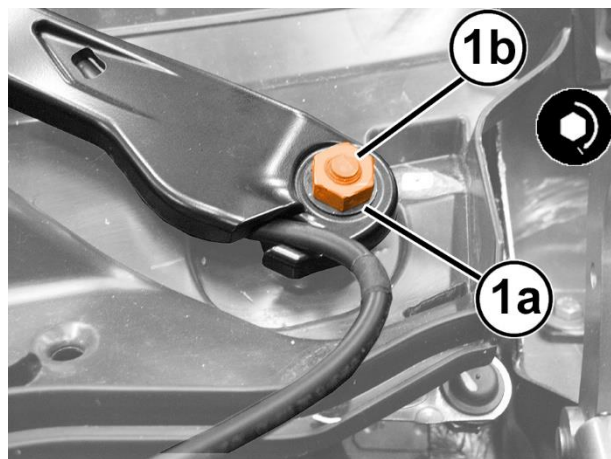
Figure 74 – Wiper Arm

103. Insert the washer (1a) and tighten the nut (1b) to the prescribed torque of 29 N·m (21 ft. lbs.) (Figure 74).

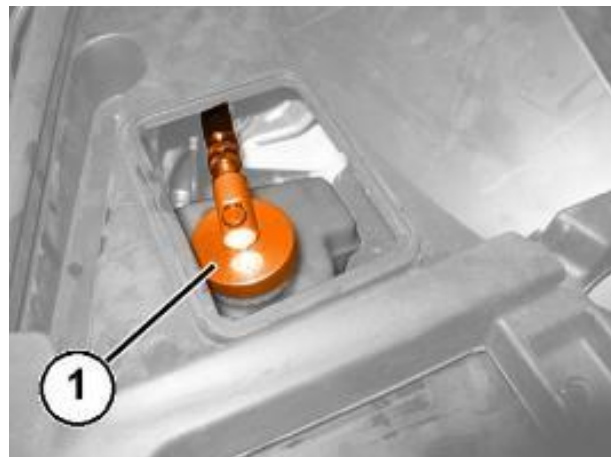
Figure 75 – Bleeding Equipment

115. Connect the bleeding equipment (1) to the brake fluid reservoir and pressurize the system (Figure 75).

NOTE: The operating pressure must be kept at 2 - 3 bar (29 - 43 psi) during the “First stage” and “Second stage” described below.

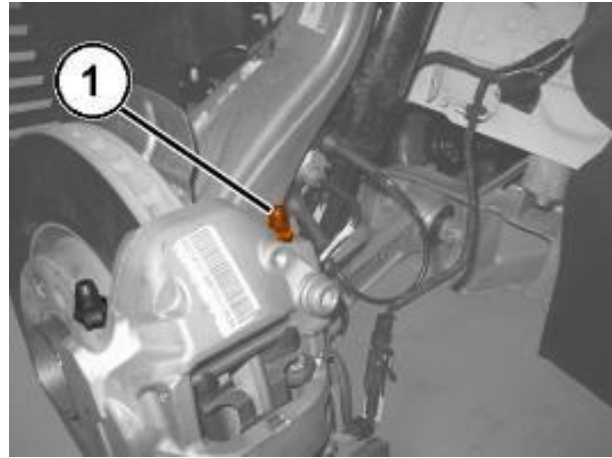
Figure 76 – Brake Bleeder Valve

116. Working at the right front caliper, position the brake fluid recovery hose to the INNER bleeder screw (1) and to the recovery container. Open the INNER bleeder screw (1) and without applying any pedal pressure on the system, allow a small amount of brake fluid to drain into the recovery container. Then tighten the bleeder screw and remove the recovery hose (Figure 76).

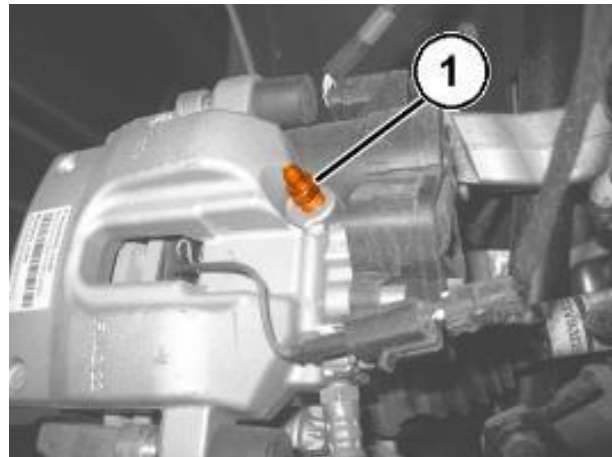
Figure 77 – Brake Bleeder Valve

118. Working at the right rear caliper, position the brake fluid recovery hose to the bleeder screw (1) and to the recovery container. Open the bleeder screw (1) and without applying any pedal pressure on the system, allow a small amount of brake fluid to drain into the recovery container. Then tighten the bleeder screw and remove the recovery hose (Figure 77).

- 123. Connect the pipe to the valve of the rear right brake caliper. Open the valve, slowly press the brake pedal down fully three or more times, until there are no more air bubbles in the hose through which the oil flows into the container. Tighten the bleed valve to the prescribed torque of 10 N·m (89 In. lbs.) (Figure 77).

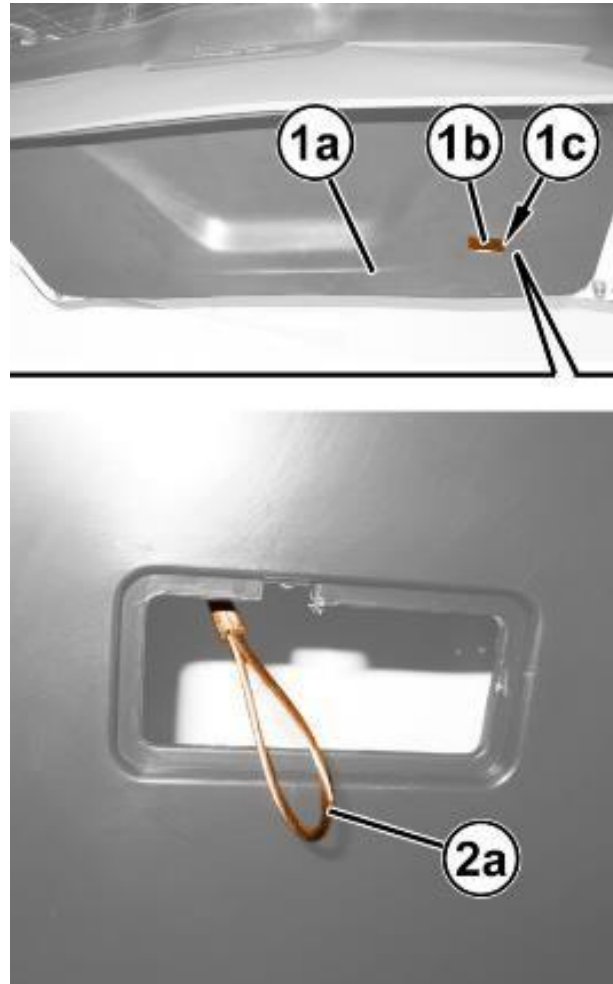
**Figure 79 – Lid Lock Release**

5. To be able to reopen the luggage compartment lid, even if it accidentally closes with the battery disconnected, before disconnecting the battery it is necessary to Remove cover (1b) on the luggage compartment lid (1a). There is a cable (2a) that is attached to the cover that will pull out of the opening. Leave it hanging out of the luggage compartment. Then pull the cable to release the luggage compartment lid latch (Figure 79).

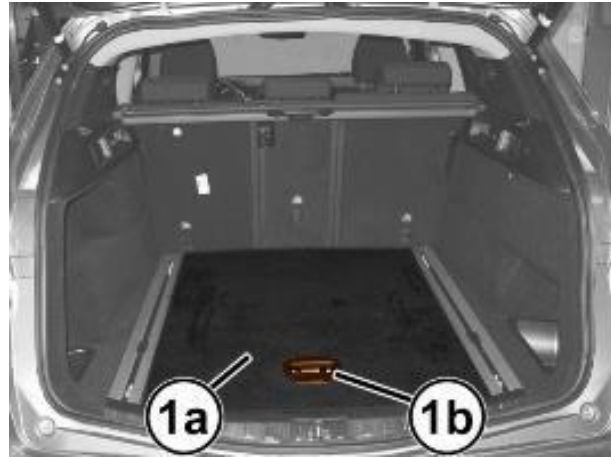
Figure 80 – Load Floor Cover

6. Using the handle (1b), lift out the load floor cover (1a) (Figure 80).

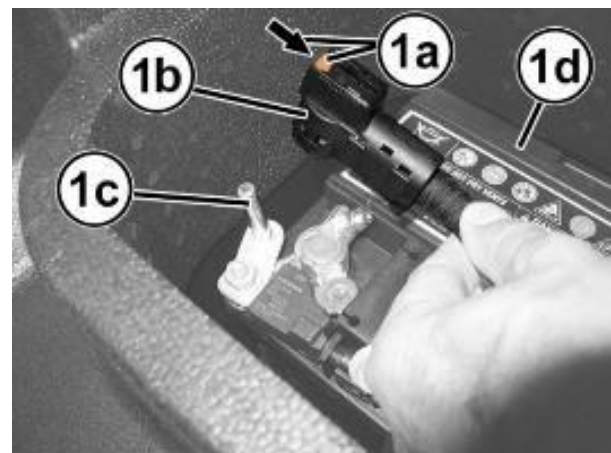
Figure 82 – Battery Negative Cable

8. If equipped with an Intelligent Battery Sensor (IBS), disconnect the IBS connector.
9. Press the retainer (1a) and disconnect the terminal (1b) from the “negative dummy terminal” (1c) of the battery (1d) (Figure 82).
10. Move the terminal out of the way and isolate it (1b) (Figure 82).

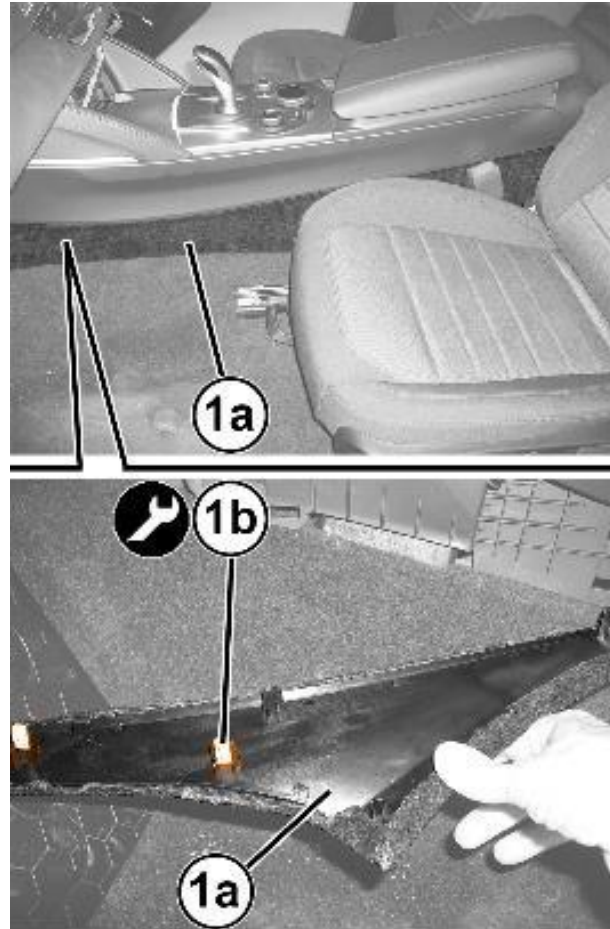
Figure 83 – Console Side Closure

11. Remove the console side closure (1a), by disengaging the various inner retainers (1b) using the appropriate tool 2000040516 (Figure 83).

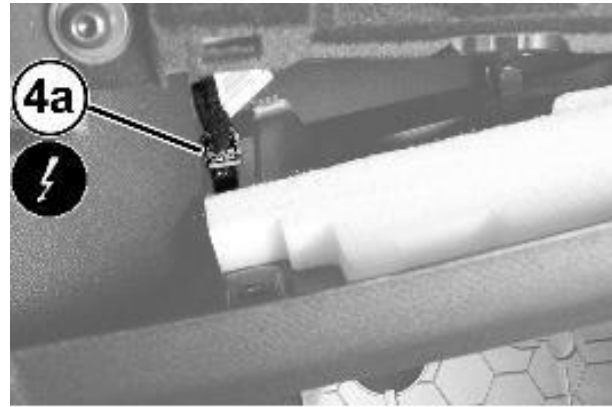
Figure 84 – Lower Lining

12. Remove the screws from the housings (1a) of the lower lining (1b) (Figure 84).

13. Release the retaining button from the housing (2a), using the special tool Trim Stick C-4829A (1823015000) (Figure 84).

14. Pull down the lower lining (1b) by releasing the inner retainers (3a) (Figure 84).

15. Disconnect the electrical connection (4a) for the courtesy lights on the lower lining (Figure 84).

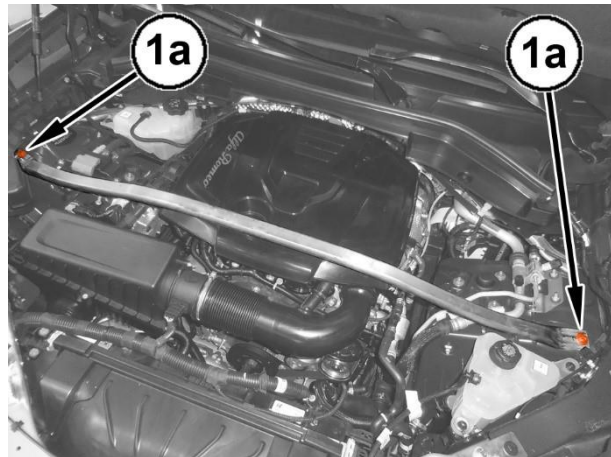
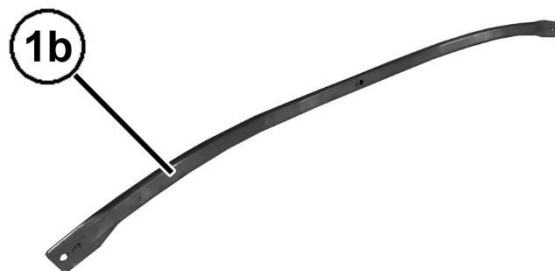
Figure 86 – Strut Bar

17. Remove the screws (1a) and remove the strut bar (1b) (Figure 86).

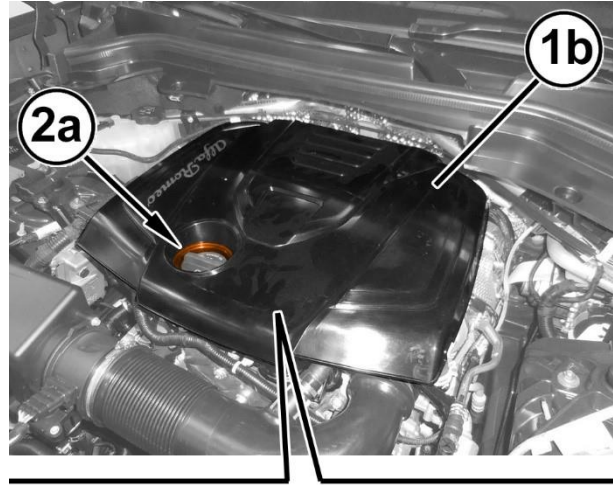
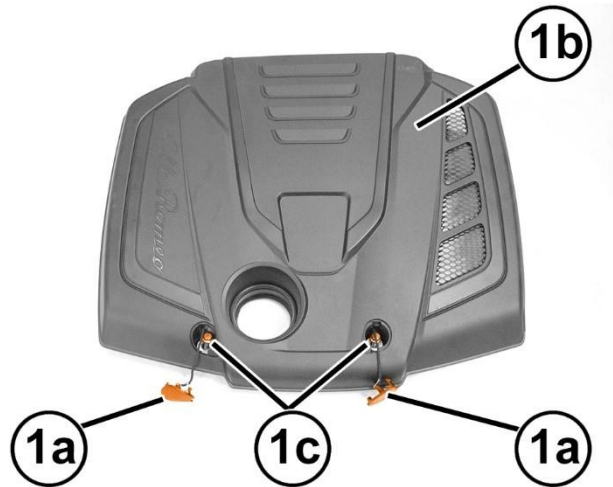
Figure 87 – Soundproofing Cover

18. Disengage covers (1a) of the cover (1b) and remove the screws (1c) (Figure 87).

19. Disengage from the rear retaining pins and remove the soundproofing cover (1b) complete with seal (2a) for the engine oil (Figure 87).

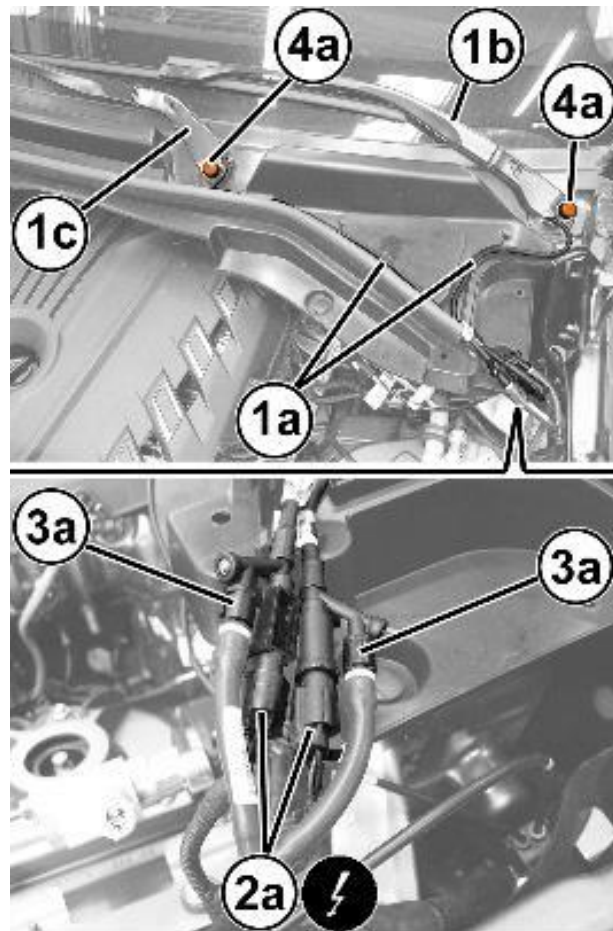
Figure 88 – Wiper Arm

20. Release from its housing the pipe (1a) of the windshield wiper arm (1b) or (1c) that is being detached (Figure 88).
21. Disconnect the electrical connection (2a) for the concerned windshield wiper arm (1b) or (1c) (Figure 88).
22. Disconnect the quick connector (3a) of the pipe (1a) that is being detached (Figure 88).
23. Release the nut cover (4a) at the base of the windshield wiper arm that is being detached (Figure 88).

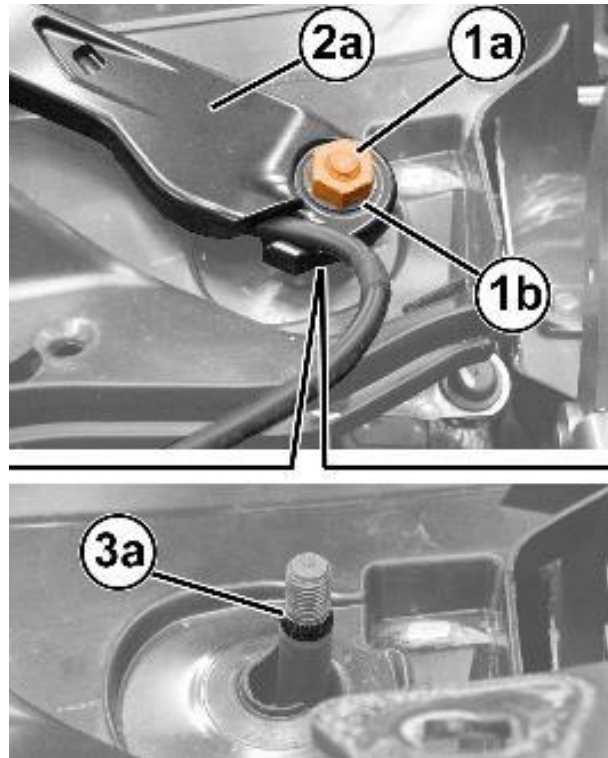
**Figure 89 – Wiper Arm**

24. Remove the nut (1a) and keep the washer (1b) (Figure 89).
25. Remove the windshield wiper arm (2a) complete with the pipe and windshield washer jet (Figure 89).
26. If necessary, remove the wiper arm using a suitable extractor to release the ribbed truncated cone coupling (3a) (Figure 89).

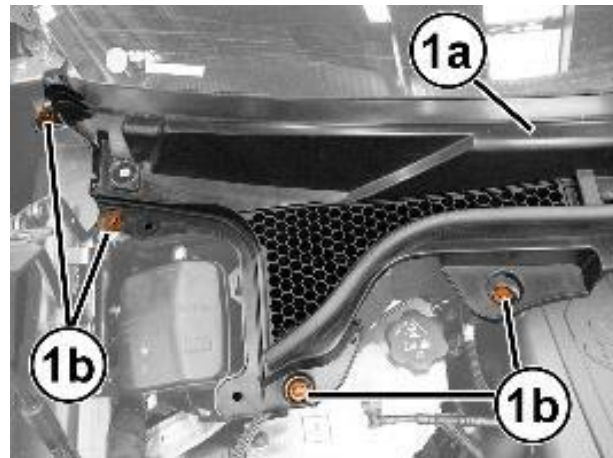
Figure 90 – Windshield Trim

27. Working on the right side of the windshield frame trim (1a), remove the screws (1b) (Figure 90).

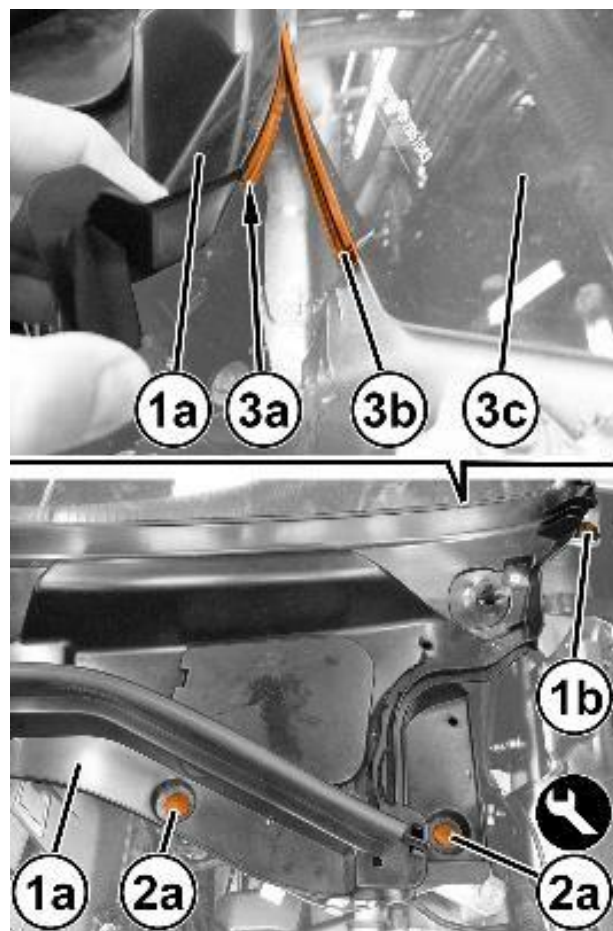
Figure 91 – Windshield Trim

31. Keep the windshield base trim (1a) (Figure 91).

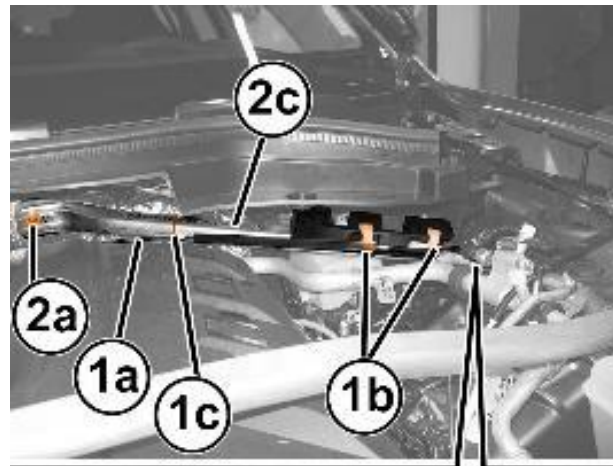
32. Release the rod (1a) from the retainers (1b) and the band (1c) (Figure 92).

33. Remove the nut (2a) and the screws (2b), and remove the left bar (2c), releasing it from its position (Figure 92).

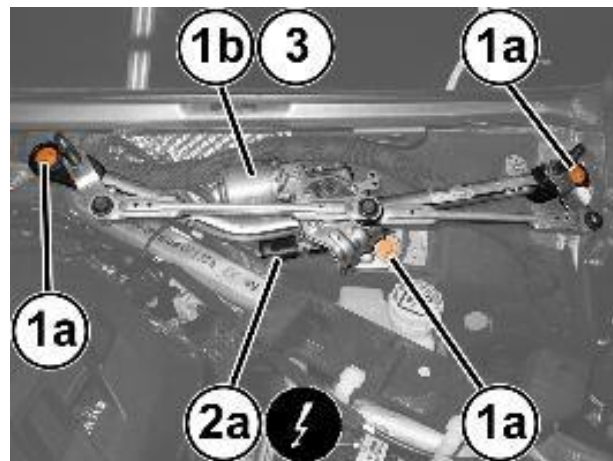
Figure 93 – Wiper Assembly

35. Move the windshield wiper assembly (1b) slightly and disconnect the electrical connection (2a) from the windshield wiper motor (Figure 93).

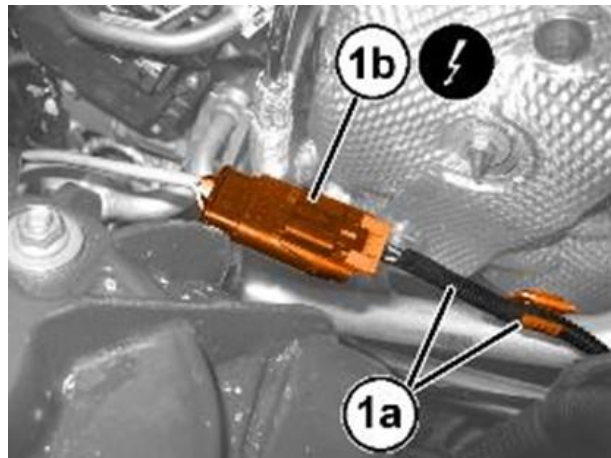
Figure 94 – Electrical Connector

38. Release the wiring (1a) and disconnect the electrical connection (1) for the upper oxygen sensor (Figure 94).

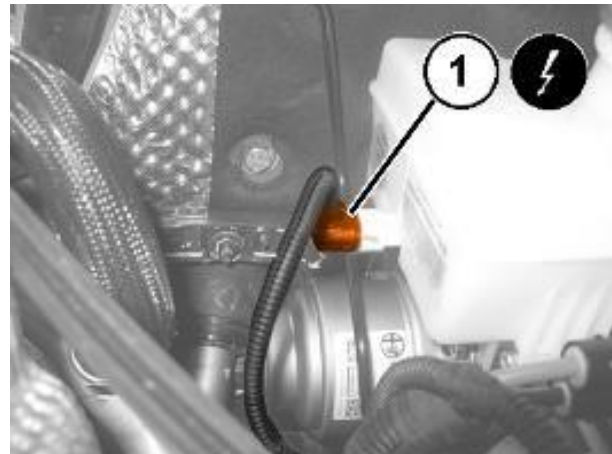
Figure 95 – Electrical Connector

39. Disconnect the electrical connection (1) of the brake fluid minimum level warning light switch (Figure 95).

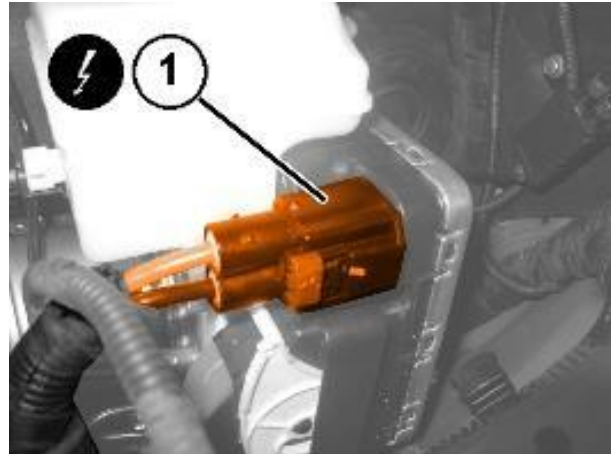
Figure 96 – Electrical Connector

40. Disconnect the electrical connection (1) of the ABS control module (Figure 96).

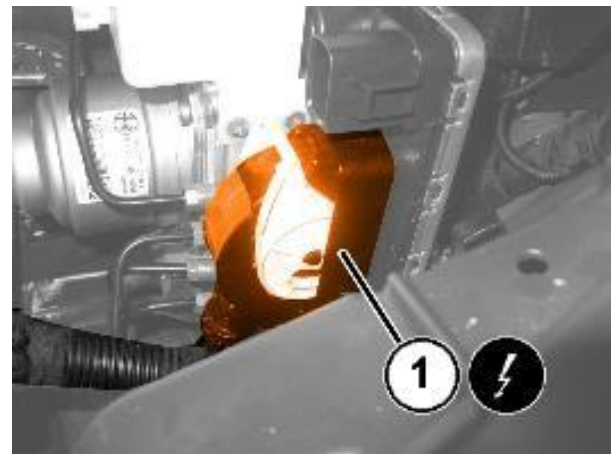
Figure 97 – Electrical Connector

41. Disconnect the electrical connection (1) of the ABS control module (Figure 97).

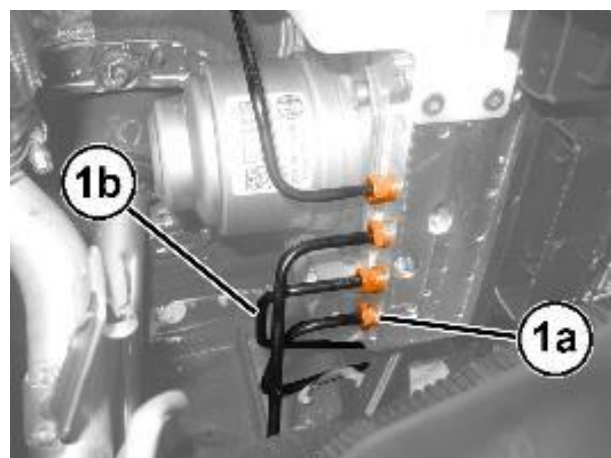
Figure 98 – Brake Fluid Pipes

42. Unscrew the connectors (1a) and disconnect the brake fluid pipes (1b) from the ABS control module (Figure 98).

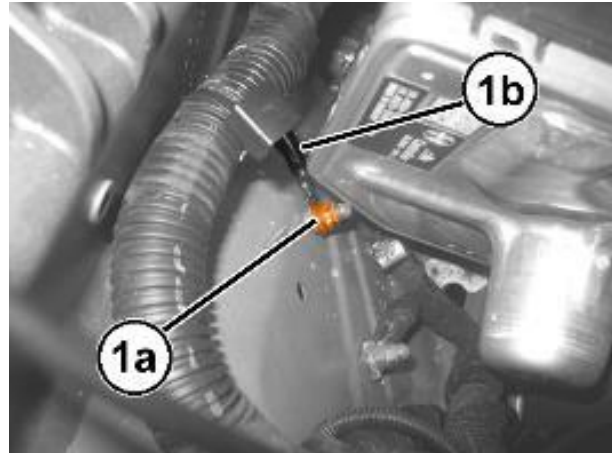
Figure 99 – Electrical Ground

43. Remove the nut (1a) and disconnect the earth lead (1b) from the body (Figure 99).

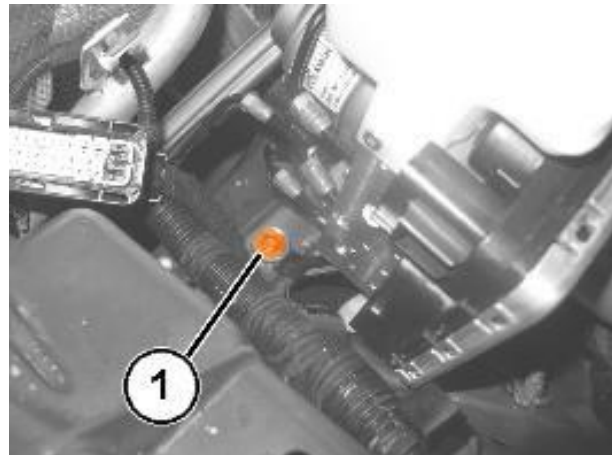
Figure 100 – Mounting Bracket

NOTE: To facilitate the subsequent removal of the ABS control module, we advise loosening the screws attaching the aforementioned bracket to the ABS module first.

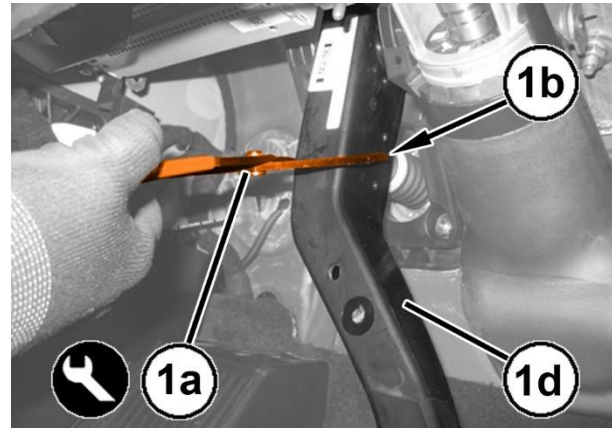
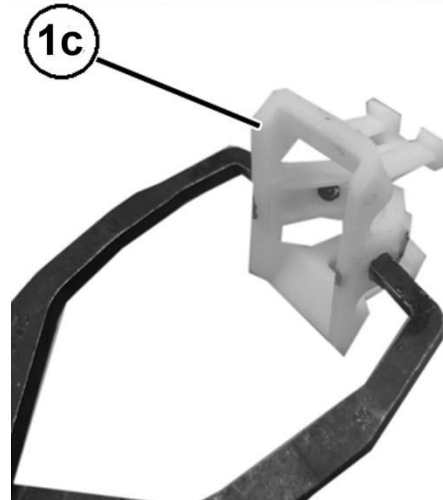
Figure 101 – Brake Pedal Retainer

45. Using the brake switch pliers 2000010500 (1a) positioned on the rear part of the holes (1b) of the brake pedal, compress the retaining device (1c) and retract the brake pedal (1d) at the same time in order to release the pedal from the ABS module push rod (Figure 101).

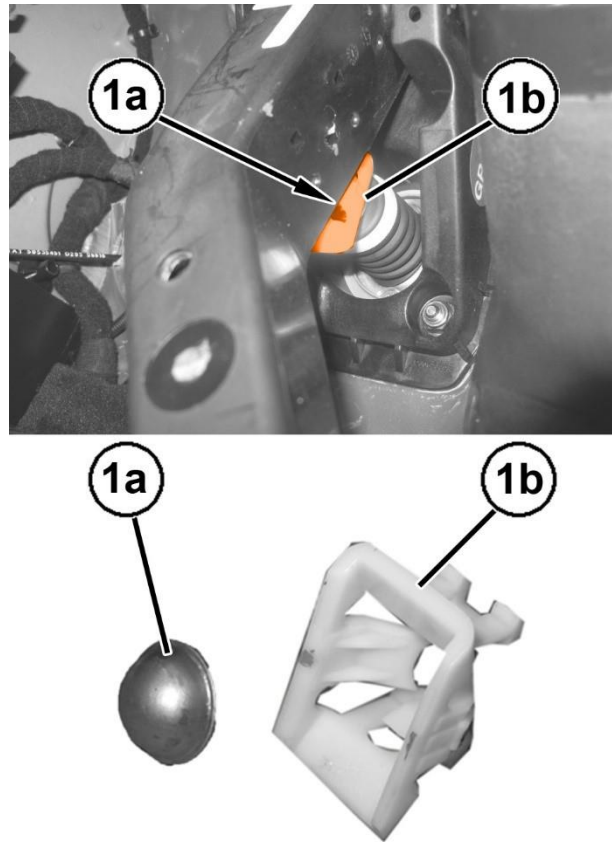
Figure 102 – Brake Pedal Retainer

NOTE: The retaining device must be replaced whenever the push rod is disconnected.

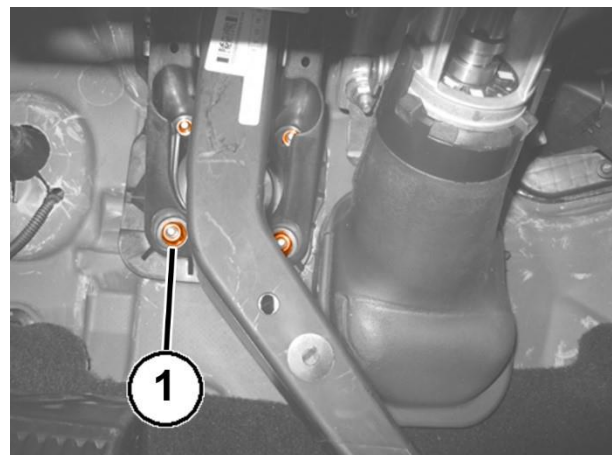
Figure 103 – ABS Module Nuts

47. Remove the nuts (1) attaching the ABS module to the pedal unit mounting (Figure 103).

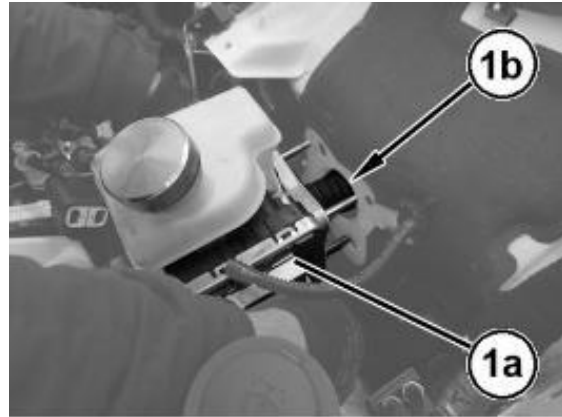
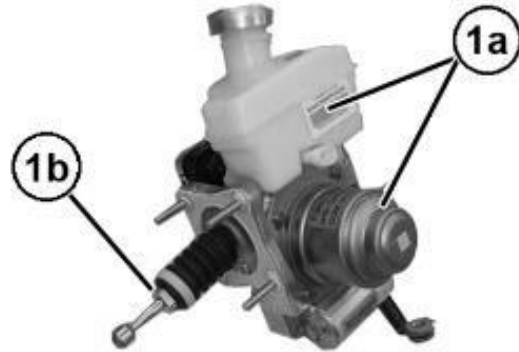
Figure 104 – ABS Module

- 48. Retract the ABS module (1a) and remove it releasing the push rod (1b) from the firewall (Figure 104).

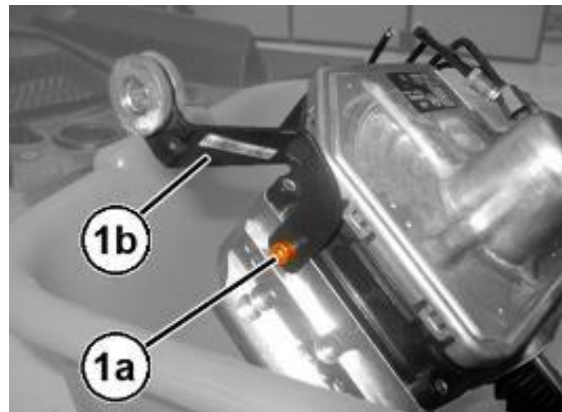
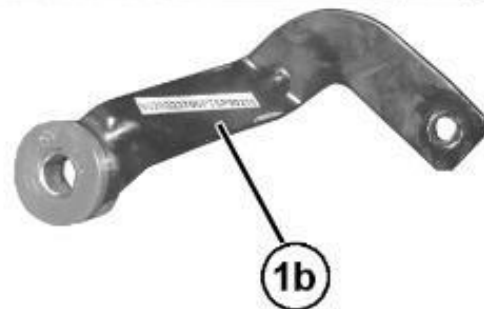
Figure 105 – ABS Module

- 49. Remove the screw (1a) and remove the ABS control module support bracket (1b) (Figure 105).

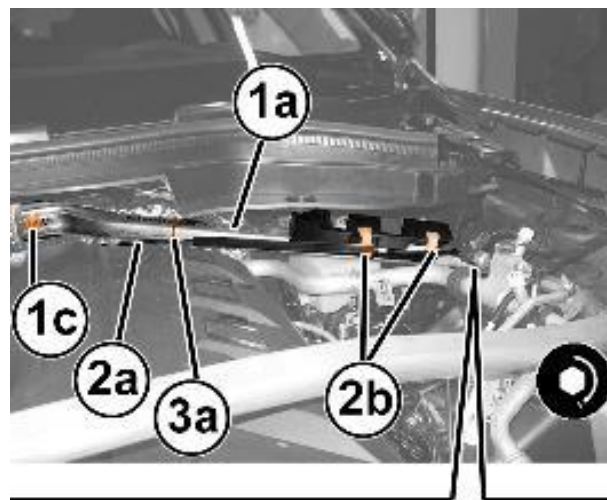
65. Position the left bar (1a), and tighten the screws (1b) and the nut (1c) to the prescribed torque of 20 N·m (15 ft. lbs.) (Figure 106).

66. Secure the rod (2a) to the retainers (2b) and the band (1c) (Figure 106).

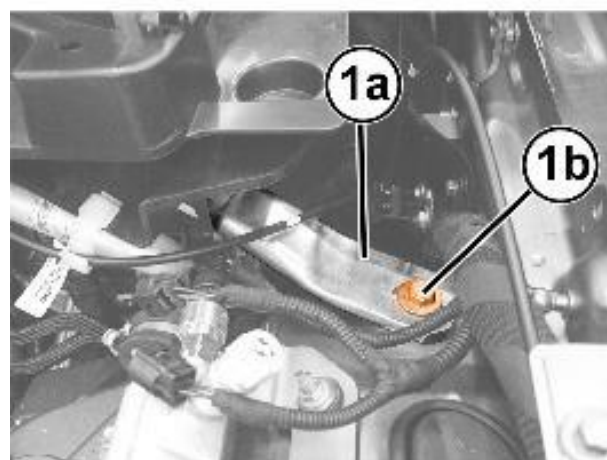
Figure 106 – Body Reinforcement

67. Apply the band (3a) (Figure 106).

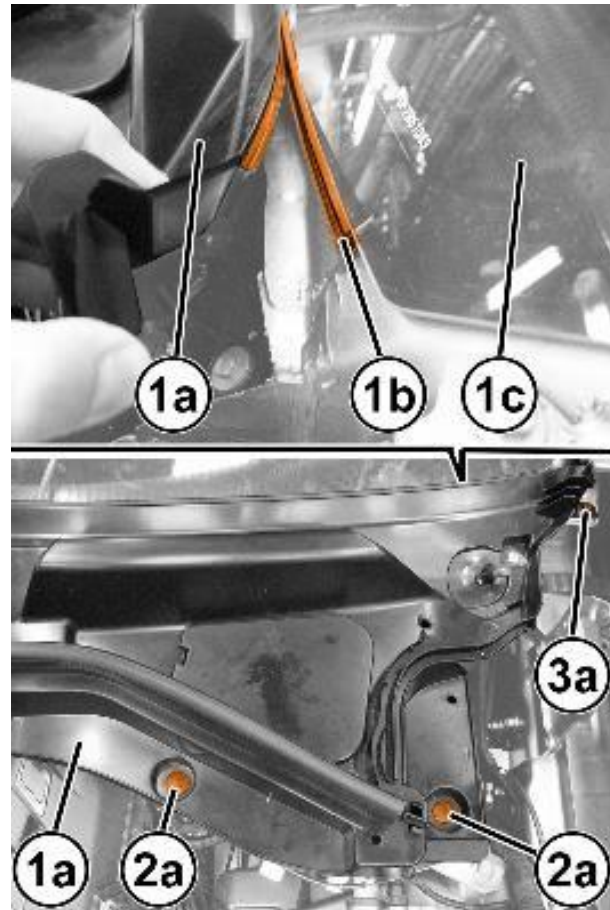
Figure 107 – Windshield Trim

68. Position the windshield base trim (1a) in position and engage the retaining profile (1b) along the entire windshield base (1c) (Figure 107).

NOTE: If necessary, use soapy water to facilitate inserting the trim (1a) into the retaining profile (1b) (Figure 107).

CAUTION: Do not press the trim (1a) excessively into the retaining profile (1b) to avoid damaging the windshield (Figure 107).

69. Apply the retaining buttons (2a) with central pin (Figure 107).

70. Tighten the screw (3a) (Figure 107).

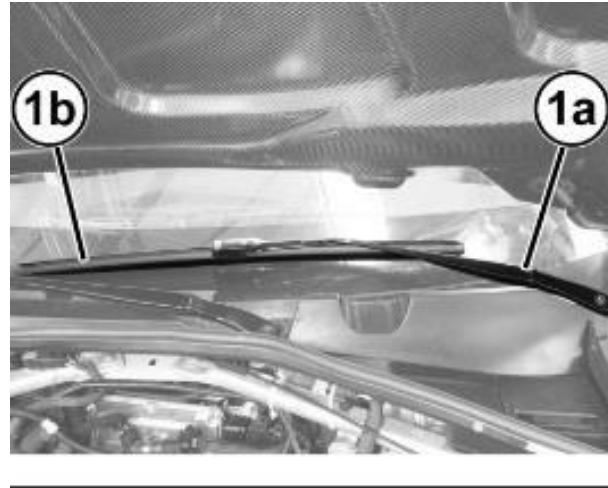
Figure 108 – Wiper Arm

72. Place the windshield wiper arm (1a) in position aligning the blade (1b) with the references (1c) etched on the windshield (Figure 108).

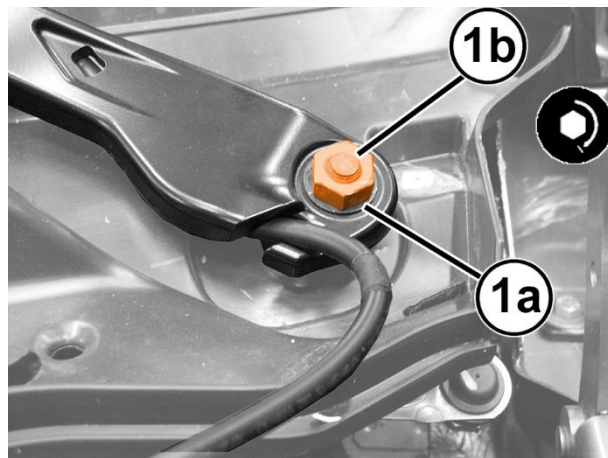
Figure 109 – Wiper Arm

73. Insert the washer (1a) and tighten the nut (1b) to the prescribed torque of 29 N·m (21 ft. lbs.) (Figure 109).
