Safety Recall Y24 / NHTSA 21V-309 ABS Hydraulic Control Unit

2020 - 2021 (GA) Alfa Romeo Giulia

2019 - 2021 (GU) Alfa Romeo Stelvio

Replace the Anti-Lock Brake System (ABS) Hydraulic Control Unit (HCU).

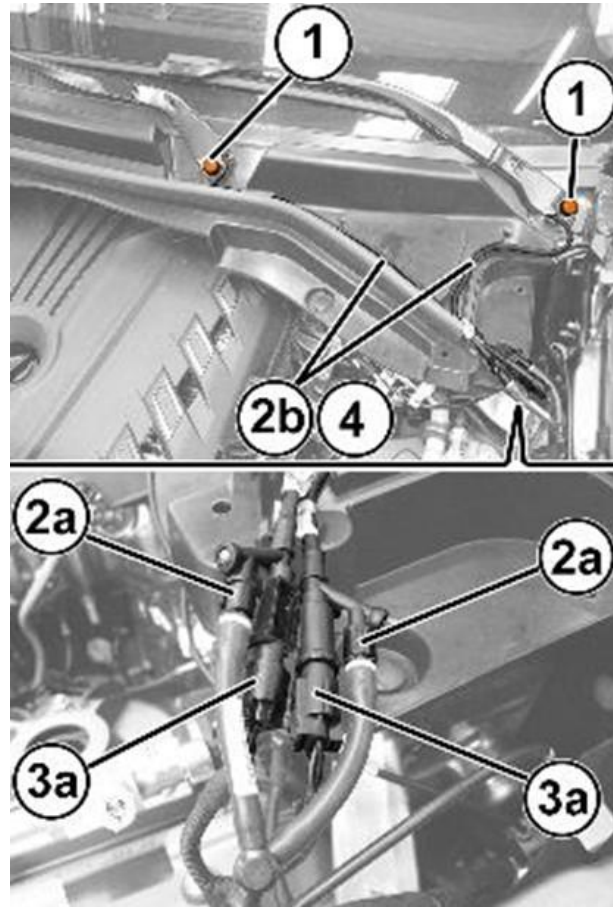
**Figure 110 – Wiper Arm**

74. Engage the nut cover (1) (Figure 110).
75. Connect the quick connector (2a) of the pipe (2b) concerned (Figure 110).
76. Connect the concerned electrical connection (3a) (Figure 110).
77. Place the pipe (2b) concerned in position (Figure 110).
78. Put the soundproofing cover back in its housing engaging the retaining pins.
79. Check that the air vent is correctly positioned in its housing, then engage the retaining button with central pin.

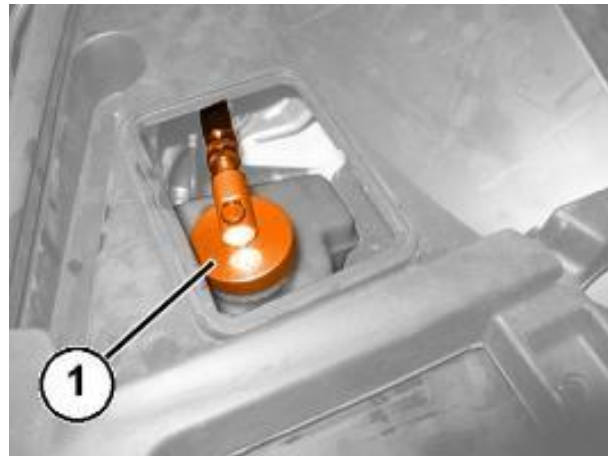
Figure 111 – Bleeding Equipment

85. Connect the bleeding equipment (1) to the brake fluid reservoir and pressurize the system (Figure 111).

NOTE: The operating pressure must be kept at 2 - 3 bar (29 - 43 psi) during the “First stage” and “Second stage” described below.

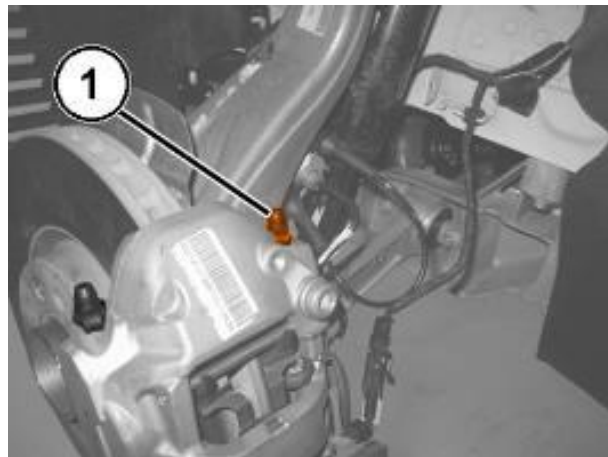
Figure 112 – Brake Bleeder Valve

86. Working at the right front caliper, position the brake fluid recovery hose to the INNER bleeder screw (1) and to the recovery container. Open the INNER bleeder screw (1) and without applying any pedal pressure on the system, allow a small amount of brake fluid to drain into the recovery container. Then tighten the bleeder screw and remove the recovery hose (Figure 112).

90. Working at the left front caliper, position the brake fluid recovery hose to the INNER bleeder screw (1) and to the recovery container. Open the bleeder screw and slowly press the brake pedal down fully three or more times, until there are no more air bubbles in the recovery hose. Then tighten the bleed valve to the prescribed torque of 10 N·m (89 In. lbs.) (Figure 112).

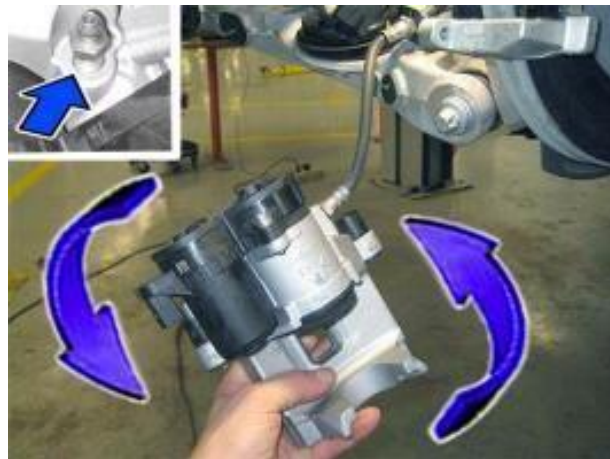
Figure 114 – Rotate Caliper

101. Turn the brake caliper very slowly several times to the various possible positions, stop the motion and keep the bleed valve pointing upwards for a few minutes.

102. Install the brake caliper(s), then repeat the bleeding steps for the caliper(s) and check the volumes using the diagnosis equipment.
