Technical Service Bulletin: TSB210113	Released Date: 30-Jul-2021
Fuel Rail Assembly Inspection and Repair Procedure: External Fuel Leaks

Fuel Rail Assembly Inspection and Repair Procedure: External Fuel Leaks

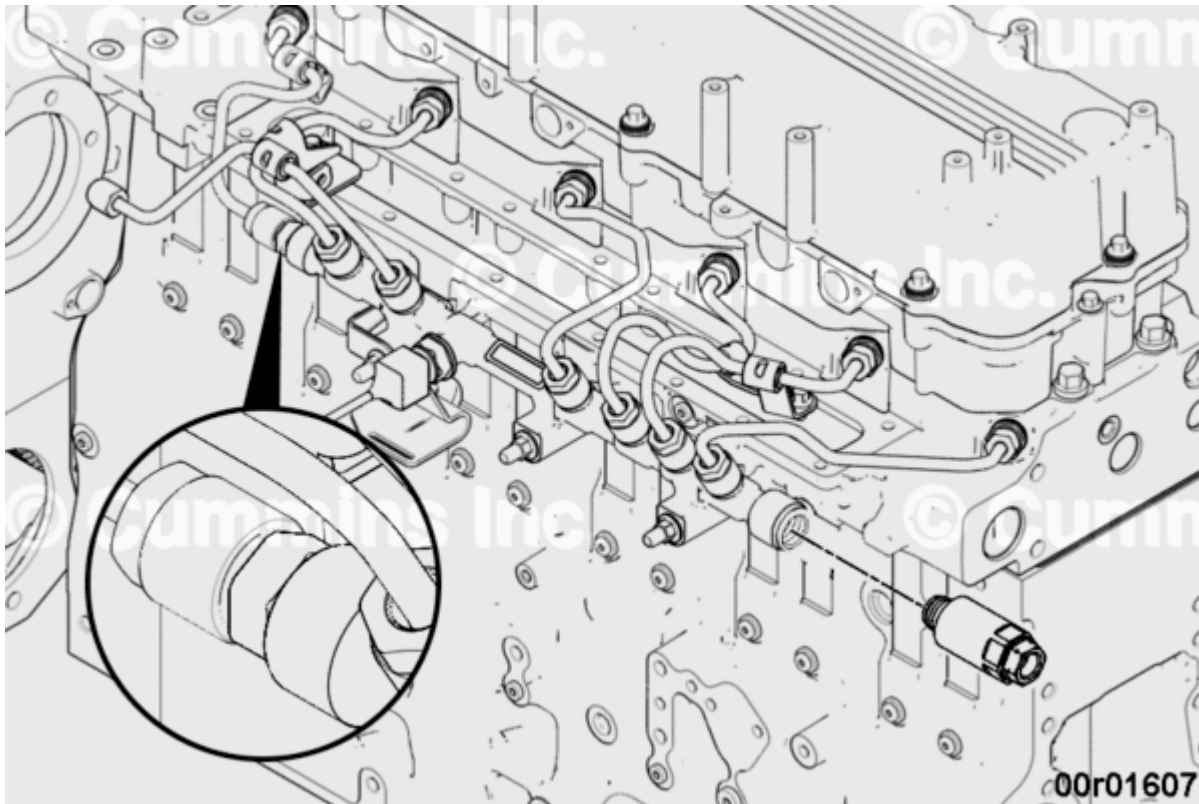
Figure 1, Removing the pressure relief valve and the high pressure fuel fitting.

- Remove the pressure relief valve and the high-pressure fuel fitting from the fuel rail.

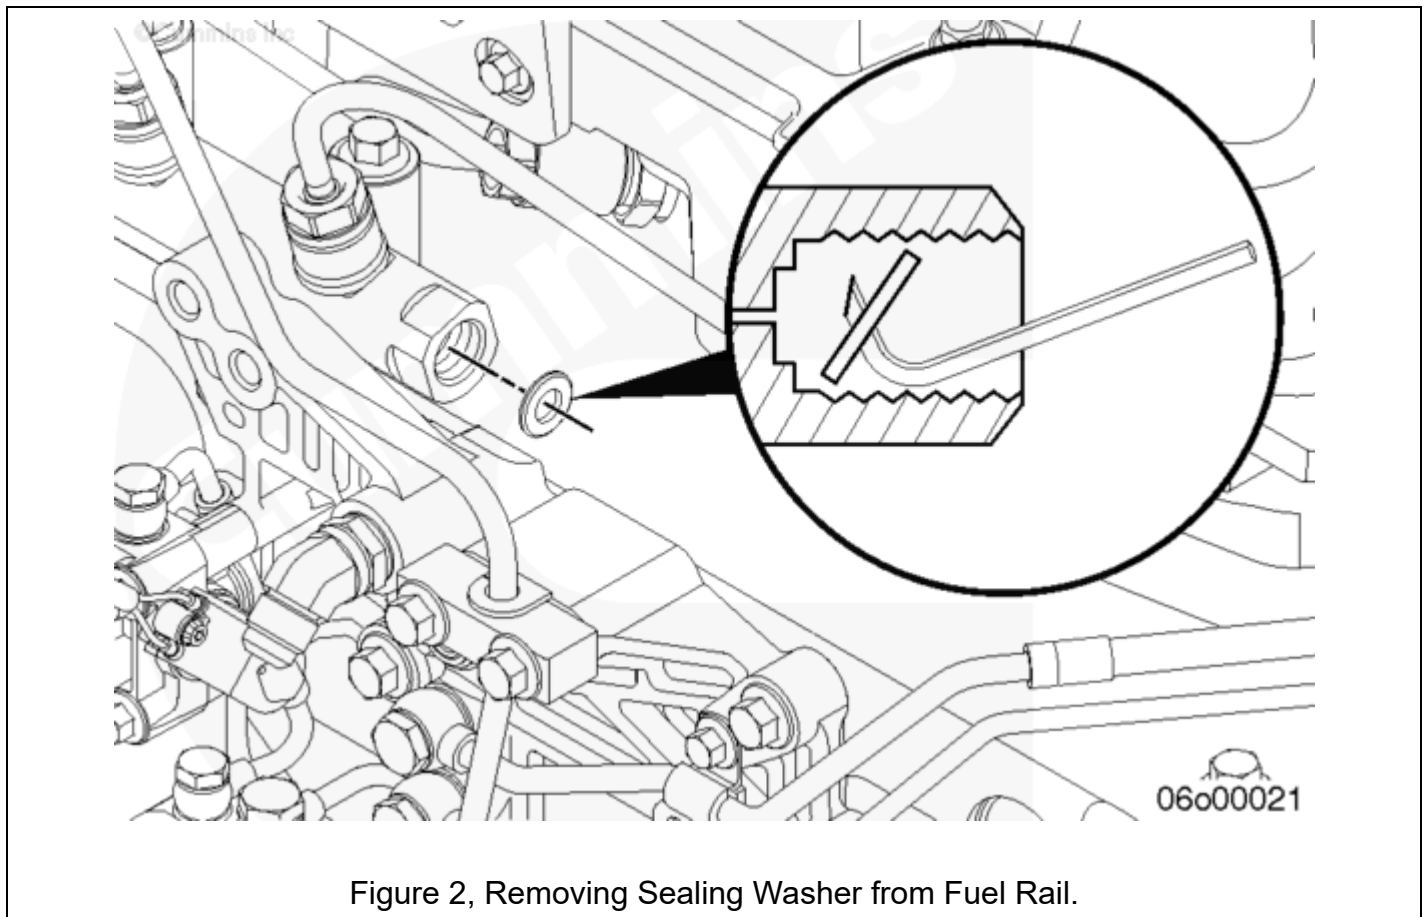
Figure 2, Removing Sealing Washer from Fuel Rail.

- Remove and discard the sealing washers. The procedure below outlines how to remove the sealing washers.

- A special tool **must** be created for the removal of the sealing washers by grinding a 45 degree angle on the short leg of a 1/8-inch or 3/16-inch Allen wrench, so that the wrench is no longer than 13 mm [½ in] long (measured from the outside of the long leg.)
- This tool acts as a mini heel bar to pry out the sealing washer without damaging the back of the hole.
- Use the modified Allen wrench to pry out the old sealing washer from the threaded hole in the fuel rail. Considerable force is required to remove the sealing washer.

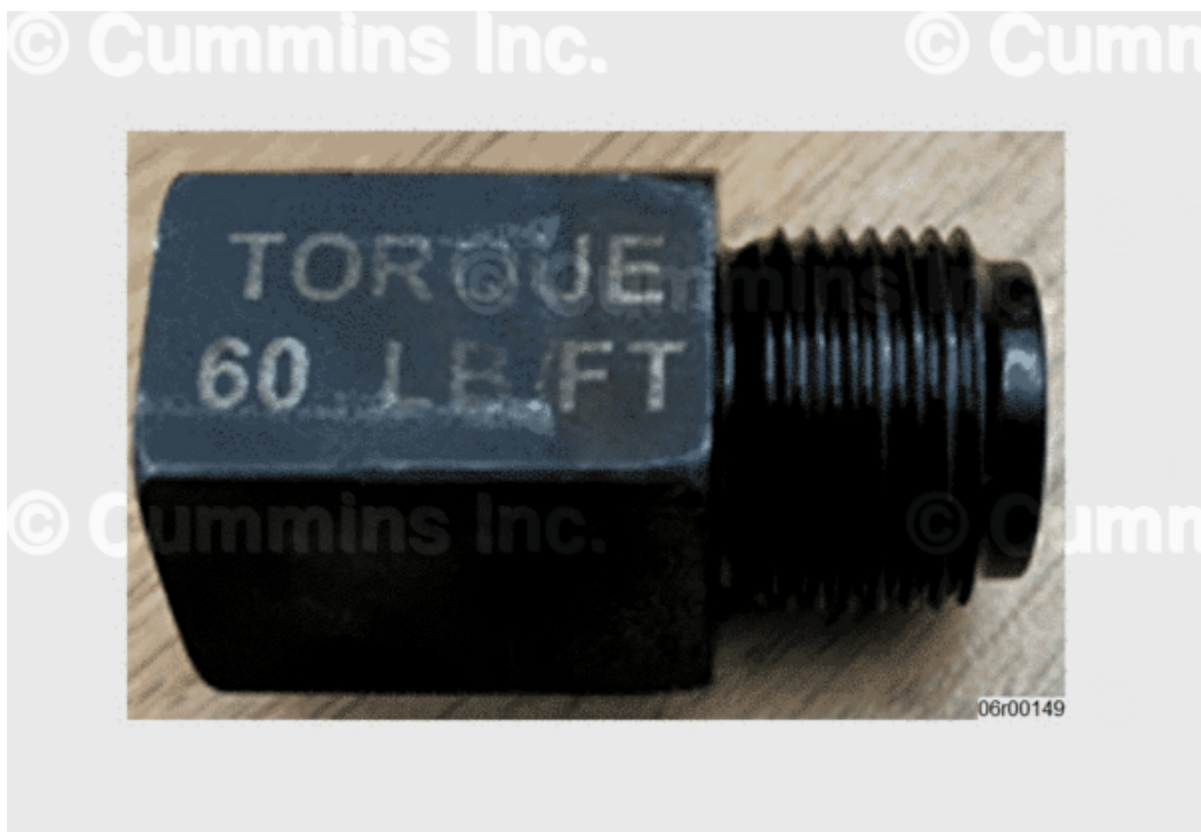
Figure 5, New Seal Installer Tool, Part Number 5573487.

- A new seal installer tool, Part Number 5573487, is now available for this repair.

- The new seal installer tool **must** be available for all repairs requiring the installation of pressure relief valve or the high pressure fuel fitting on the fuel rail. See Service Instructions section below.

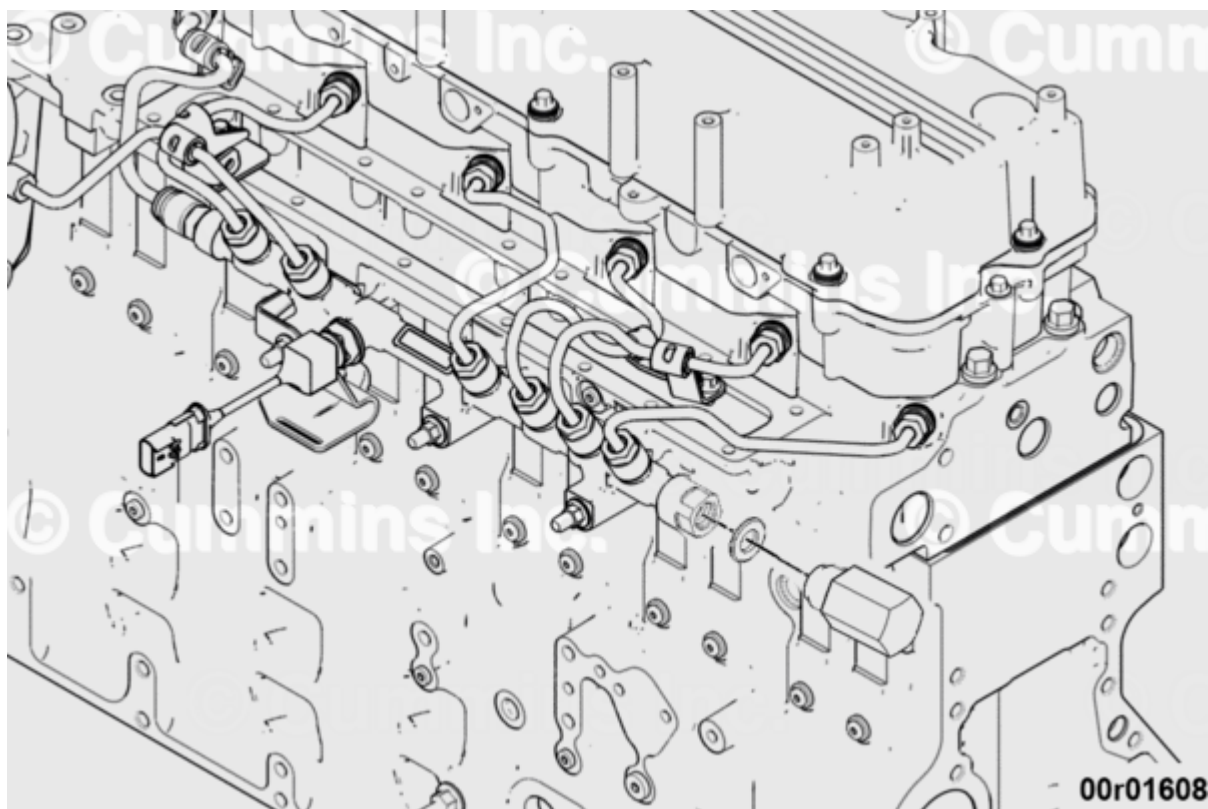
Figure 7, Installing Sealing Washer with The Seal Installer Tool.

2. Install a new sealing washer on the pressure relief valve bore in the fuel rail. Use assembly lubricant, Part Number 3163087, or equivalent, on the threads and the face of the seal installer tool. Use seal installer tool, Part Number 5573487, to seat the sealing washer fully in the fuel rail bore.

3. Torque the seal installer tool.

Torque Value: 81 n•m [60 ft-lb]

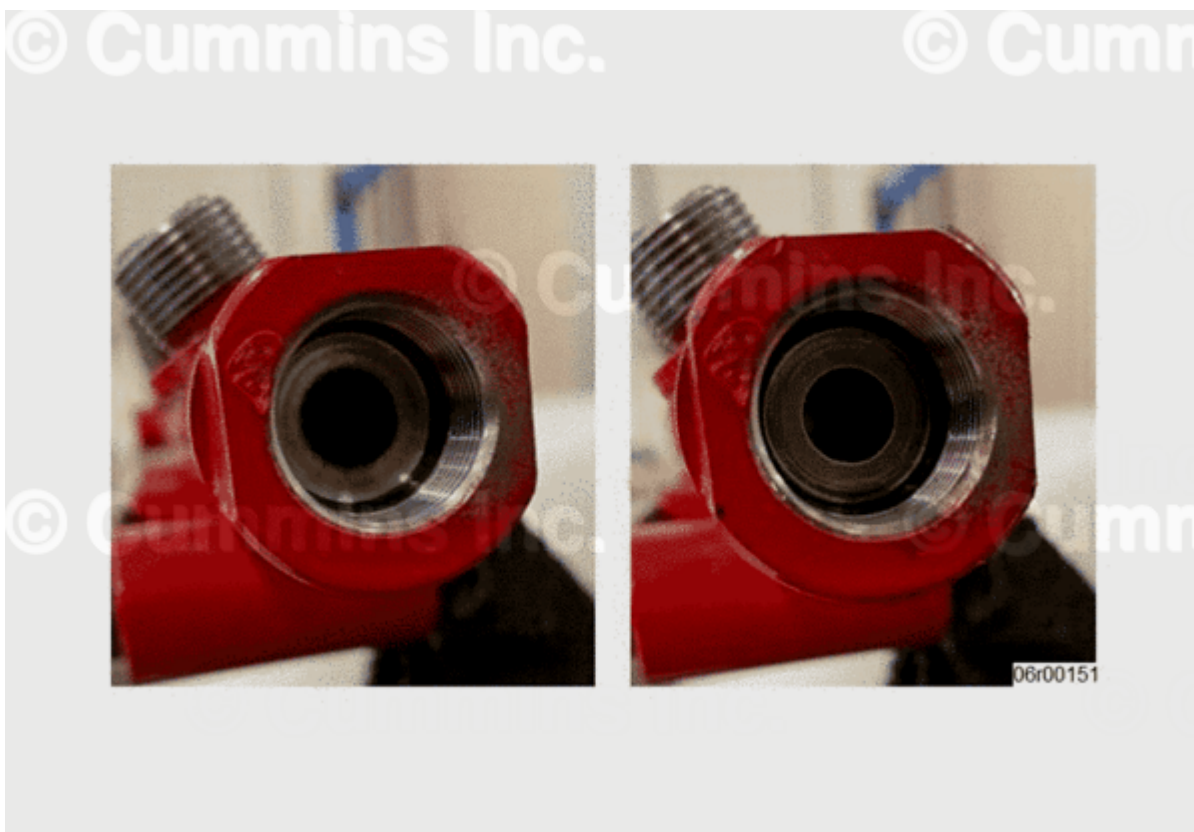
Figure 8, Left: Sealing Washer Not Installed, Right: Sealing Washer Installed Correctly.

4. Remove the seal installer tool after the sealing washer has been installed. Verify that the sealing washer remains seated inside the fuel rail after the seal installer tool is removed.

9. If either of the sealing washers do **not** remain seated inside the fuel rail after the seal installer tool has been removed, use of seal installer tool is not required. Install washer in bore.
