PRODUCT CAMPAIGN BULLETIN

APPLICABILITY: 2018-2019MY Legacy and Outback 2.5L and 3.6L
 2020MY Legacy and Outback 2.5L and 2.4L (Turbo)
 2018-2020MY Impreza
 2019-2020MY Ascent
 2018MY Forester (Turbo)
 2018-2019MY WRX
 2018-2019MY BRZ

NUMBER: WRG-21R
DATE: 08/24/21
REVISED: 12/01/21
NHTSA ID: 21V587

SUBJECT: Fuel Pump Impeller Failure

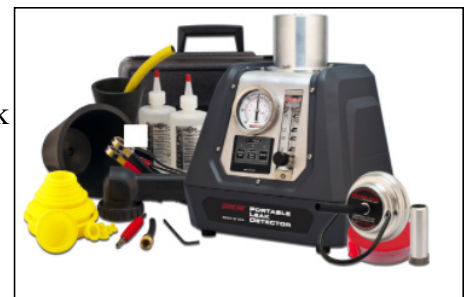
- **Redline Detection Smoke Pro (RDL-95-0051).** Used for leak testing the fuel tank chamber and fuel pump assembly. This is already a required essential Subaru Special Service Tool.

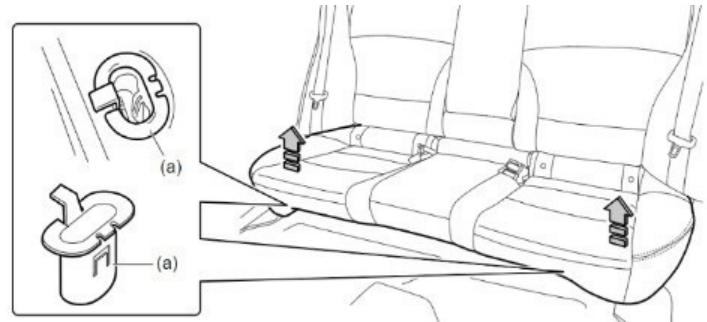
When removing the rear seat cushion (all models except Ascent & BRZ), if the plastic retaining clips (a) (p.n. **64396KA010** for 18-19 Legacy / Outback and **64333FJ000** for Impreza, WRX, Forester, and 20 Legacy / Outback) in the floor come out, they become **one-time use** items and **MUST** be replaced during reassembly. When installing the seat cushion, always confirm the seat belt buckles are returned to the proper positions.

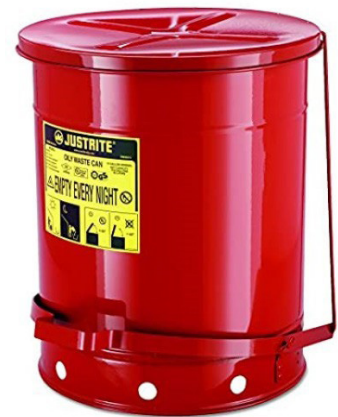
IMPORTANT: When performing these procedures, shop cloths contaminated with gasoline will be created. It is **CRITICAL** they be handled safely and following proper disposal guidelines. Always store contaminated shop cloths in an approved safety can as shown here.

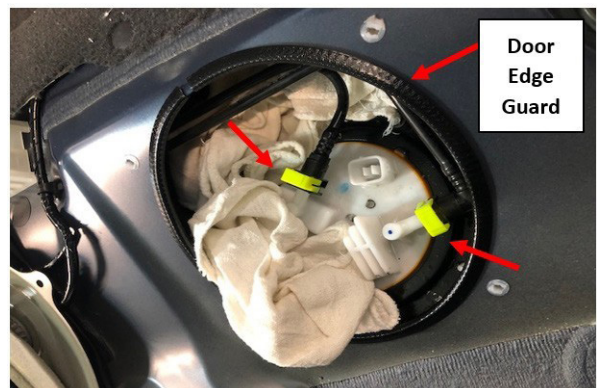
After removing the rear seat cushion assembly and the (main) fuel pump access cover, use a length of small hose (sliced lengthwise), vinyl door edge guard as shown here or electrical tape to cover the edge of the access opening in the floor panel. This will protect any removed fuel line(s) and Technician hands from cuts or abrasions resulting from sharp edges. The photo here shows the power harness unplugged and shop cloths in place to absorb residual fuel that may remain in the lines after removal from the pump assembly.

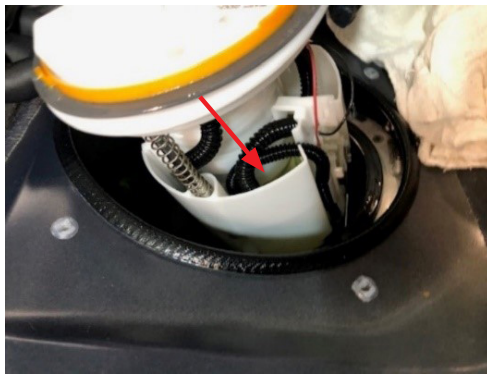
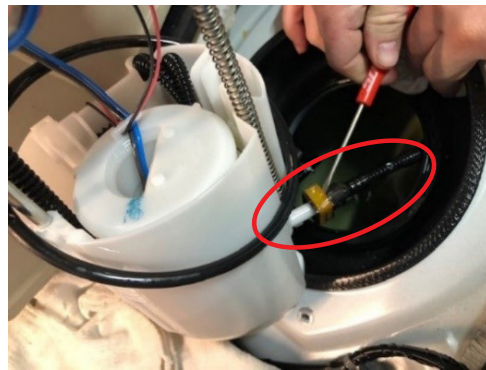
Have a small fuel-safe drain pan in place to catch any spilled fuel as the pump assembly is **CAREFULLY** lifted out of the fuel tank. If available, use a vacuum bleeder with a collection reservoir and hose to draw some of the stored fuel out of the fuel chamber surrounding the pump and filter to help avoid spillage. **NOTE:** On Ascent, there is a jet pump fuel tube attached to the lower portion of the fuel pump assembly as shown below, right which must also be removed before the pump assembly can be completely removed from the vehicle. Release the retaining clip with a small flat-blade screwdriver and remove the line but, secure the line with electrical tape or Mechanic's wire to keep it from falling into the tank once it is removed. If not secured, it will fall into the tank and have to be "fished" out prior to reinstalling the pump assembly.

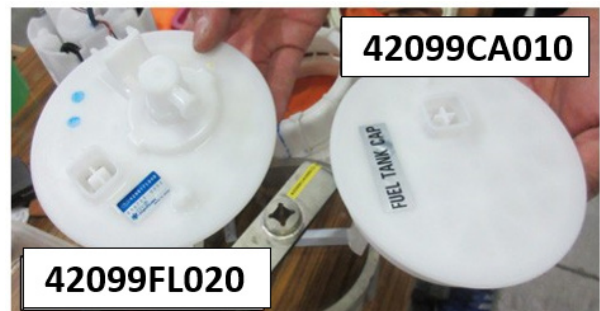
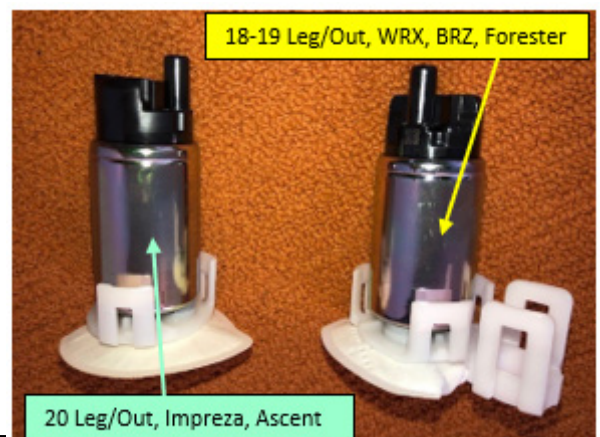
NOTE: When searching STIS for the applicable Service Manual procedures for reference, select **Fuel Filter REMOVAL** to get the detailed procedure for separating the pump / filter sock assembly from the complete fuel pump assembly. Fuel Filter removal is **NOT** required to complete this procedure. The replacement pumps come with a new filter sock already in place as shown here.

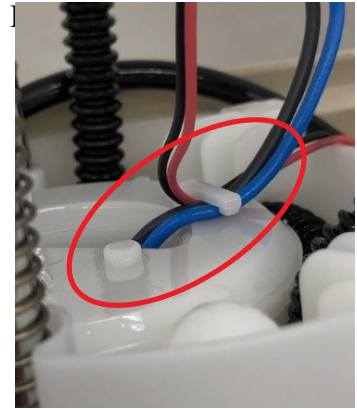
For this recall, the 2-wire (Blue / Black) fuel pump wiring harness indicated as 1-time use in the Service Manual is reused but, should be inspected for damage or any evidence of overheating (discoloration of connectors, etc.). **IMPORTANT:** If any damage e.g. distorted or melting plastic connectors, overheated wiring or terminals is identified, the harness **MUST** be replaced.] fuel pump.

When reinstalling the thinner (Black / Red) fuel sender wires into the 2 retaining clips, they go into the clips first and are held in place by the thicker fuel pump harness wires.

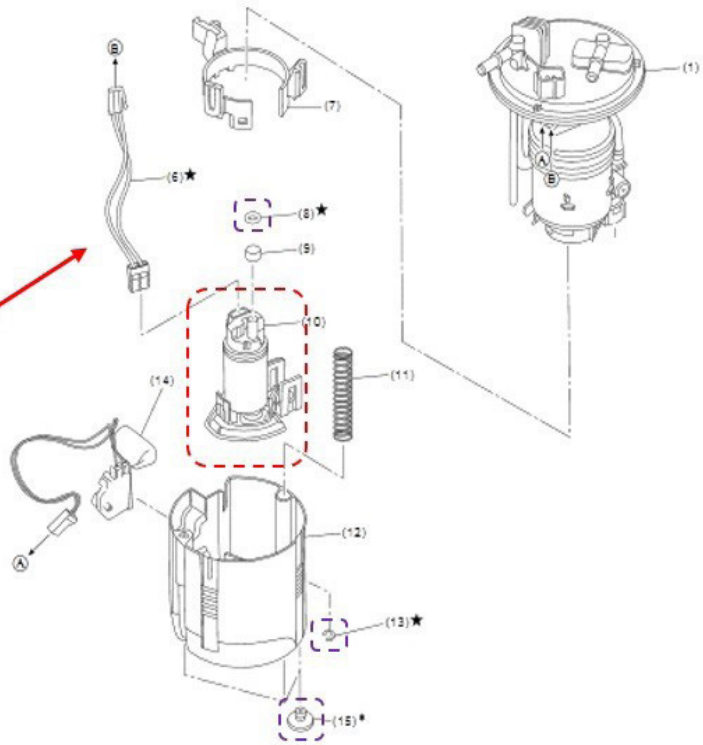
For this Campaign procedure, the connector cable (6) does not need to be replaced.

However, if either of the following conditions are found, replace it.

- Cracking of the harness insulation or
- Deformation / discoloration of any connector or terminal.

*The 3 rubber cushions (15) on the bottom of the fuel chamber and included in the kit must be replaced as they are 1-time use.

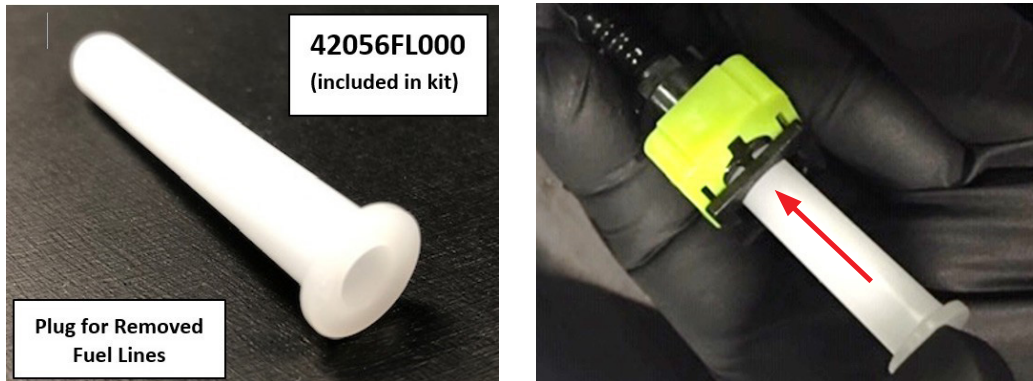
Release the quick disconnect fitting at the fuel pump outlet pipe. **While covering the fuel pipe with a clean shop cloth to catch any residual pressurized fuel**, slide the fuel delivery pipe off the fuel pump outlet. Insert the plastic temporary plug supplied in the kit into the removed fuel delivery pipe. The one-time use temporary plug is included in the replacement fuel pump parts kit.

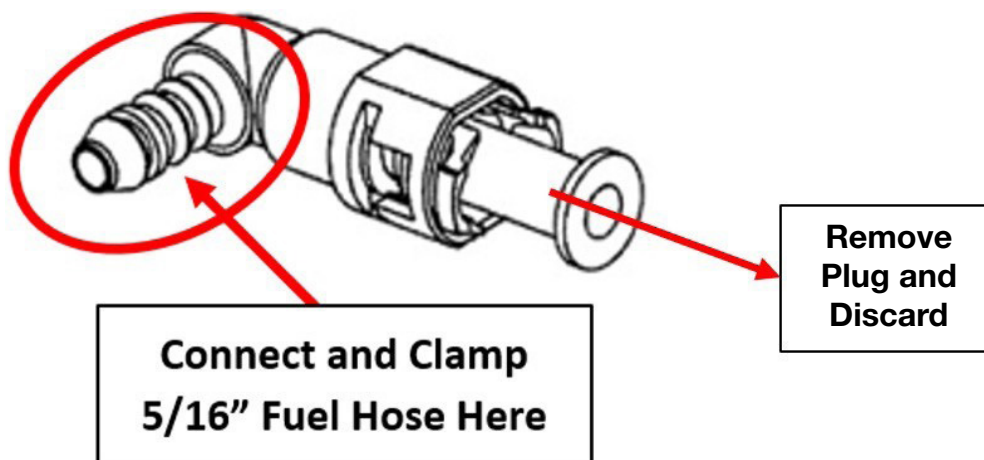
- Connect a sufficient length of 5/16" rubber fuel hose to the male hose barb portion of the adapter fitting. Always secure it with a small hose clamp to prevent leakage. Remove the plastic plug from the adapter and connect the adapter / hose assembly to the male fuel discharge tube of the fuel pump as shown below. Put the other end of the rubber fuel hose securely into a safety container to collect the drained fuel. Once the drain hose assembly is securely in place, connect the SSM4, turn the ignition ON and from the Active test item menu, select Fuel Pump Control to operate the fuel pump. Drain the fuel tank down until the fuel gauge reads at or below 2/3 full.

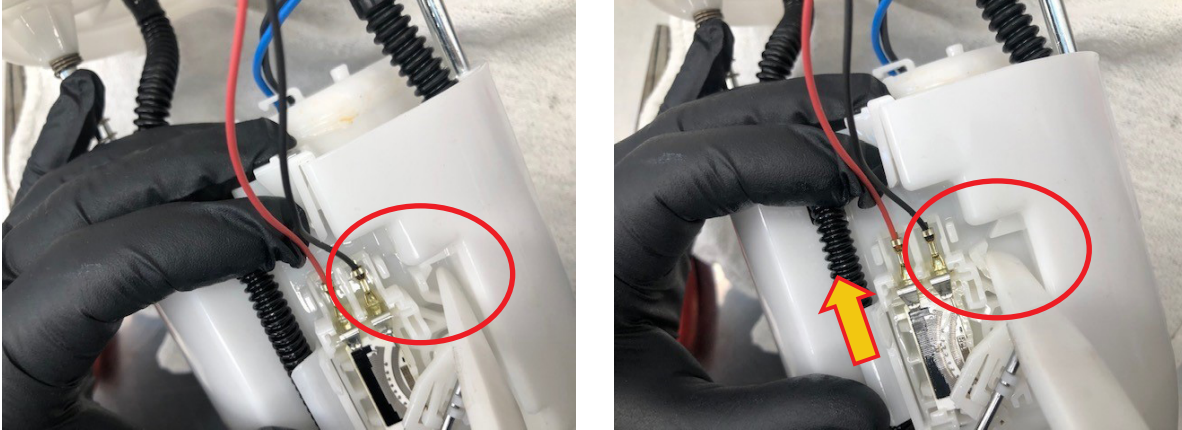
IMPORTANT: If any damage e.g. distorted or melting plastic connectors, overheated wiring or terminals is identified, the harness **MUST** be replaced. Release the retaining clip (a plastic trim tool is being used here) and slide the sending unit upward. **NEVER** touch the contact surface of the sending unit and use care to avoid bending or otherwise damaging the float arm and contact point.

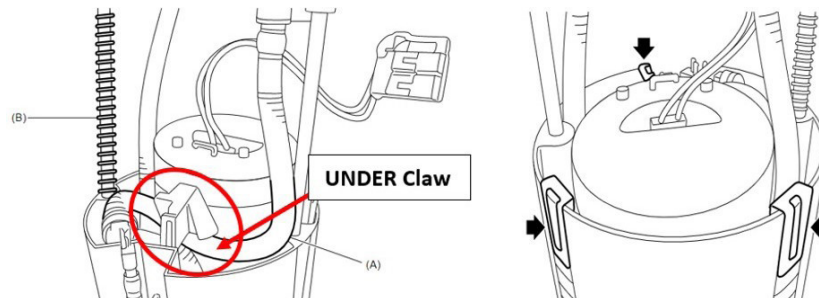
- Replace all 3 rubber cushions (feet) on the bottom of the fuel chamber, replacements are included in the kit. Failure to replace these may result in a later noise complaint.
- **CAREFULLY** refit the tube assembly back into the fuel chamber until it clicks into position.
- Refit the tube back on to the bottom side of the fuel chamber.
- Refit the spring **(B)** to the rod with the snap ring groove then re-install the pump / filter assembly into the fuel chamber. **IMPORTANT:** Confirm tube **(A)** is routed **UNDER** the retaining claw then lock all 3 claws in place.

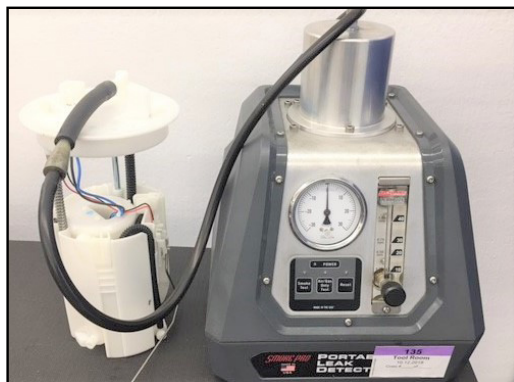
- Leak test the fuel pump assembly to confirm there are no leaks PRIOR TO reinstalling the assembly into the fuel tank. Using the Redline Smoke Pro, apply approximately 0.47PSI (3.2Kpa) to the pump assembly as shown. Confirm the applied pressure can be held for **10 seconds**. If the pressure can be held, continue with installation. If pressure cannot be held, check the jet pump seating and o-ring condition. If the pump does not pass the leak test and disassembly is required, it is **IMPORTANT** to never reuse the one-time use o-ring.

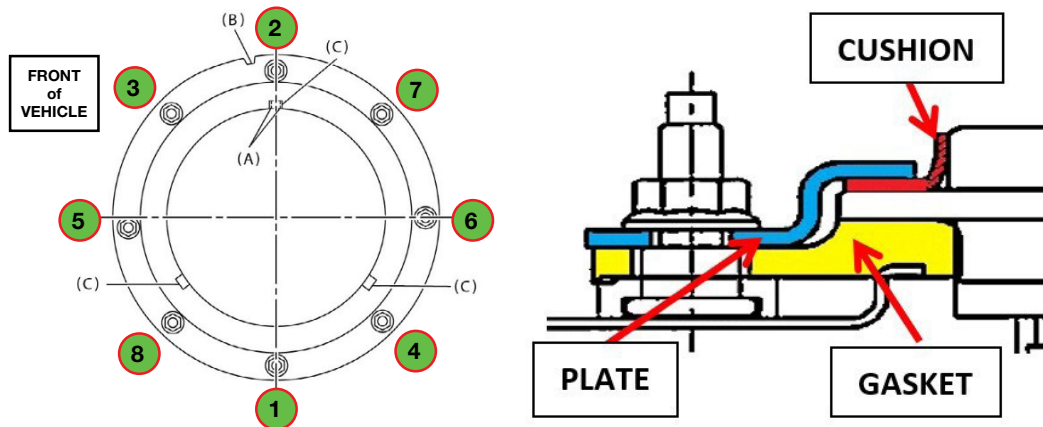
- CRITICAL:** Lightly hand tighten all nuts in the sequence shown below. Complete tightening of the 8 retaining nuts to the specified torque: **4.4 Nm, (3.2 ft. lbs. or 38 inch- pounds)** following the sequence shown below. **NEVER** use air or electric powered tools to tighten these nuts as the studs may be damaged.

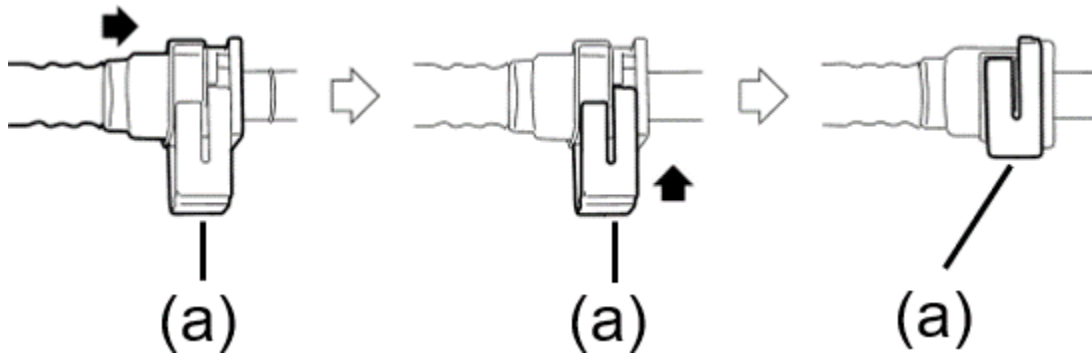
IMPORTANT REMINDERS: Discard the plastic fuel line plug as it is a one-time use item. Reusing the plug may damage the connector's internal o-ring and cause a fuel leak.

- Ensure both the pipe and tube are clean and dry
- If the slider does not move easily, confirm the pipe is engaged on the tube
- ALWAYS confirm the pipe is fully engaged after connecting and check for any leaks

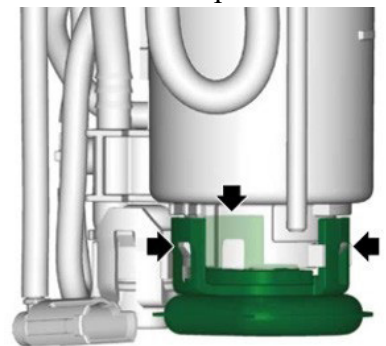
- Once the fuel pump assembly has been removed, install the applicable plastic plug tool into the fuel tank opening to prevent contamination from entering the tank and fuel vapors from accumulating in the vehicle interior. If the plug is not available, cover the opening with a clean shop cloth. The plug is not required when replacing the complete fuel pump assembly due to the very short time the tank will be open for that repair.

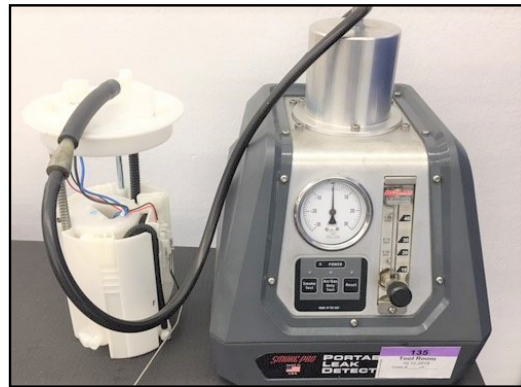
- Confirm the 3 claws securing the fuel filter assembly into the fuel chamber are fully engaged.
- Secure the fuel tube to the outside of the fuel chamber and reconnect it at the bottom.
- Push the fuel filter assembly in the direction of the arrow to compress, and install the new clip supplied in the kit.
- Leak test the fuel pump assembly to confirm there are no leaks **PRIOR TO** reinstalling the assembly into the fuel tank. Using the Redline Smoke Pro, apply approximately 0.47PSI (3.2Kpa) to the pump assembly as shown. Confirm the applied pressure can be held for **10 seconds**. If the pressure can be held, continue with installation. If pressure cannot be held, check the jet pump seating and o-ring condition. If the pump does not pass the leak test and disassembly is required, it is **IMPORTANT** to never reuse the one-time use o-ring.

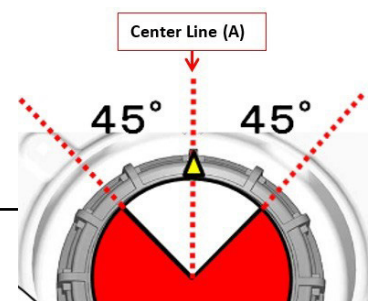
than 45 degrees, the fuel level sensor will likely be damaged. When properly tightened, the index mark on the ring nut Δ should align with the fuel pump indexing arrow Δ (Center Line (A)).

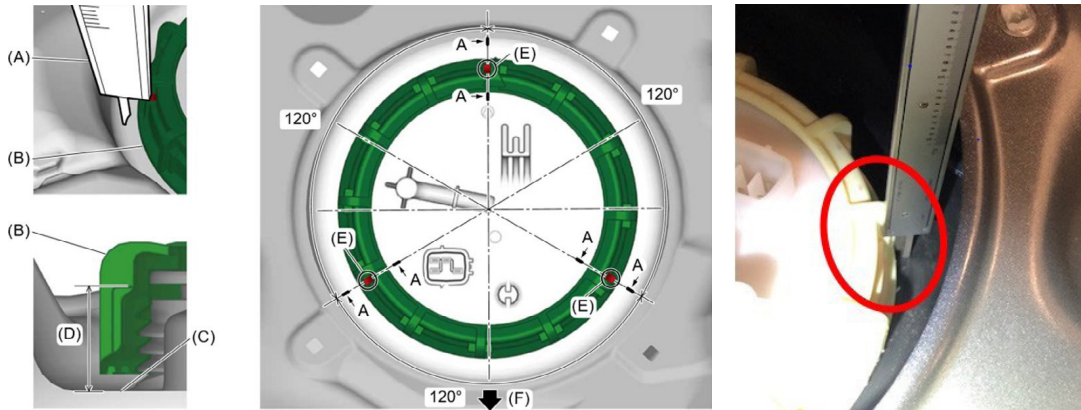
- If the difference between any of the three measurements exceeds $\pm 1.5\text{mm}$ or $.060$ inch, loosen and re-tighten the ring nut to correct any cross-threading.
- If the ring nut or fuel pump gasket are deformed, cracked or damaged, they **MUST** be replaced.

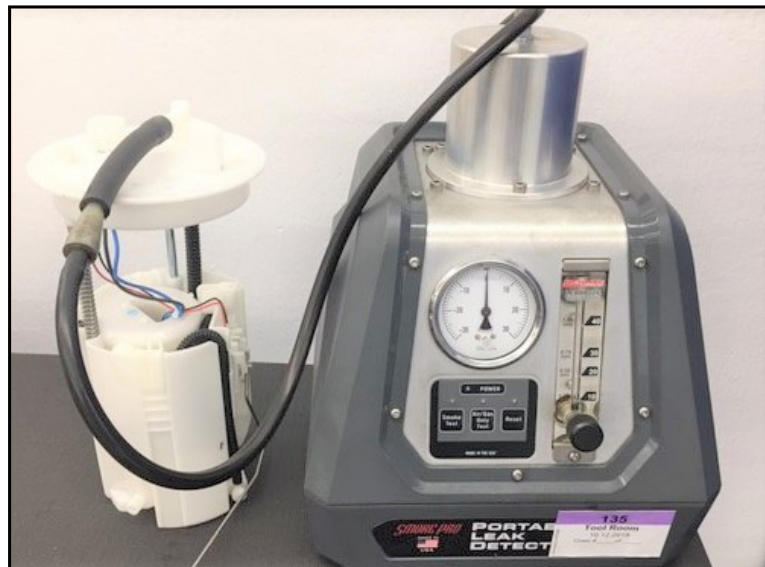
- Leak test the fuel pump assembly to confirm there are no leaks **PRIOR TO** reinstalling the assembly into the fuel tank. Using the Redline Smoke Pro, apply approximately 0.47PSI (3.2Kpa) to the pump assembly as shown. Confirm the applied pressure can be held for **10 seconds**. If the pressure can be held, continue with installation. If pressure cannot be held, check the jet pump seating and o-ring condition. If the pump does not pass the leak test and disassembly is required, it is **IMPORTANT** to never reuse the one-time use o-ring.

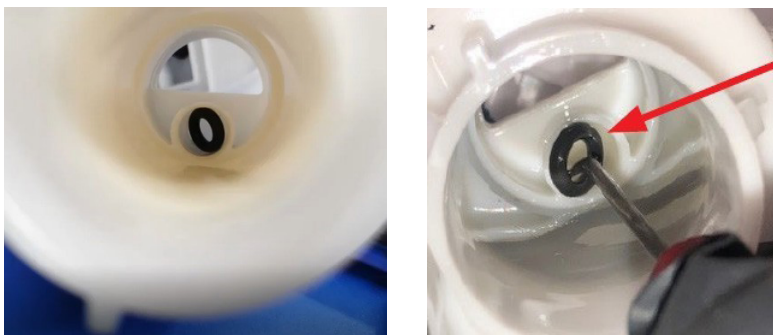
original fuel pump component from the filter housing, ALWAYS confirm the original o-ring either came out with the pump or, it is removed from its bore BEFORE attempting to install the new fuel pump as shown here.

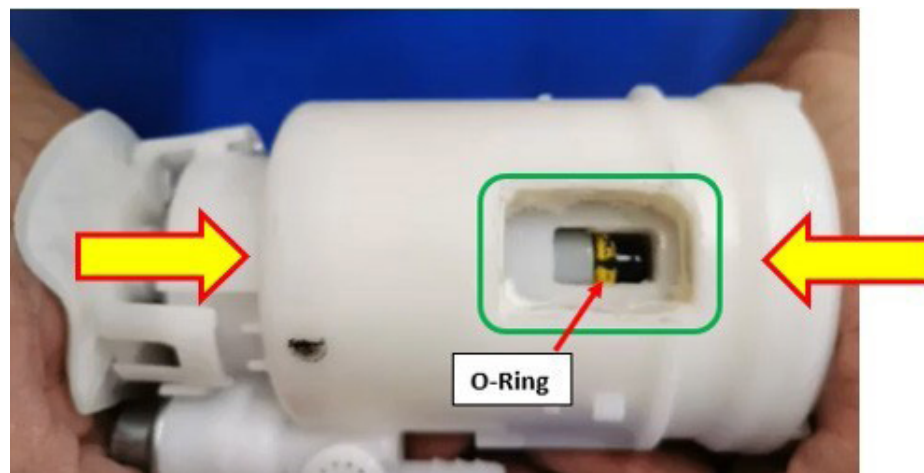
CRITICAL TIP: Align and press the new fuel pump **FIRMLY, SQUARELY** and **STRAIGHT** into the filter housing in **ONE** smooth, continuous motion.

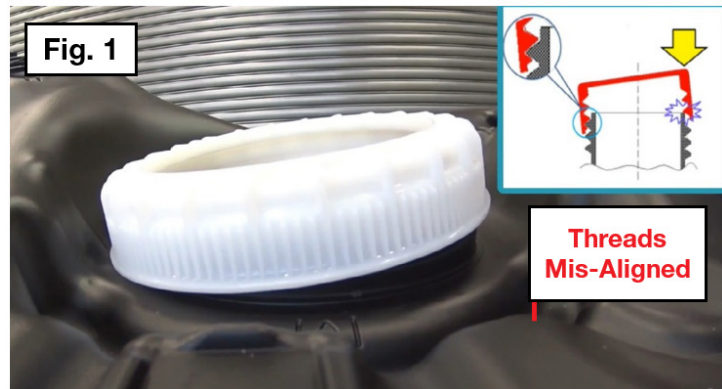
Fig. 2 shows the Special Tool installed onto the Ring Nut making the mis-alignment easier to identify before attempting to tighten it.

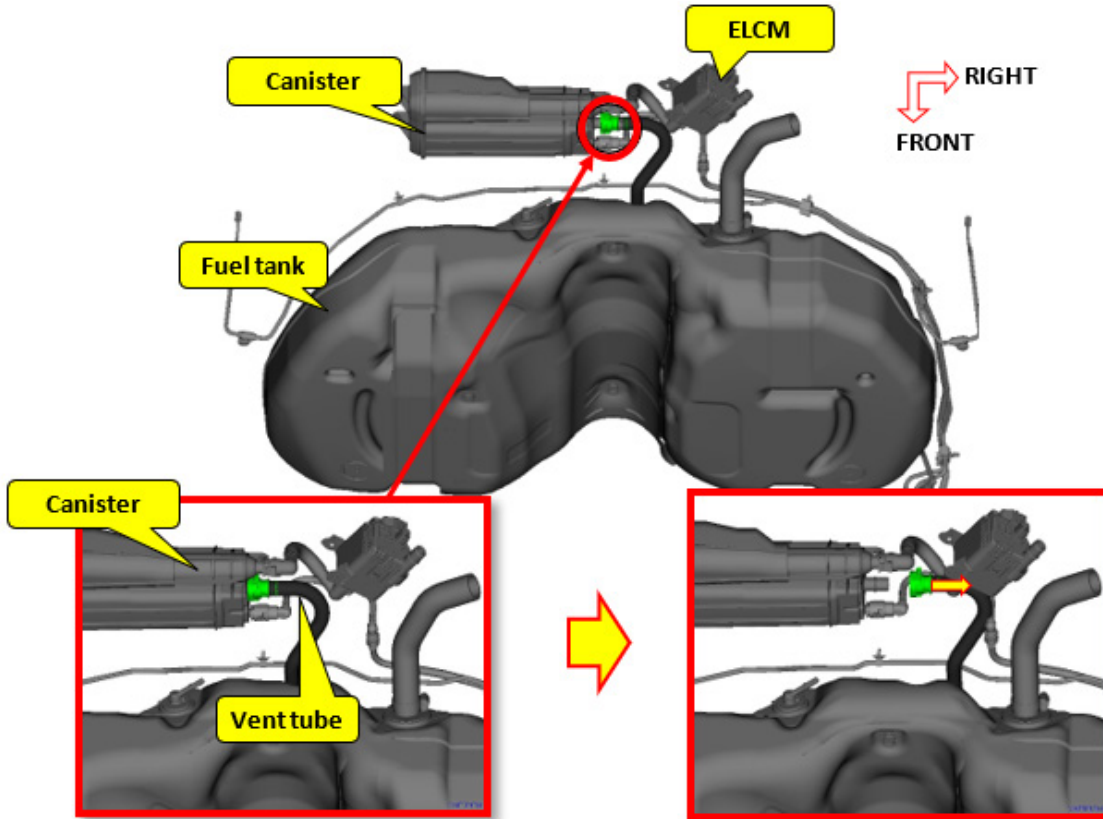
(STEP :1) Using the **Redline Detection Smoke Pro (RDL-95-0051)**, apply **10kpa (1.45 PSI)** at the vent tube. **NOTE:** These pressures for this test are higher than those specified when confirming proper sealing of the fuel pump. Check to ensure the pressure is retained for **10 seconds**. Is the pressure retained?
