AMB6 - Checking Three-Point Belt and Replacing it if Necessary (Stop Delivery/Recall Campaign)

Model Line: **Taycan (Y1A)**

Concerns: **Child locking function on three-point belt**

Information: **There is a possibility that the child-seat lock on the three-point belts in the affected vehicles will not always function properly due to a defective locking lever.**

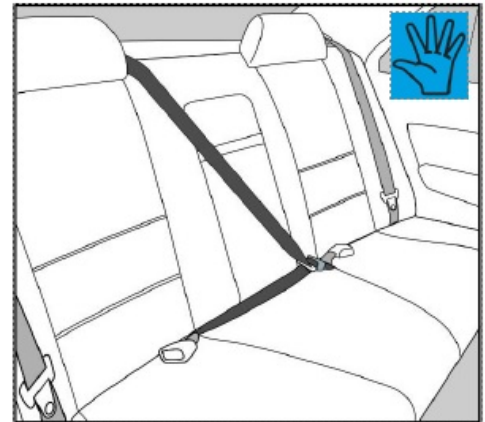
Closing three-point belt

- 1 Insert three-point belt with the seat-belt fastener into the seat-belt buckle and lock it ⇒ *Closing three-point belt.*

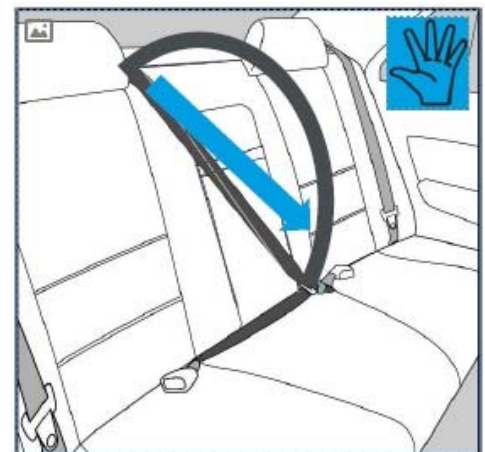
Pulling out belt strap

- 3 While holding the belt strap in place with your hand ⇒ *Holding belt strap -Right picture-* (only for rear center three-point belt), pull the belt strap out fully ⇒ *Pulling out belt strap* in order to activate the child locking function (ALR automatic locking retractor).

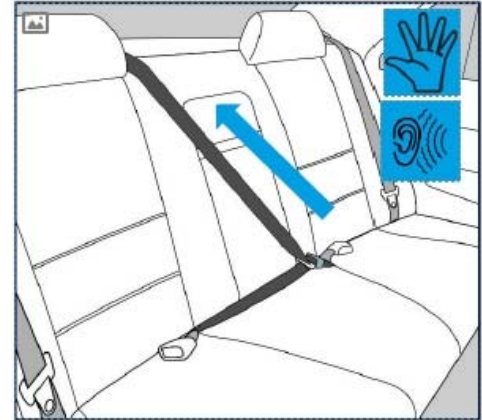
Retracting belt strap

- 4 Allow the belt strap to retract slowly, checking whether an audible click can be heard while it retracts
 ⇒ *Retracting belt strap*.
 Keep holding the belt strap with your hand (only for rear center three-point belt).

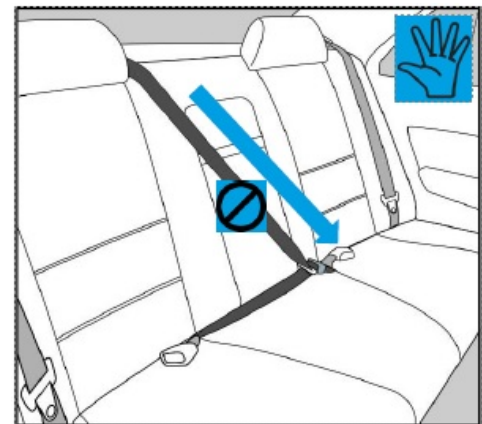
Pulling out belt strap and checking belt locking system

- 5 As soon as the belt strap has retracted, check whether it can be pulled out again or is blocked
 ⇒ *Pulling out belt strap and checking belt locking system*.

When checking the three-point belt(s), if you discover that the **belt strap does not lock**, the three-point belt(s) affected must be replaced. To do this, continue with:

- ⇒ *Technical Information '270689 Replacing front (passenger's side) three-point belt' and/or*
- ⇒ *Technical Information '270689 Replacing rear left / right three-point belt' and/or*
- ⇒ *Technical Information '270689 Replacing rear centre three-point belt'*
