Safety Recall

Code: 24HH

Subject	Engine Control Unit (ECU) Software															
Release Date	October 5, 2021															
Affected Vehicles

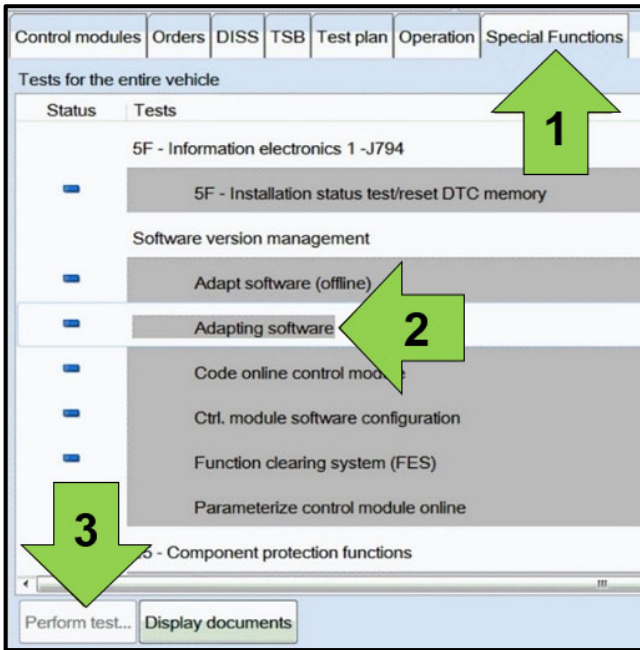
- Once the GFF scan is complete, select “Special functions” <arrow 1>, then “Adapting software” <arrow 2>, then select “Perform test” <arrow 3>.

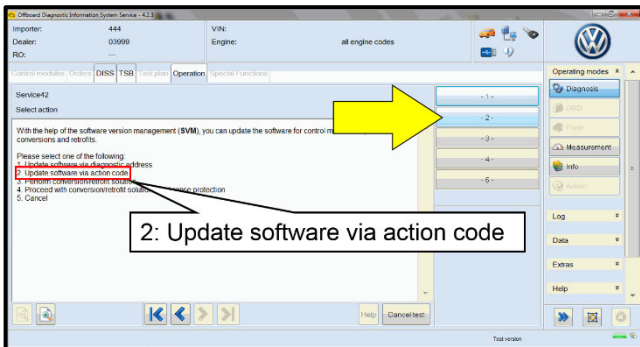
- Select the correct option to “Update software via action code” OR “Software update via measured code”.

NOTE
The different options to perform the SVM operation may vary based on model.

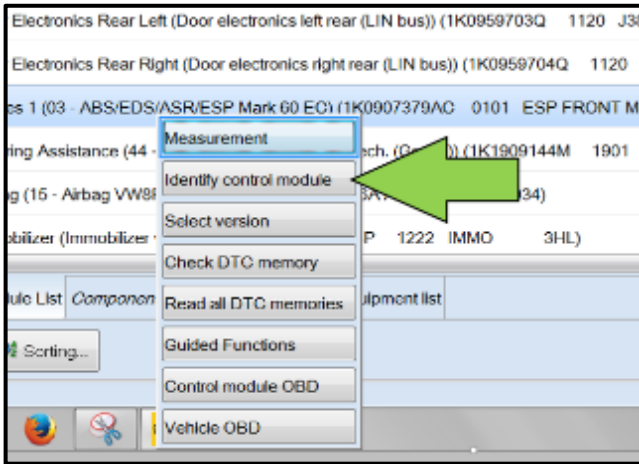
- After the software update is completed and before sending the GFF Log Online:
 - Select the “Control Module” tab.
 - Scroll down and right click on the module that was updated (0001).
 - Select “Identify Control Module” <arrow>.

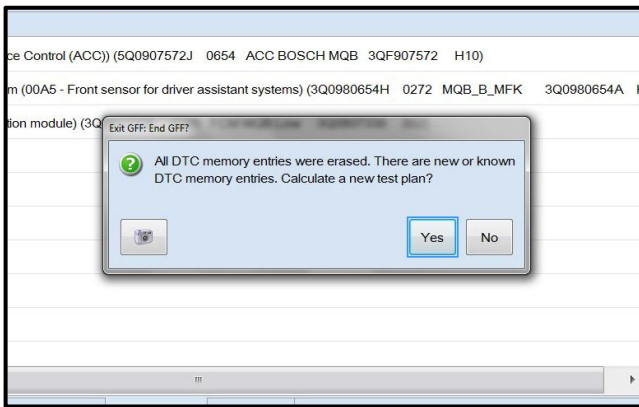
- Exit GFF and send diagnostic protocol online when prompted.
