**SUBJECT:** **Safety Recall 21S39 - Supplement #1**  
 Certain 2015 through 2021 Model Year Transit vehicles equipped with Dual Rear  
 Wheels  
 Torsional Damper Service Kit Update

## CERTAIN 2015-2021 MODEL YEAR TRANSIT VEHICLES EQUIPPED WITH DUAL REAR WHEELS — TORSIONAL DAMPER SERVICE KIT UPDATE

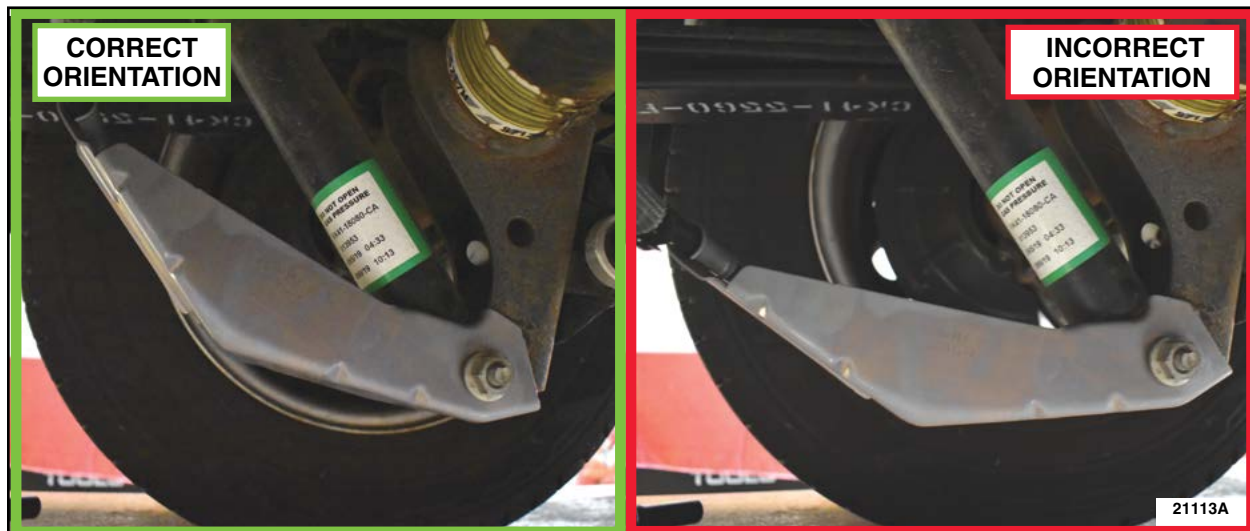
FIGURE 1

**NOTE:** Ensure the RH parking brake cable bracket is in the correct orientation prior to torquing the shock nut. See Figure 1.

1. Remove and replace the passenger side right hand (RH) parking brake rear cable. Please follow the workshop manual (WSM) procedures in Section 206-05.
