SUBJECT: NEW VEHICLE DEMONSTRATION / DELIVERY HOLD -Compliance Recall 21C19 Certain 2021 Model Year Explorer and Aviator Vehicles Seat Side Air Bag Attachment Studs

NEW VEHICLE DELIVERY HOLD -Compliance Recall 21C19

CERTAIN 2021 MODEL YEAR EXPLORER AND AVIATOR VEHICLES — SEAT SIDE AIR BAG ATTACHMENT STUDS

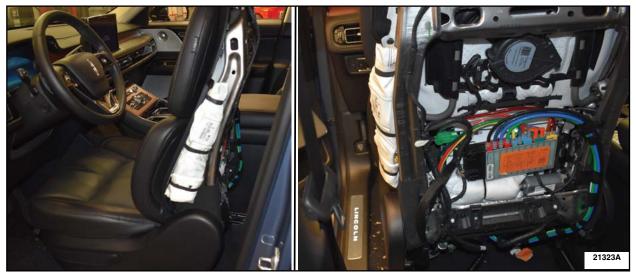
FIGURE 1

NOTE: The seat(s) do not need to be removed to complete this procedure. See Figure 1.

- 2. Based on Attachment IV Repair Table, remove and replace either the front driver or front passenger seat side air bag. Please follow the Workshop Manual (WSM) procedures in Section 501-20B.
- **NOTE:** Attachment nuts are to be included with SAB module kit. Original SAB attachment nuts are to be discarded.
- NOTE: Aviator shown, Explorer similar.

1. Use Attachment IV - Repair Table to determine if left hand (LH) or right hand (RH) side air bag (SAB) needs replacement per Vehicle Identification Number (VIN). Per build data, it will only be one (1) side.
