# Product Safety Recall

## A212335470 Mispositioned Emergency Jack May Not Support Vehicle

**Release Date:** October 2021

**Revision:** 02

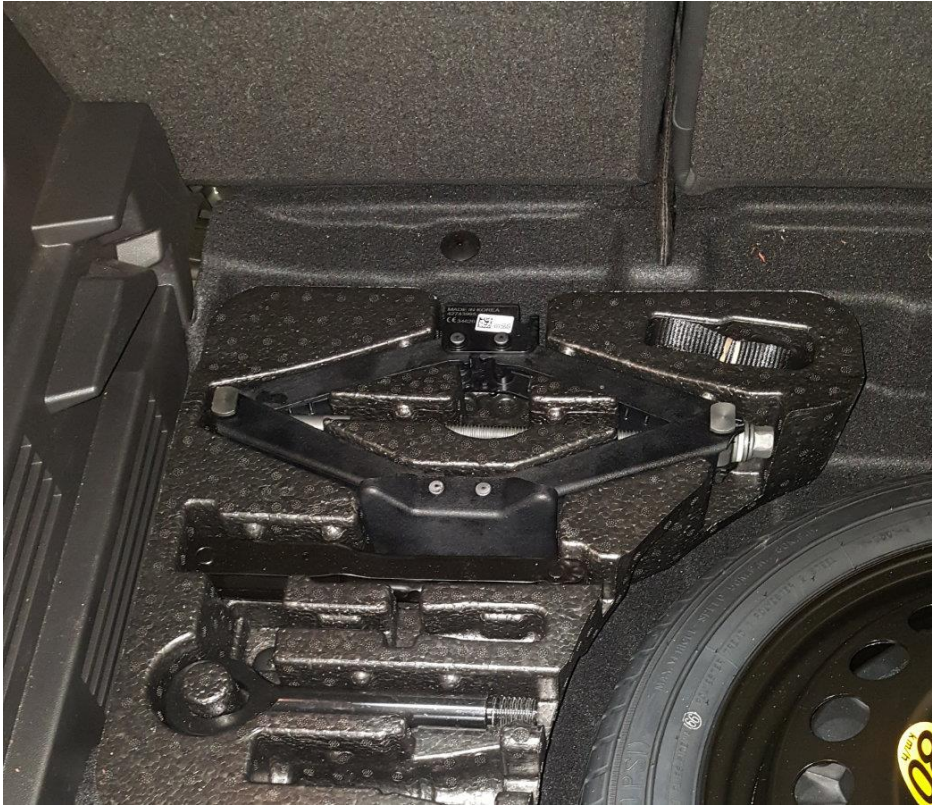
5861200

1. Remove the Load Floor Stowage Compartment Cover. Refer to *Load Floor Stowage Compartment Cover Replacement* in SI.

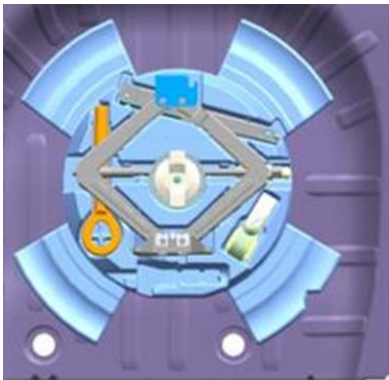
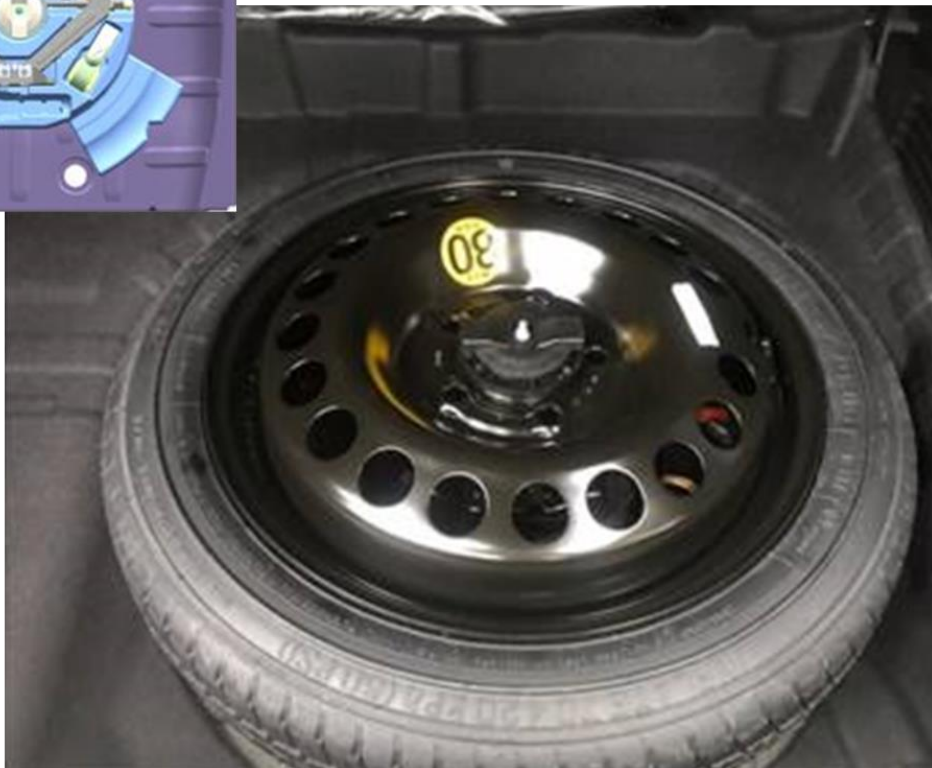
5862952

2. Locate the plastic jack on the left-hand side of the vehicle, towards the front of the stowage compartment.
  - The jack will be on the left-hand side of the vehicle, towards the front of the stowage compartment if the vehicle is equipped with a subwoofer.
  - If the vehicle is NOT equipped with a subwoofer, remove the spare tire to access the jack.
3. Remove the plastic jack and replace it with a steel jack, as shown.
  - Scrap the plastic jack.
4. Replace the spare tire if it was removed.
5. Replace the Load Floor Stowage Compartment Cover. Refer to *Load Floor Stowage Compartment Cover Replacement* in SI.
