# Product Safety Recall

## N212349040 Driver Front Airbag Inflator May Rupture

**Release Date:** December 2021

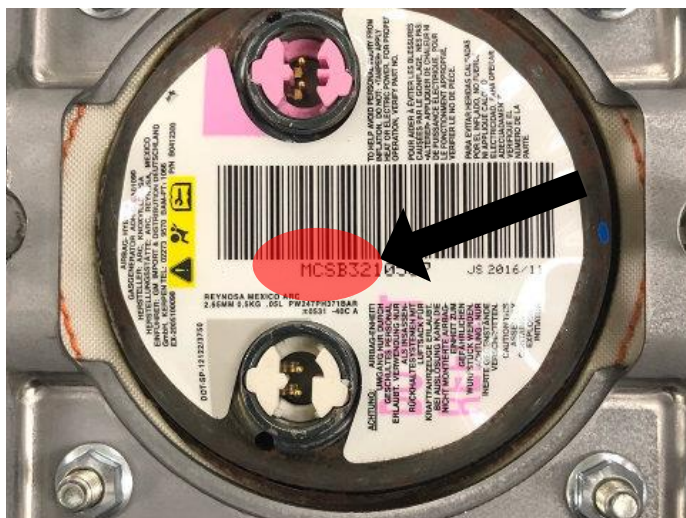
5907947

1. Remove the steering wheel airbag assembly. Refer to *Steering Wheel Airbag Replacement* in SI.

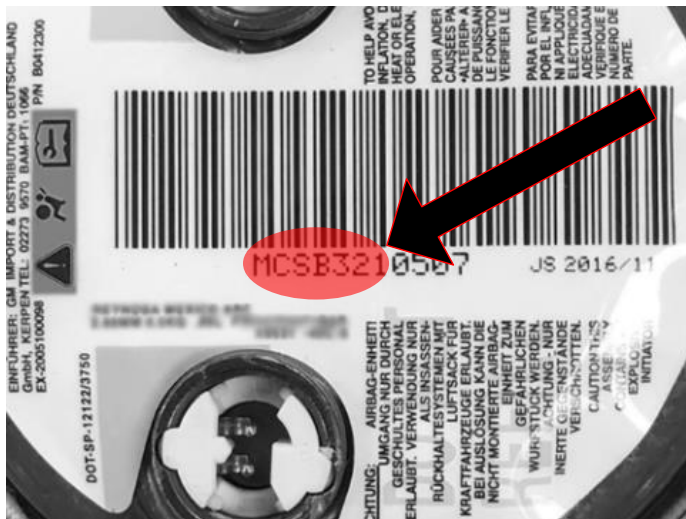
5907948

2. Locate the lot number on the back of the airbag inflator.

- If the lot number **begins with** MCSB321 or MCTB321, proceed to step three.
  - If the lot number **does not begin** with MCSB321 or MCTB321, record the serial # of the original module. Reinstall the steering wheel airbag assembly. Refer to Steering Wheel Airbag Replacement in SI.
3. Replace the steering wheel airbag assembly. Refer to *Steering Wheel Airbag Replacement* in SI. **Do Not Deploy the AIRBAG.**
