# RECALL 21V784 REMEDY INSTRUCTIONS

Make(s): Puma  
 Model(s): PUT32BH2B  
 Model Year(s): 2021 & 2022

Concern:  
 A second black wastewater-holding tank ventilation pipe was not installed in the vehicle.

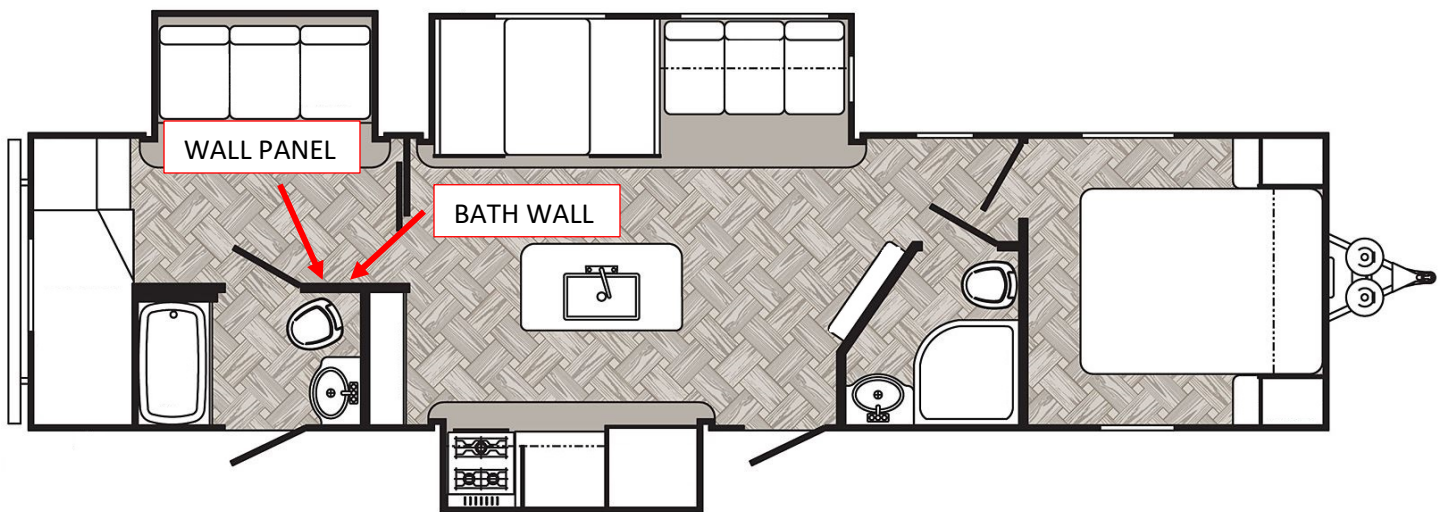
FIGURE 1

STEP 1: LOCATE THE BATH WALL IN FIGURE 1;

STEP 3: REMOVE THE WALL DÉCOR PANEL FACING THE BUNK ROOM, NOTATED IN FIGURE 1;

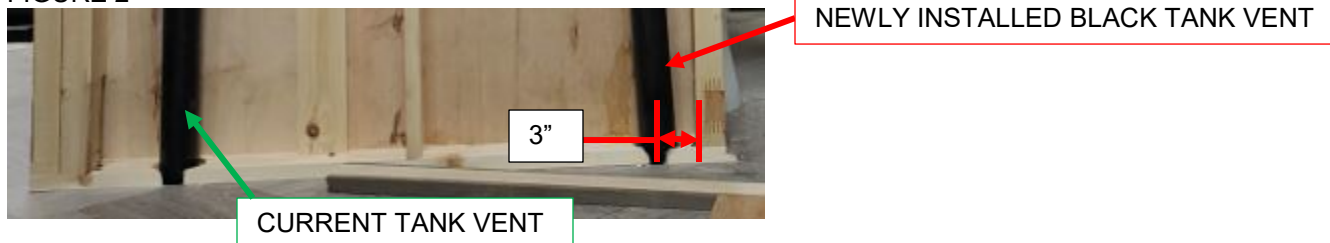
FIGURE 2

STEP 4: MEASURE FROM THE INSIDE OF THE PINE FORWARD 3" AND MARK THE BOTTOM PINE BOARD IN THE VERY CENTER (FIGURE 2);

STEP 5: USE A 2 ¼" HOLE SAW AND DRILL A HOLE THROUGH THE BOTTOM PINE BOARD IN THE WALL AND YOU WILL FIND A FLOOR HOLE ALREADY PRESENT. **DO NOT DAMAGE THE HOLDING TANK.**

**CAUTION: ENSURE PRIOR TO DRILLING THE HOLE – ENSURE YOU DO NOT DRILL A HOLE THAT WILL BE OUTSIDE OF THE WALL. DO NOT TEAR THE LINO.**
