RECALL 21V785 REMEDY INSTRUCTIONS

Make(s): ENTRADA CLASS C MOTORHOME
Model(s): MANY, SEE BELOW
Model Year(s): 2022

Concern:
The front leveling jack brackets may be installed to high and may compromise the brake lines, causing the brake lines to wear.

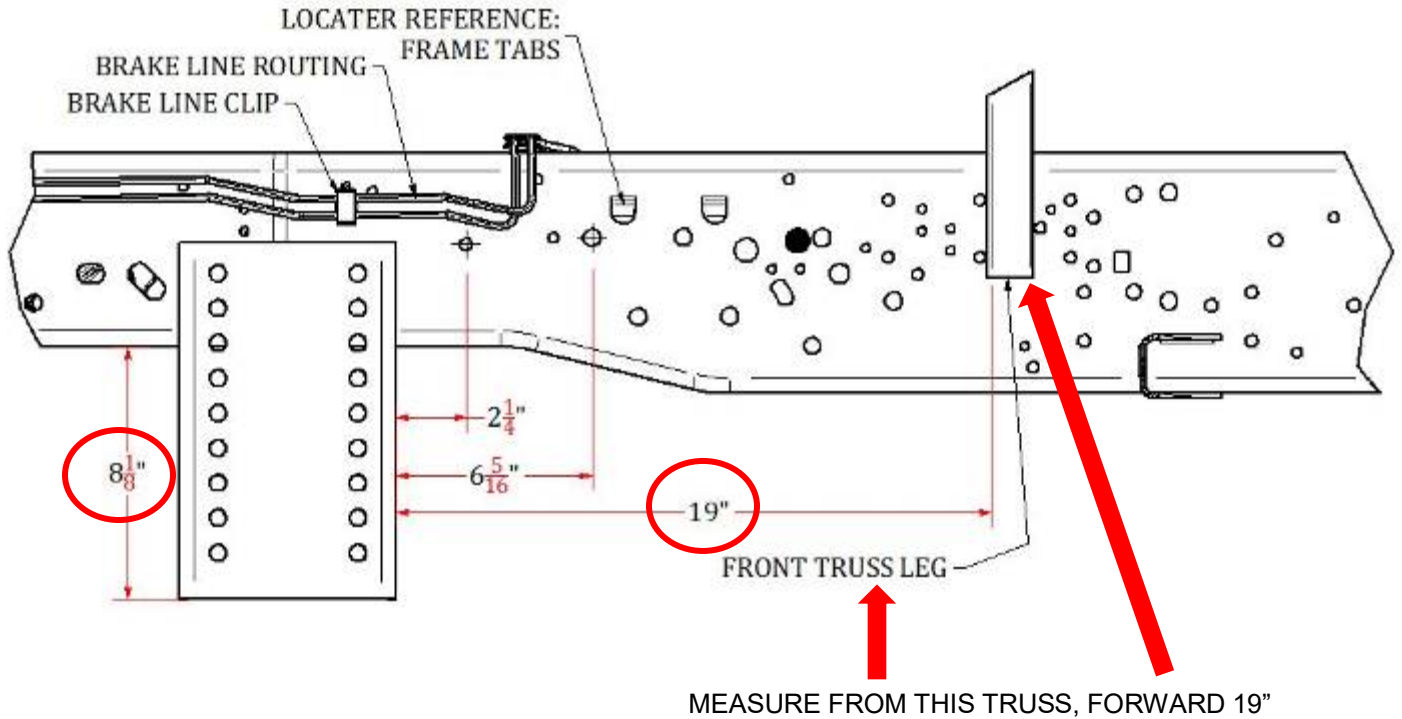
STEP 10: PROPERLY LOCATE BRACKET, 19" FROM ZERO, 8-1/8 DOWN FROM THE BOTTOM OF THE FRAME TO BOTTOM OF THE BRACKET, SEE FIGURES ON REVERSE PAGE;

← FRONT OF UNIT

STEP 9: ISOLATE AND PROTECT THE BRAKE LINE(S) FOR THE WELDING PROCESS OF THE JACK BRACKETS;

STEP 11: WELD JACK BRACKET INTO PLACE;
