**Repair Procedure – Updated August 12, 2022**

**Safety Recall 5321K – Multi-Model Fuel Pump May Fail – MX-5 ONLY Supplement**

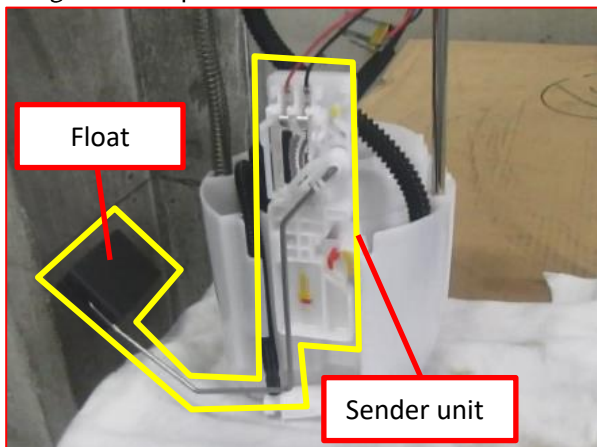
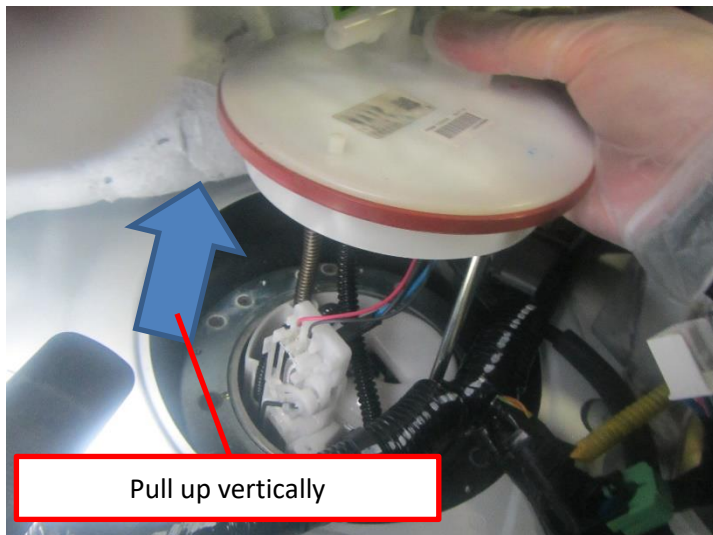
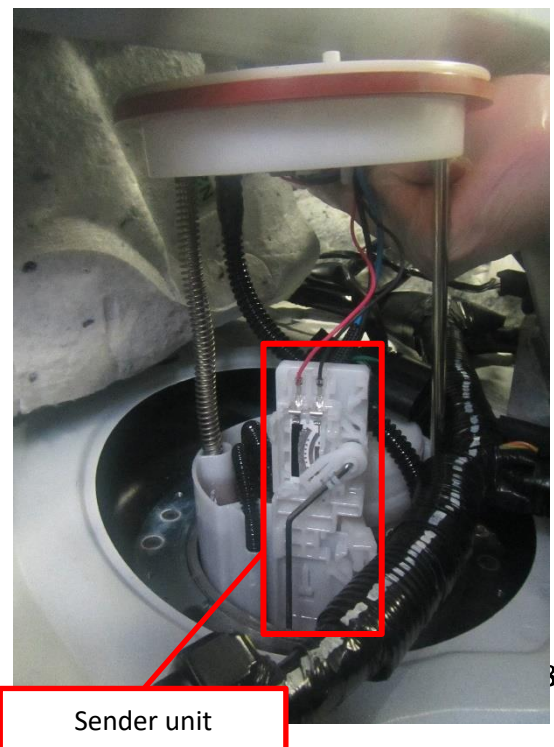
Image for the part 'Sender unit' with float. Be careful the float may damage and bend easily.

1. Remove the fuel pump unit from fuel tank refer to Workshop manual. [Click here for the procedure](#)
2. Pull up the fuel pump unit carefully until sender unit is appeared

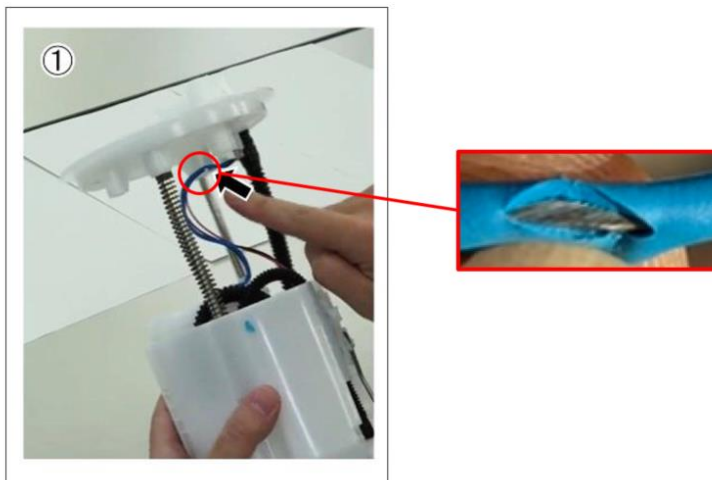
**IMPORTANT NOTE:** Check for broken, cut, frayed or chafed wire on FDM units as in the photo (1) below.

- If found to be damaged, the harness must be replaced. ***Be very careful with the harness as it can easily be damaged.***
- Part ordering: **Order the harness from the Restricted Parts Ordering (RPO) Screen through the Dealer Assistance Group (DAG).** You must have an open RO and the vehicle must be down. The Parts & Warranty information has been updated with the correct part number for the MX-5.

Harness Part Number	Model
292135-1074 (Length - 25CM)	MX-5

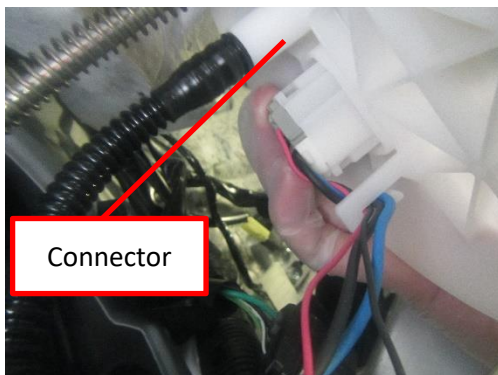
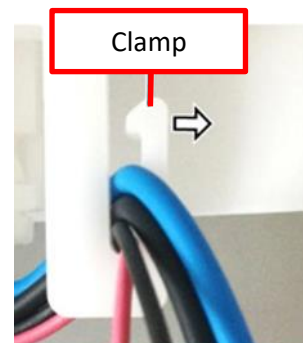
1, Remove the connector and harness from clamp.

※Image for the harness with clamp.

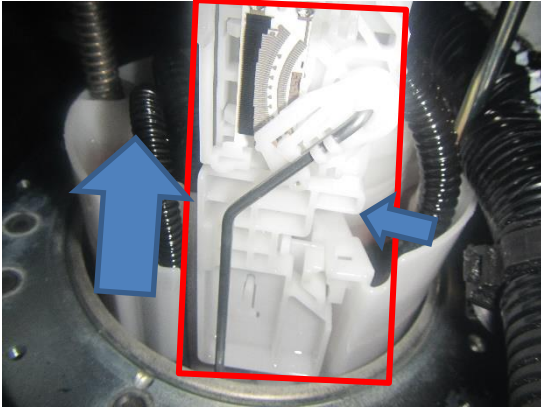
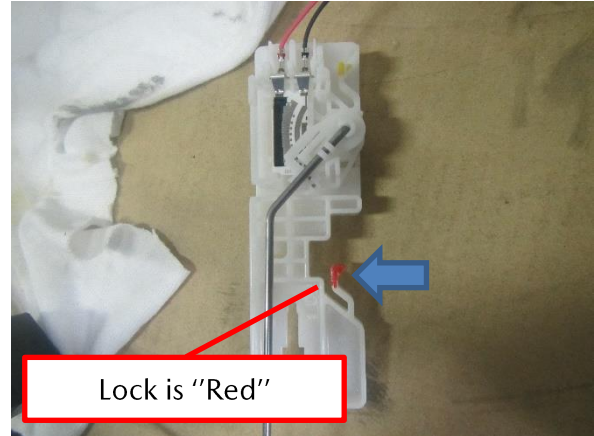
2, Release the 'Lock' then pull up the sender unit vertically.

※Image for the 'Lock' position.

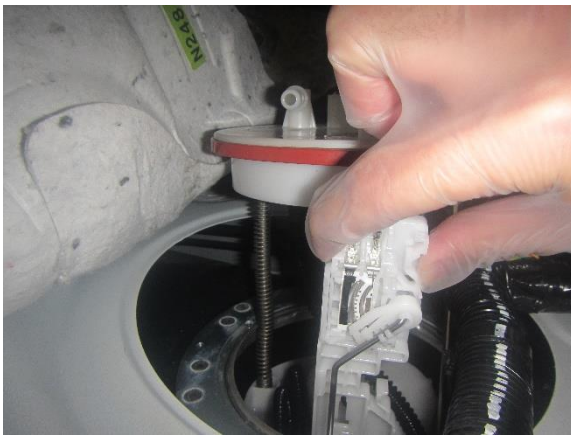
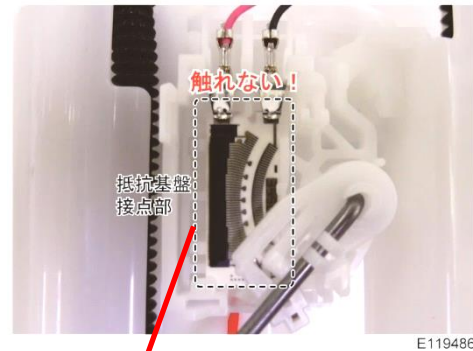
3, Hold the sender unit with harness up and go down the fuel pump unit vertically.

※Do not touch the sensor.

Do not touch terminals.

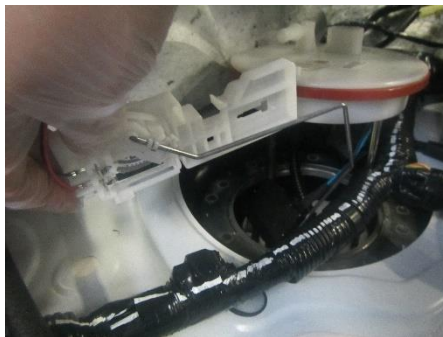
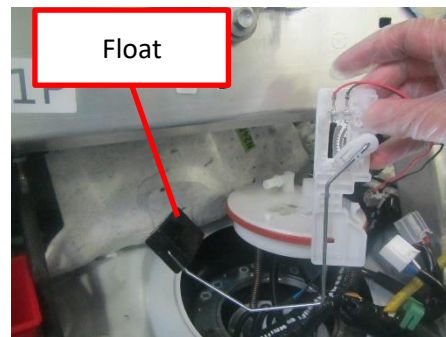
4, Be sure that the float part of the sender unit does not contact the fuel tank.

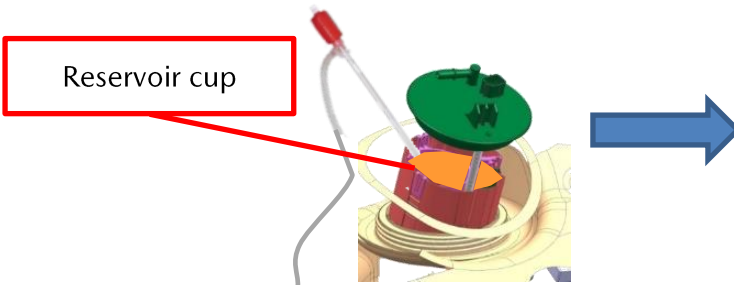
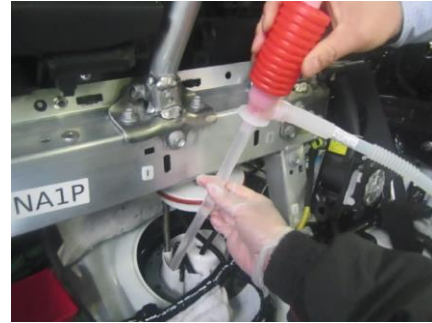
4. Remove the fuel remaining in the unit's reservoir cup with a dropper.

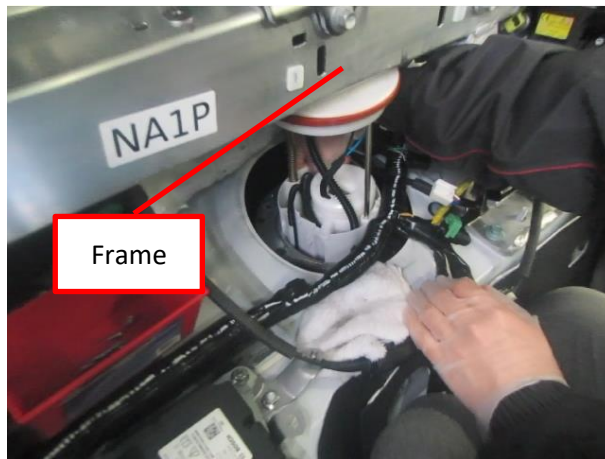
1, Lift the unit to the limit of the frame.

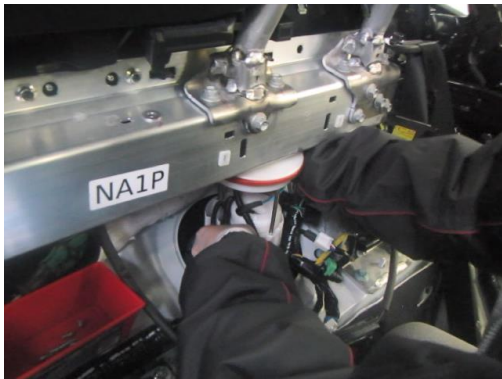
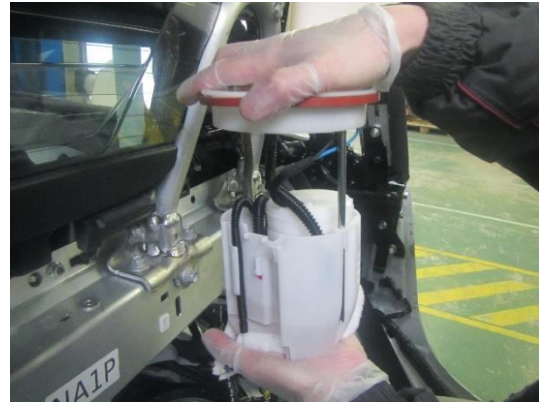
2, Apply the upper part of the unit to the frame and compress.

※Image of compression.

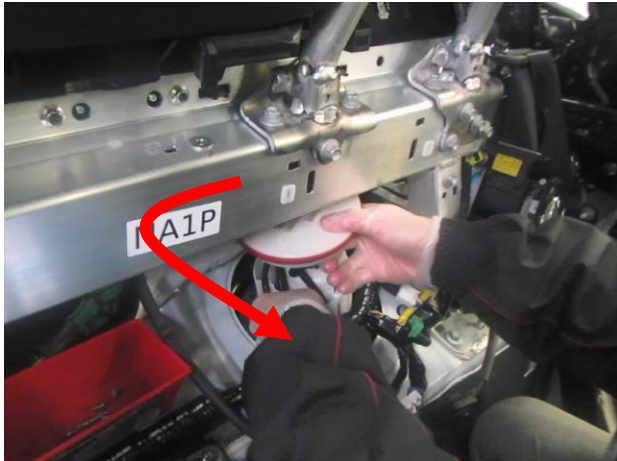
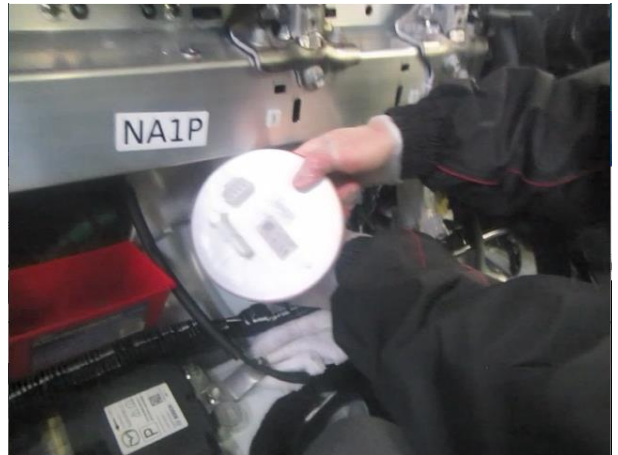
3, Slide the fuel pump unit as shown by the arrow to remove it from the fuel tank.

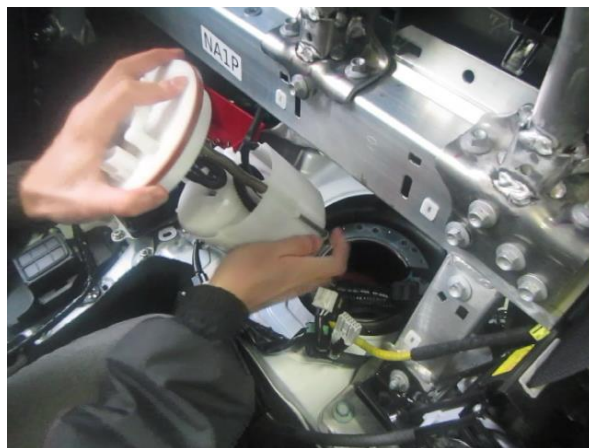
1, Compress the unit.

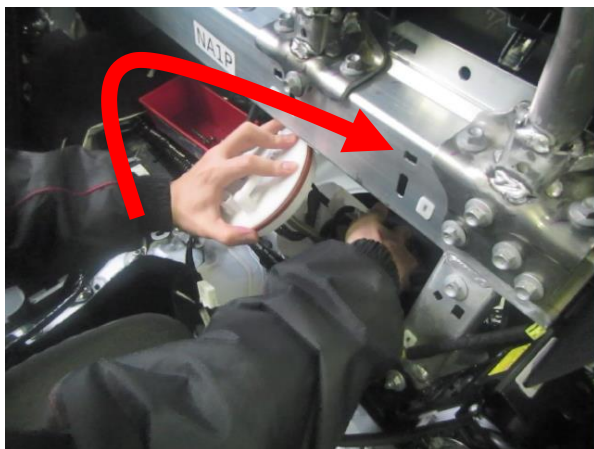
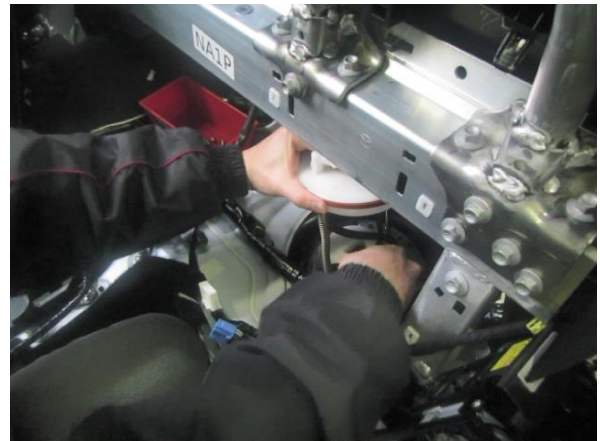
2, While compressed, push under the frame and rotate the fuel pump unit in the direction of the arrow to install the unit into the fuel tank.

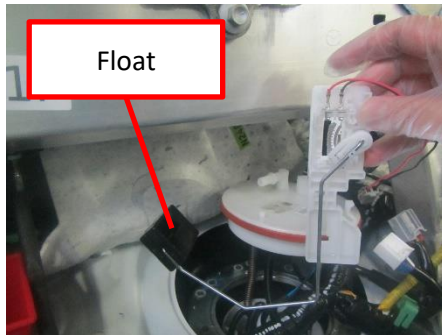
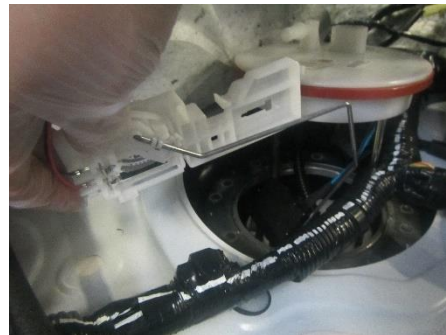
1, Reinstall the sender unit inside. Make sure that the floating part does not contact to the fuel tank.

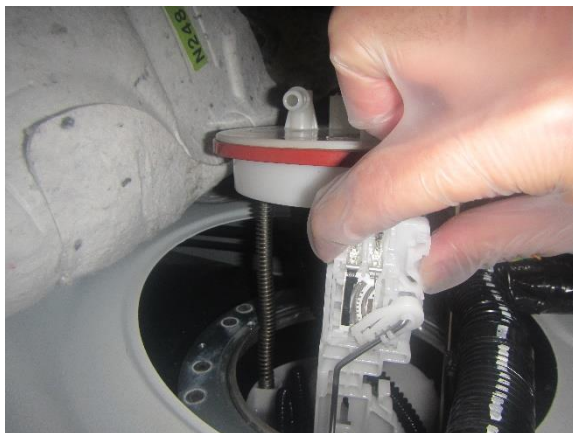
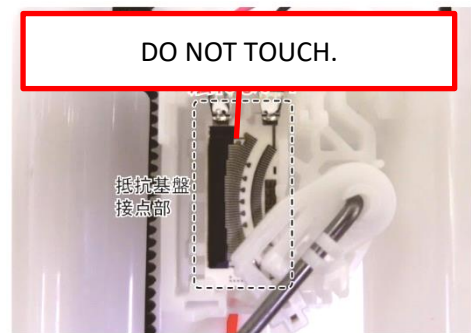
2, Hold the sender unit in your hand and slowly lower the fuel pump unit.

※Do not touch the sensor.

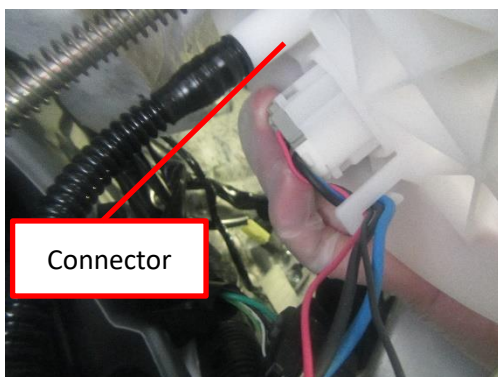
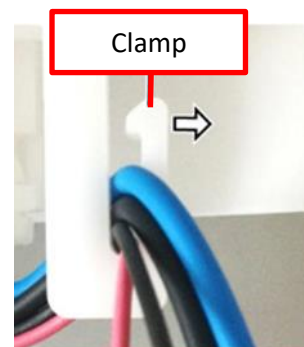
4, Install the connector and harness from clamp.

※Image for the harness with clamp.

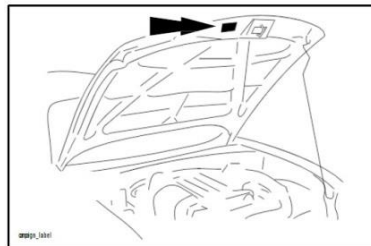
2. Affix it to the hood as shown:
