**SUBJECT: NEW VEHICLE DEMONSTRATION / DELIVERY HOLD
Compliance Recall 21C36**

Certain 2021-2022 Model Year Maverick and Mach-E Vehicle
Rear Seat Belt Anchor Thread Repair

CERTAIN 2021 MODEL YEAR MAVERICK AND MUSTANG MACH-E VEHICLES — DRIVER AND REAR SEATBELT BUCKLE ATTACHMENT REPAIR

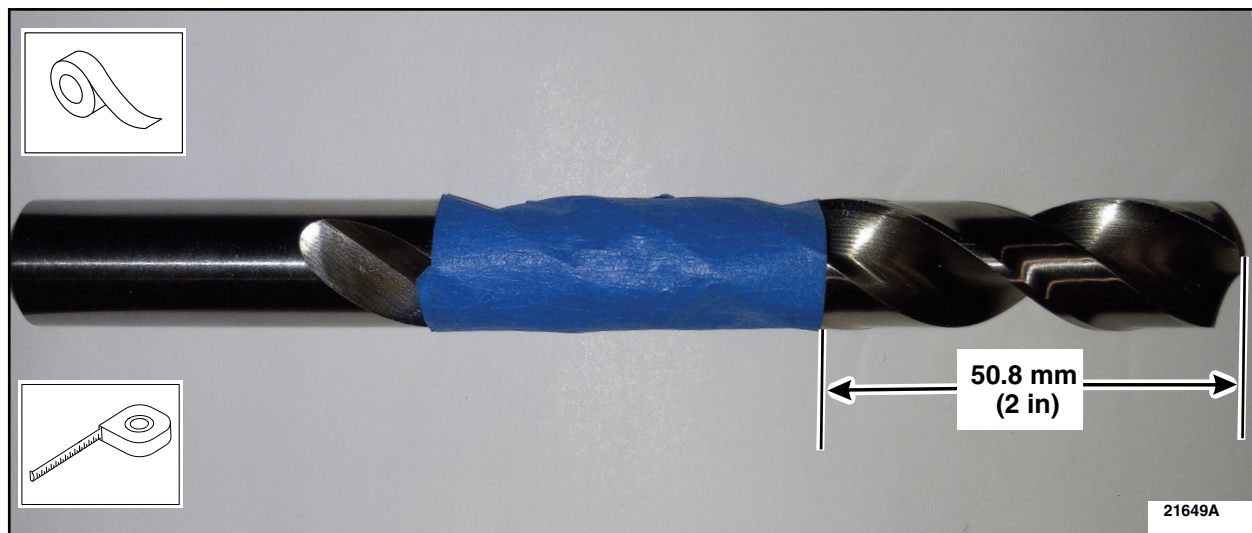
FIGURE 1

NOTE: Set a depth gauge on the drill bit supplied with the M12 x 1.75mm thread repair insert kit at 50.8 mm (2 in). See Figure 1.

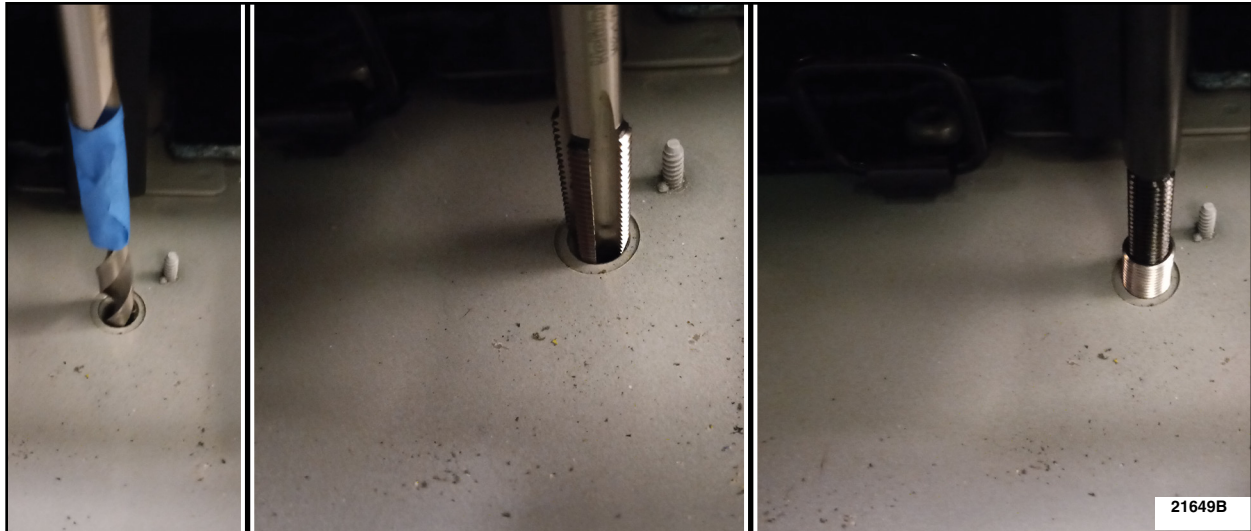
FIGURE 2

2. Using a M12 x 1.75mm thread repair insert kit, drill out – or repair the anchor bolt hole. Use the instructions contained with the kit to install the thread repair kit. See Figure 2.

3. Thoroughly clean all debris from the repair area before reinstalling the LH, RH and Center rear seatbelt buckles.

4. Reinstall the LH, RH and Center rear seatbelt buckles by reversing the removal procedure.

- Torque: 41 lb.ft (55 Nm).

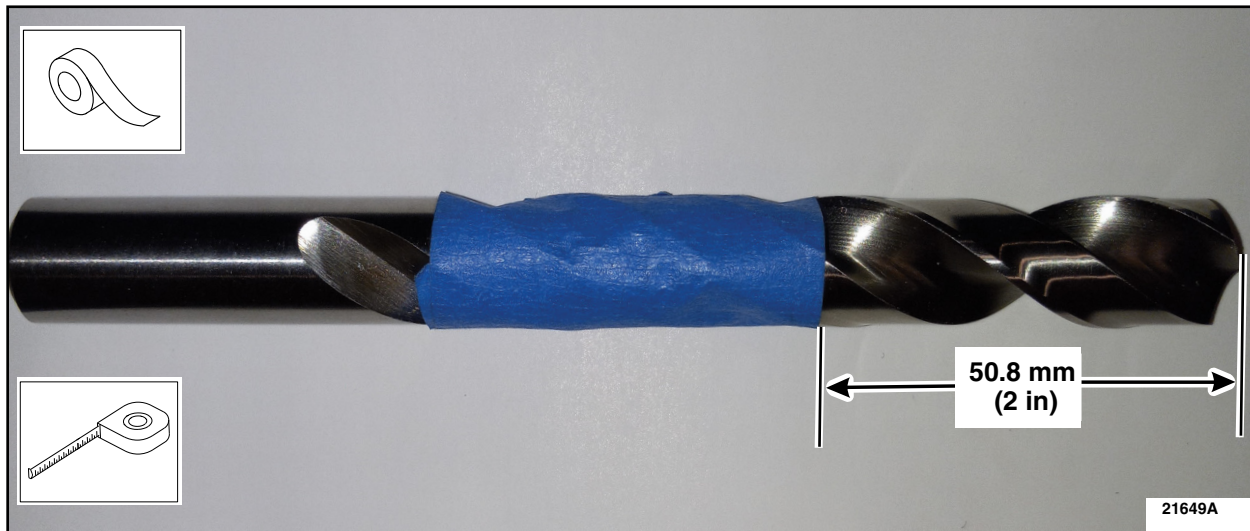
FIGURE 3

NOTE: Set a depth gauge on the drill bit supplied with the M12 x 1.75mm thread repair insert kit at 50.8 mm (2 in). See Figure 3.

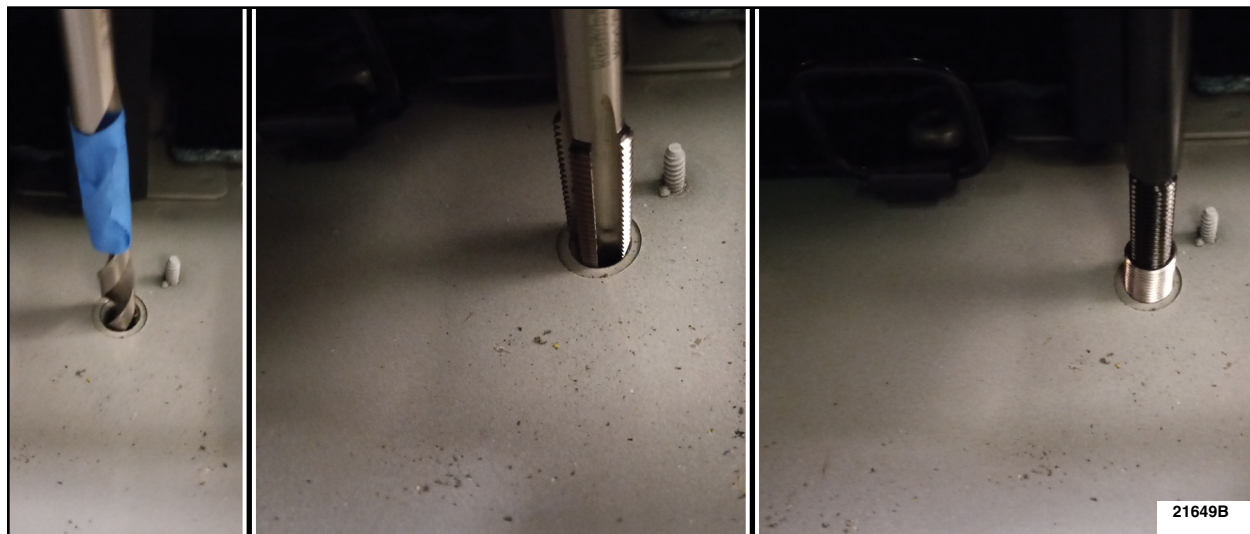
FIGURE 4

3. Using a M12 x 1.75mm thread repair insert kit, drill out – or repair the anchor bolt hole. Use the instructions contained with the kit to install the thread repair kit. See Figure 4.

4. Thoroughly clean all debris from the repair area before reinstalling the LH, RH and Center rear seatbelt buckles.
5. Reinstall the RH and Center rear seatbelt buckles by reversing the removal procedure.
 - Torque: 30 lb.ft (40 Nm).
6. Reinstall the Rear Seats by reversing the removal procedure.
