Service Bulletin

Hub Grease Inspection and Replacement Instructions

SAF-HOLLAND® Axles with ConMet PSP Drum Brake Hubs

December 2021

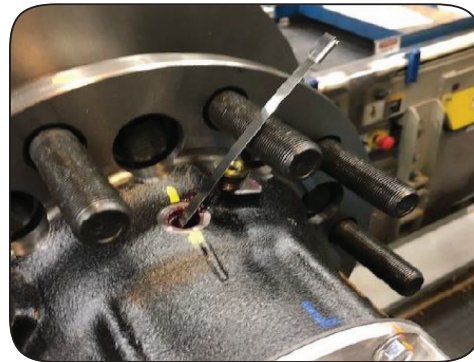
Figure 1

1. Orientate hub so that the fill port is located at the 12 o'clock position.
2. Remove fill plug and insert a clean dip-stick of 8" minimum at an angle until it makes contact with the side of the hub (**Figure 1**).
3. Remove dip stick and check amount of grease. There should be 3.0" minimum on the stick (**Figure 2**).
4. If the proper amount is present reinstall fill-plug (20-25 ft-lbs).
5. Mark the hub at the fill-plug with a green paint mark (**Figure 3**).
6. If the proper amount is not present proceed to Section 3.

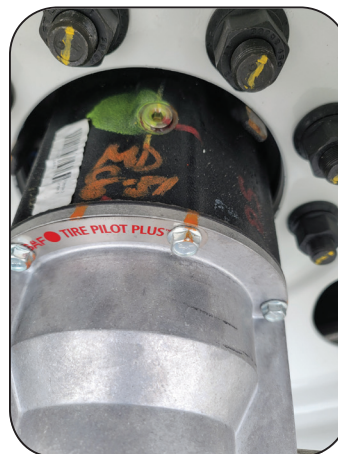
Figure 3

1. Tear down wheel end, clean and inspect bearing journals, and threads.
2. If spindle is in good condition replace with new wheel end following ConMet installation procedure 10084844.
3. Mark the hub at the fill-plug with a green paint mark (**Figure 3**).
4. If spindle is deemed not satisfactory replace both axle (refer to section 4) and wheel end.
5. Mark the hub at the fill-plug with a green paint mark (**Figure 3**).
