RECALL 22V004 / 2022-002 REMEDY INSTRUCTIONS

Concern:
 Per Sailun Tire Americas, Inc.: "The defect is associated with a steel belt package design change that could contribute to a tread belt separation or tread delamination, increasing the risk of a crash."

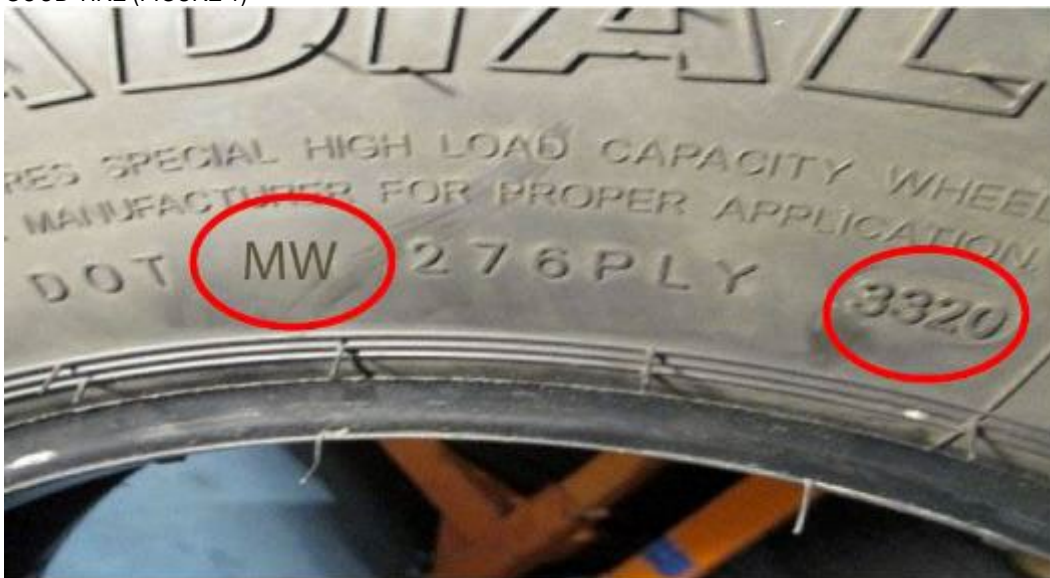
GOOD TIRE (FIGURE 1)

STEP 2: IF THE TIRE HAS DOT FACTORY CODE OF "MW" – REGARDLESS OF DATE CODE (2020 – 4120) THE TIRE IS GOOD AND DOES NOT REQUIRE REPLACEMENT SEE FIGURE 1;

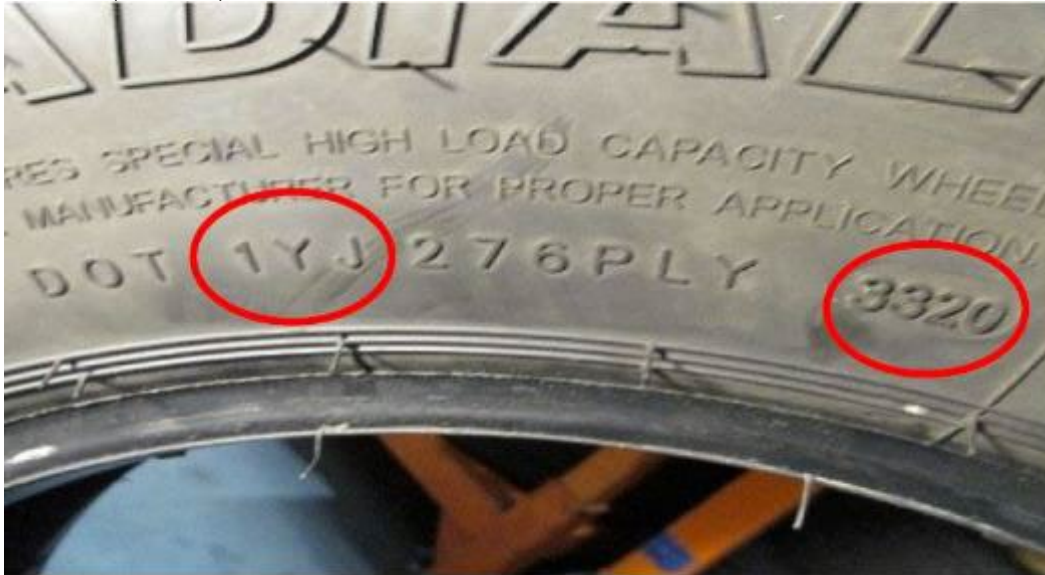
BAD TIRE (FIGURE 2)

IF THE TIRE HAS A DOT FACTORY CODE OF "1YJ" AND A DATE CODE BETWEEN 2020 THROUGH 4120, THE TIRE IS BAD AND NEEDS TO BE REPLACED SEE FIGURE 2;

STEP 1: DISCONTINUE USE OF THE TIRE;

STEP 2: SUBMIT PHOTOS OF THE TIRE(S) THAT NEED TO BE REPLACED (THE PHOTO'S ARE REQUIRED TO SHOW THE DOT FACTORY AND DATE CODE (AS SHOWN IN BOTH OF THE TIRE FIGURES. THIS IS A CONDITION OF PAYMENT AND REPLACEMENT;

STEP 3: ONCE A REPLACEMENT TIRE ARRIVES, REMOVE TIRE FROM RIM – OR USE A TIRE SHOP;
 A DEALER MAY ALSO USE A TIRE SHOP THAT CARRIES SAILUN TIRES AND HAVE THE SHOP REPLACE THE TIRE UNDER THE **SAILUN RECALL 21T018**, FOREST RIVER WILL STILL REIMBURSE THE DEALER FOR REMOVING, DISMOUNTING, AND MOUNTING ETC. PHOTOS OF THE TIRE ARE STILL REQUIRED;

STEP 4: DESTROY AND DISCARD THE BAD TIRES PER THE NOTE ON THE FRONT PAGE, AND THE NOTE BELOW. THIS IS A FEDERAL REQUIREMENT AND MUST BE FOLLOWED;

Note: Federal law requires that each recalled tire be disabled by the dealer within 24 hours after the tire has been received. Tires need to be permanently disabled by drilling three holes in one sidewall and the complete DOT code needs to be removed from the tires. When disposing of tires, please be sure that you comply with applicable state and local laws and regulations regarding disposal of tires.
