Revision 3 October 2022

Dealer Service Instructions for:

Safety Recall Z11 / NHTSA 22V-077 Plug-in Hybrid Electric Vehicle Fires

2017 - 2018 (RU) Chrysler Pacifica (PHEV)

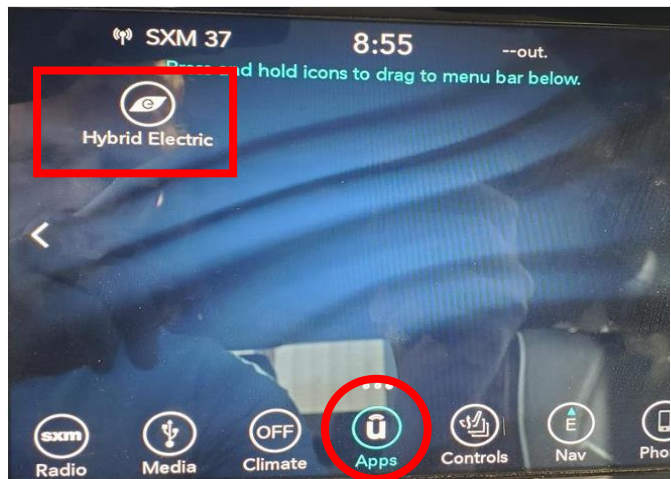
Figure 1 – Apps Display Screen

22. Select “Apps” then “Hybrid Electric” on the display (Figure 1).

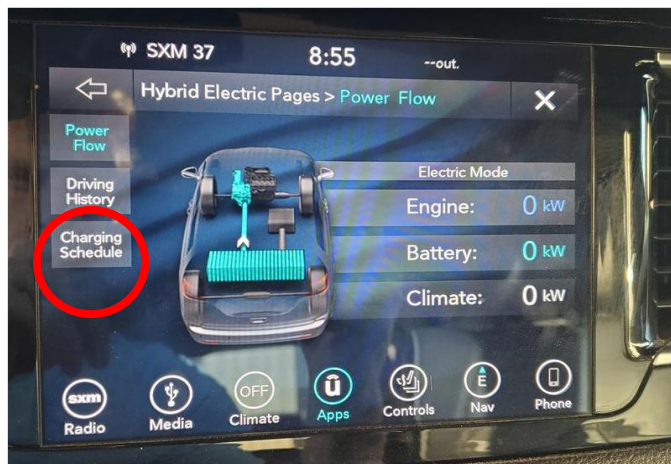
Figure 2 – Charging Schedule Display

23. Select “Charging Schedule” (Figure 2).

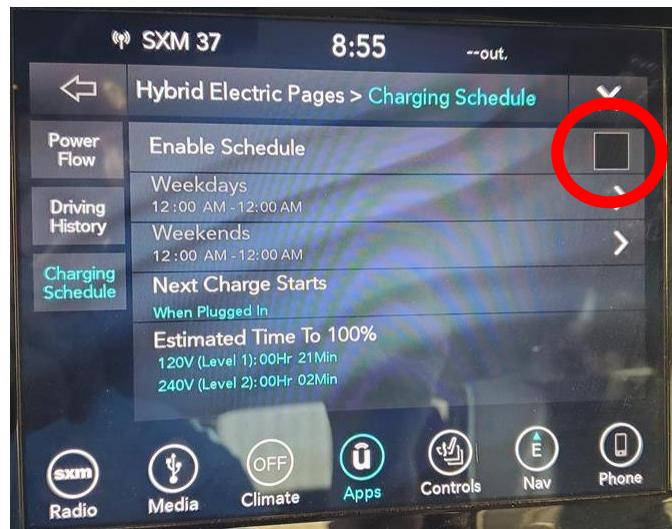
Figure 3 – Enable Schedule Screen

24. Verify the “Check Mark” is **NOT** selected in the “Enable Schedule” box (Figure 3).

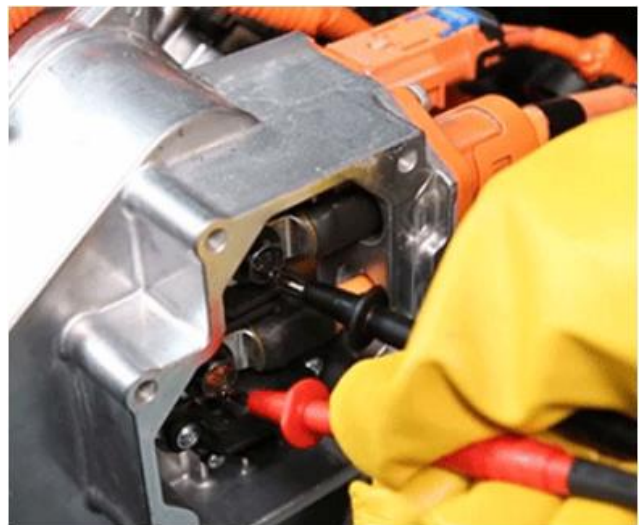
Figure 13 – Voltage Measurement

- If the voltage is greater than 0 volts, an internal condition exists within the high-voltage battery that is preventing it from being powered down. Do not attempt to carry out repairs on any of the vehicle's high-voltage components or wiring. Perform the **HIGH VOLTAGE LOSS OF ISOLATION TEST PROCEDURE** (Refer to 08 - Electrical/Standard Procedure)

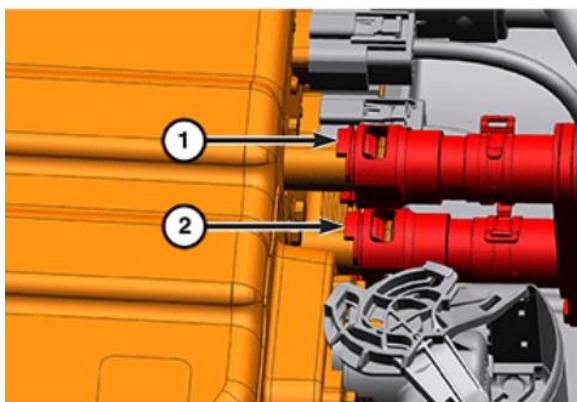
Figure 15 – Quick Connect Couplings

22. Place a suitable coolant recovery container under the coolant inlet and outlet hoses.
23. Disengage the quick-connect couplings and carefully remove the coolant inlet (1) and outlet (2) hoses from the high voltage battery (Figure 15).
