Revision 4 November 2022

Safety Recall Z11 / NHTSA 22V-077 Plug-in Hybrid Electric Vehicle Fires

2017 - 2018 (RU) Chrysler Pacifica (PHEV)

A. Battery Pack Control Module (BPCM) Software Update **and BPCM Integrity Procedure**

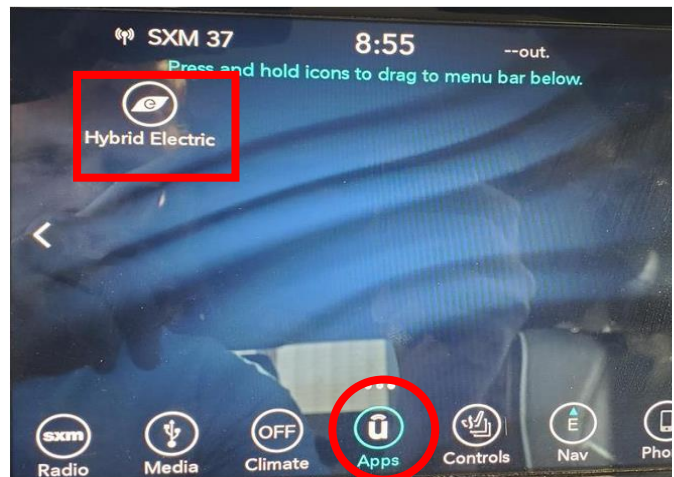
Figure 1 – Apps Display Screen

22. Select “Apps” then “Hybrid Electric” on the display (Figure 1).
23. Select “Charging Schedule” (Figure 2).

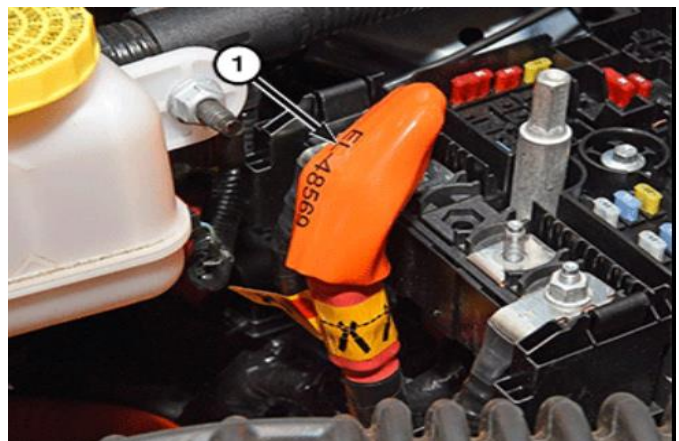
Figure 6 – Battery Cable

6. Disconnect the B+ battery cable (1) from the 12-volt Power Distribution Center (PDC) (Figure 6).
7. Isolate the battery cable terminal with Cover, Protective 10084

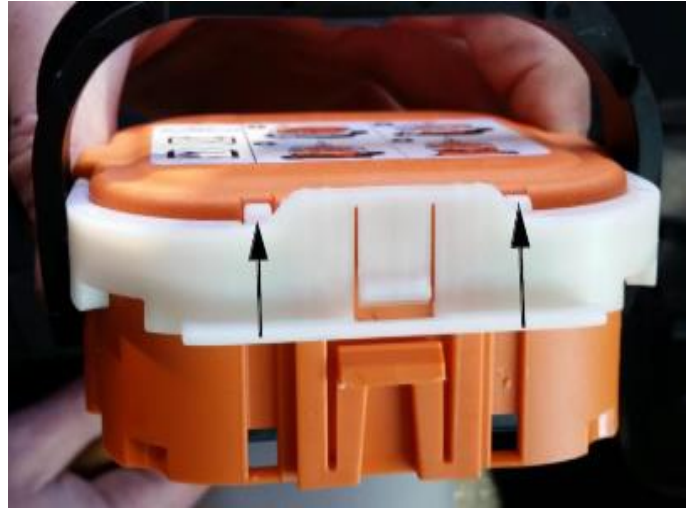
Figure 21 – MSD Position

16. Position the white sleeve in the full upright position for installation of the MSD to verify proper engagement as shown (Figure 21).

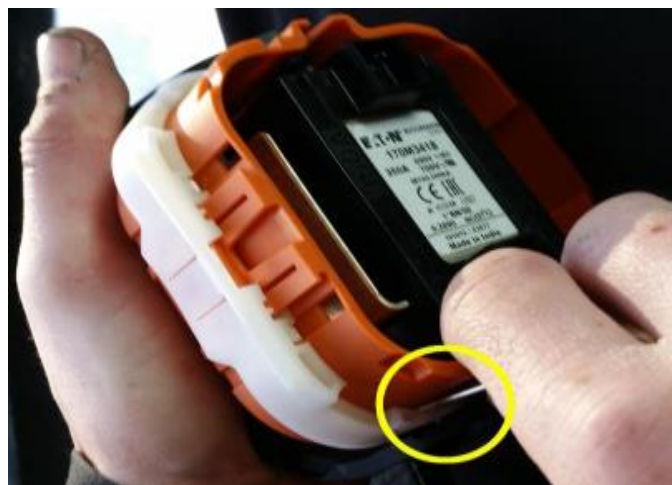
Figure 22 – White Sleeve

NOTE: If necessary, use a small screwdriver to loosen and guide the white sleeve to the full upward position as shown (Figure 22).

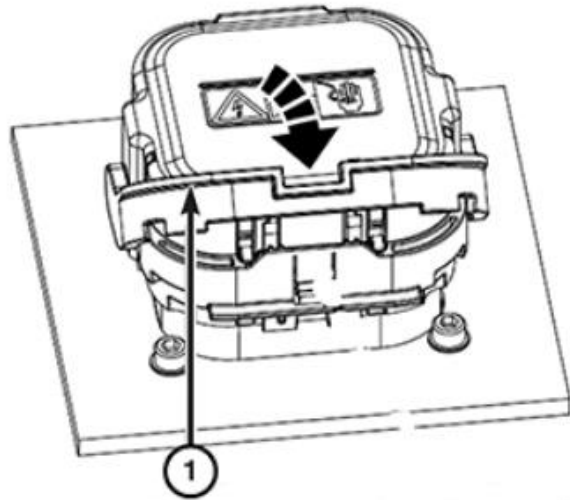
**Figure 25 – MSD Lever Locking**

20. Rotate the lever (1) while maintaining a slight force on the high-voltage MSD. The lever will engage the receptacle and draw the high-voltage MSD down onto the receptacle as the lever is rotated.

21. Rotate the lever (1) downward until it is fully engaged and locked by the lever release latch (2). An audible “click” will be heard as the lever latches into position. Gently pull the high-voltage MSD upward to ensure that it is fully seated in the receptacle and locked. If the MSD is able to be removed, repeat steps 14 – 16 (Figure 25).
