SECOND NOTIFICATION IMPORTANT SAFETY RECALL #22V113

The coupler may not have been not properly welded by vendor; this could lead to vehicle separation.

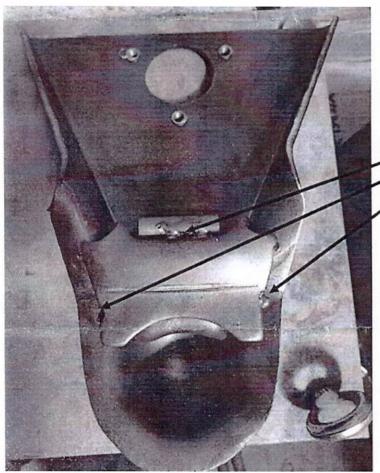
Defective Coupler

If any spot welds like on this coupler, these need to be pulled out of inventory and not used.

LEGEND MANUFACTURING is notifying dealerships of the recall. You may have the recall corrected at any LEGEND MANUFACTURING dealership. However, it is preferable if you have your selling dealership perform the remedy. The remedy will include inspection of the coupler for missing welds and if any are found, the coupler will be replaced. LEGEND MANUFACTURING completely covers your cost for the remedy; you will not be invoiced for any cost(s) relating to the above recall number.

If our Warranty Manager is not able to determine the weld's integrity, you will be instructed to contact your dealer and request a service representative come to your location and inspect and if required, replace the coupler at no charge to you. The trailer owner is responsible for arranging to have the work completed. Please state you have been notified by LEGEND MANUFACTURING regarding this recall and provide the recall number (your trailer's VIN number) to the dealership. You may also visit www.legendmfginc.com for dealer locations.
