RECALL 22V184, 2022-138 REMEDY INSTRUCTIONS

Make(s): PUMA
Model(s): MANY, SEE BELOW
Model Year(s): 2022

Concern:
The exterior griddle may be stowed while in use and increase the risk of fire.

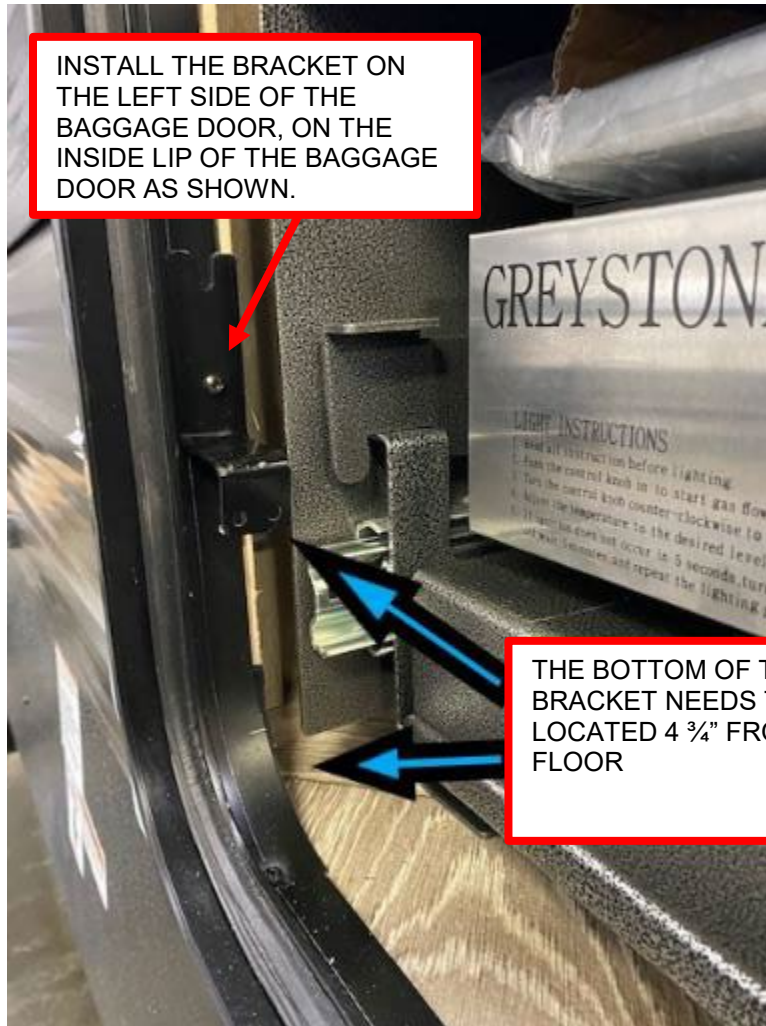
INSTALL THE BRACKET ON THE LEFT SIDE OF THE BAGGAGE DOOR, ON THE INSIDE LIP OF THE BAGGAGE DOOR AS SHOWN.

THE BOTTOM OF THE BRACKET NEEDS TO BE LOCATED 4 ¾" FROM THE FLOOR

STEP 1: REFERENCE FIGURE 1 FOR REMEDY INSTRUCTIONS;
