HYUNDAI

Technical Service Bulletin

GROUP RECALL	NUMBER 22-01-072H
DATE SEPTEMBER 2022	MODEL(S) NEXO (FE)

SUBJECT: HYDROGEN RECEPTACLE INSPECTION AND REPLACEMENT
(RECALL 224)

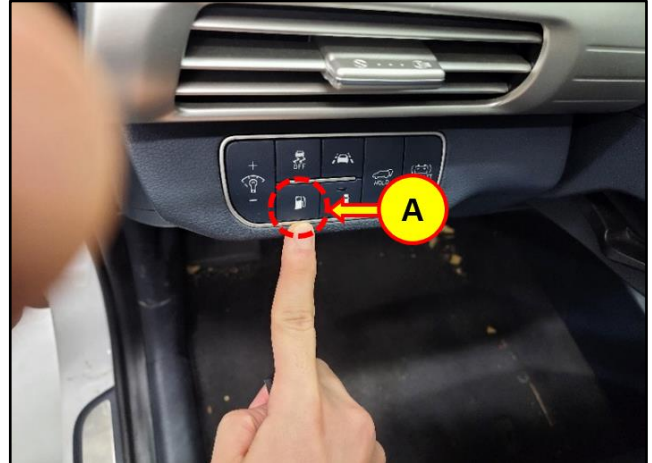
1. Turn off the vehicle.
2. Release the fuel door (A).

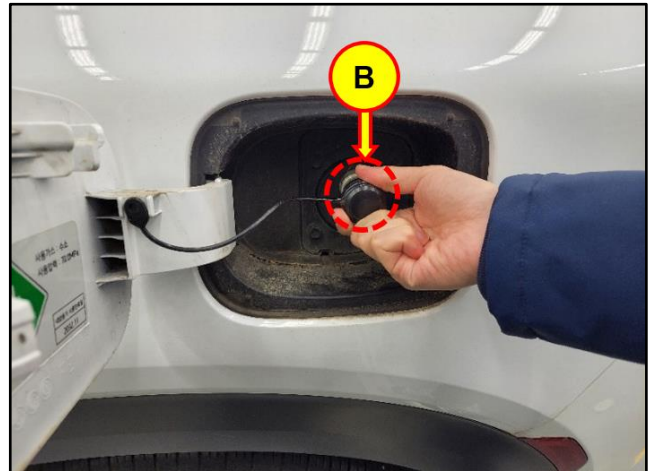
3. Remove the receptacle cap (B).

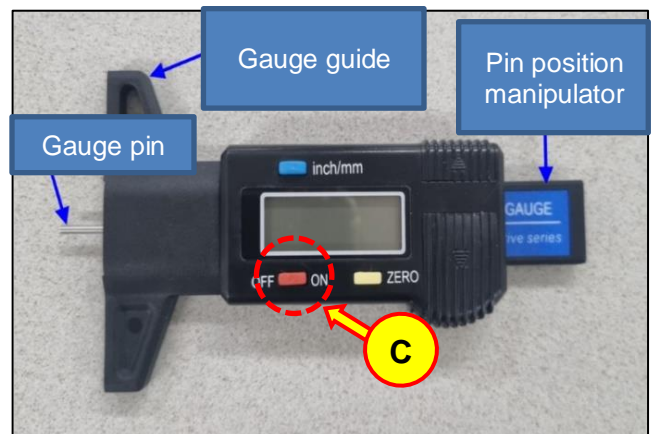
4. Press the hydrogen receptacle depth gauge power switch (C) to turn it **ON**.

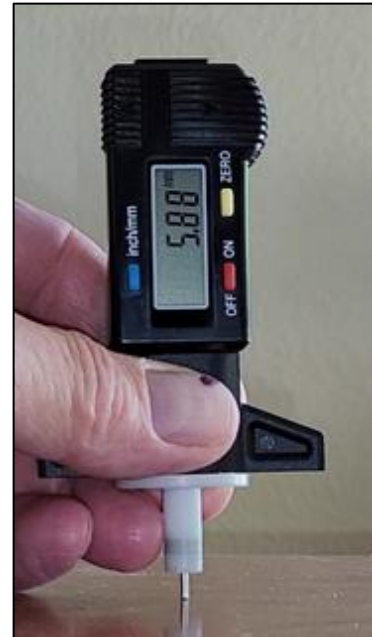
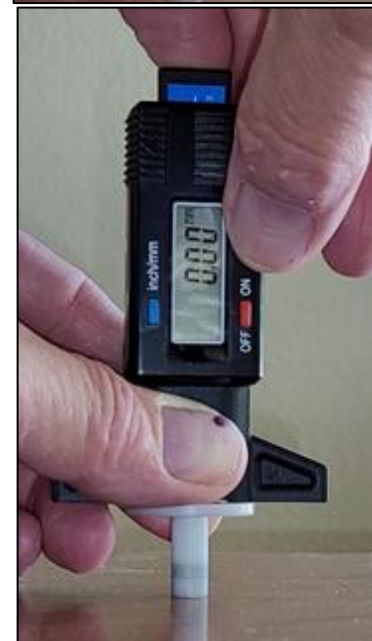
5. Insert the depth gauge into the measurement adapter and place the adapter against the surface of the GDS glass.

Push the pin position manipulator in until the gauge pin touches the surface of the GDS glass and then press the **ZERO** button.

Remove the adapter from the digital depth gauge.

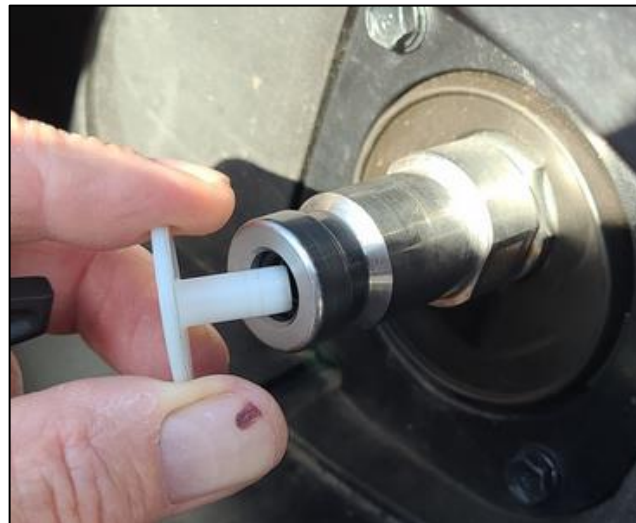
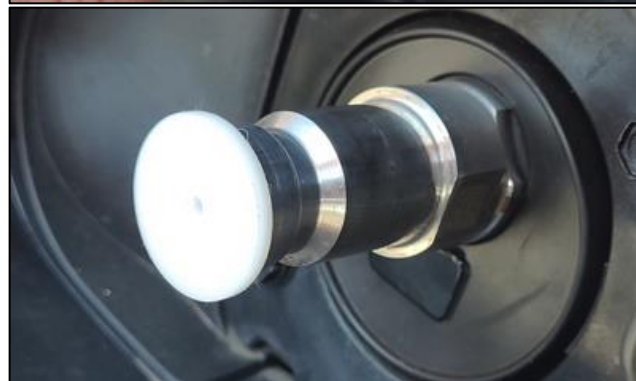
6. Insert the measurement adapter into the fill receptacle until it stops.

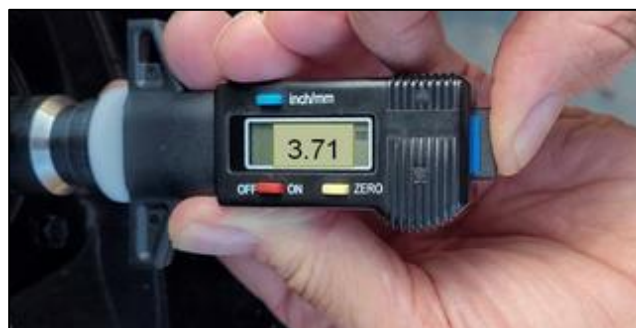
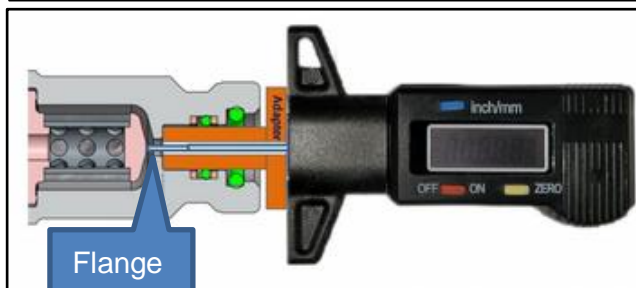
7. Insert the digital depth gauge pin into the adapter.

With firm pressure, hold the adapter and depth gauge against the flange inside the receptacle.

Push in the pin position manipulator and record the measurement on the digital display.

If the gauge and adapter are not firmly held against the inner flange in the receptacle, then a measurement error will occur.

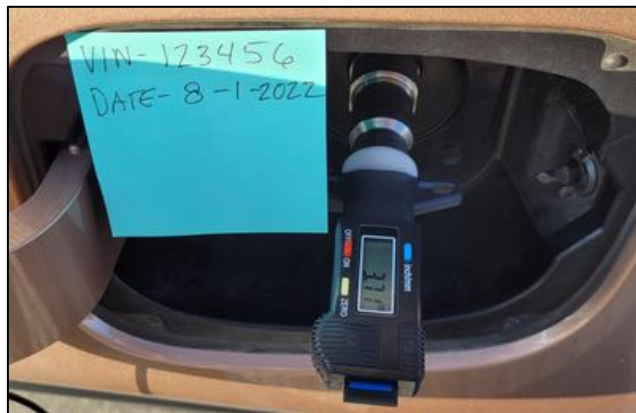
8. Photograph the measurement and a paper showing the last **6 digits** of the VIN or RO #, and the date of measurement.

Using STUI, photograph the measurement on the gauge digital display. Include in the photos a piece of paper containing the last 6 digits of the VIN or the RO #, and the date of measurement. Ensure the digital display and note are captured and in focus. Upload the photo to STUI.

9. If the measurement is **greater than 3.2mm**, the inspection procedure is complete. **NO OTHER WORK IS REQUIRED.** Submit OP Code 21D051R2.

If the measurement is **less than or equal to 3.2mm**, then replace the parts identified on page 2 using the following procedures.

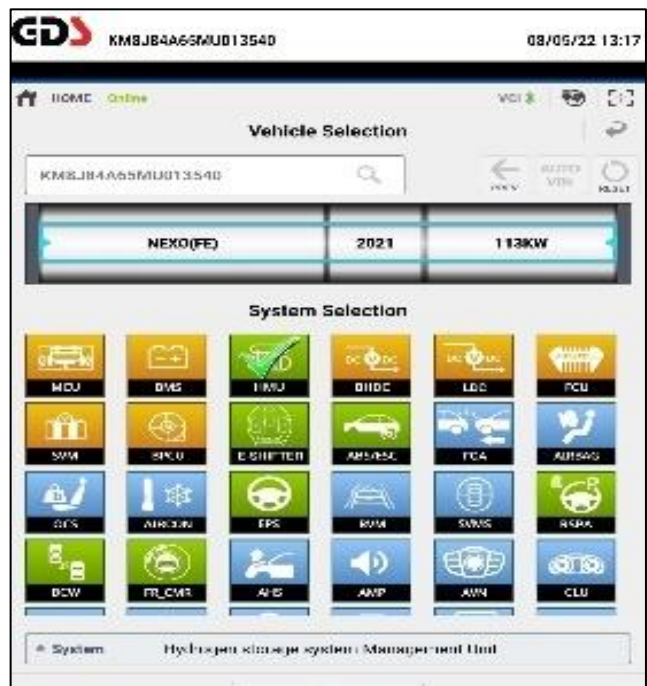
- 1. Connect the GDS-M, select the **HMU**, and then confirm the storage tank pressure.

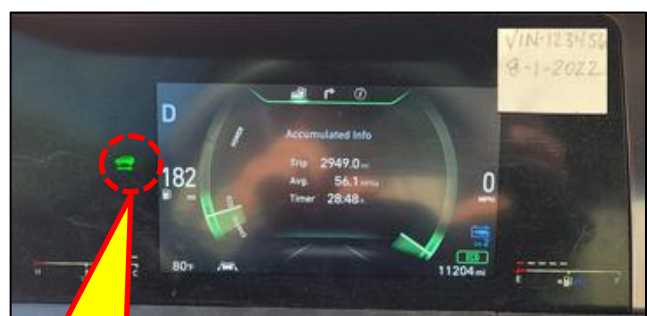
- 2. Place the vehicle in **READY** mode using the **START / STOP** push button. Photograph the fuel gauge level and a paper showing the last **6 digits** of the VIN or RO #, and the date of defueling.

Using **STUI**, photograph the fuel gauge. Include in the photos a piece of paper containing the last 6 digits of the VIN or the RO #, and the date of the defueling. Ensure the fuel gauge display, odometer, and note are captured and in focus. Upload the photo to **STUI**.

Vehicle is in **READY** mode when Indicator is illuminated.

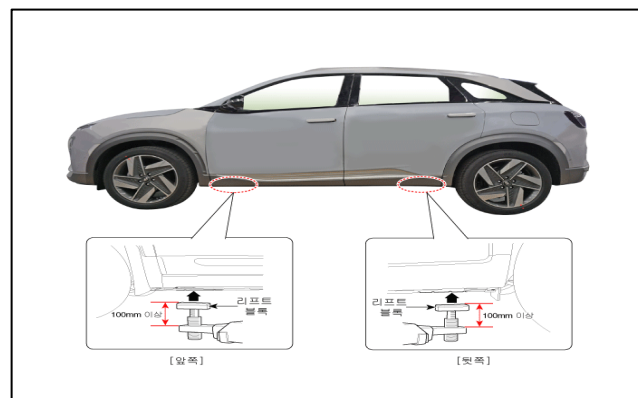
1. Storage tank pressure must be at or below **1,100 PSI**.

Raise the vehicle on a lift.

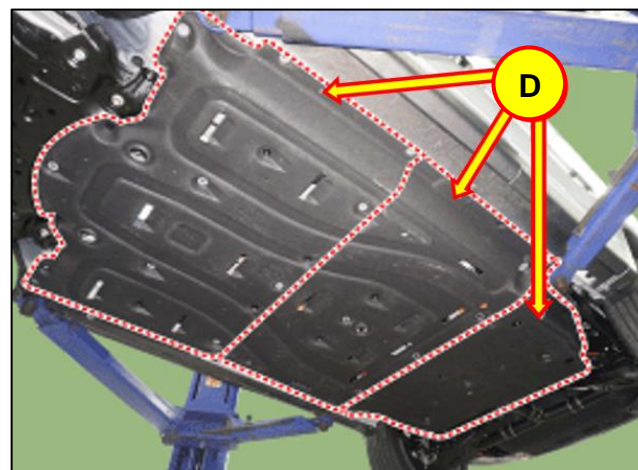
2. Remove the mounting bolts and floor undercover (D).

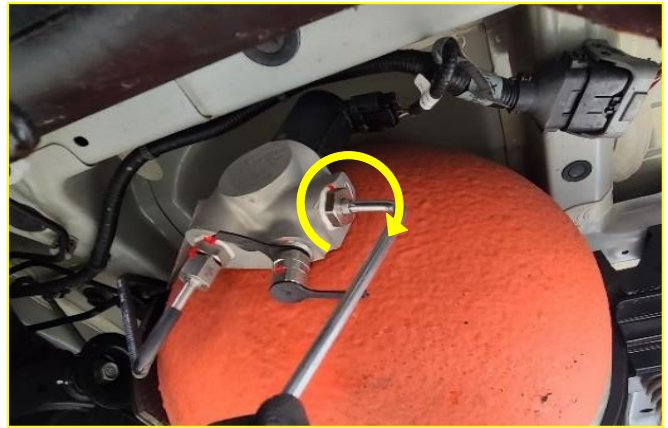
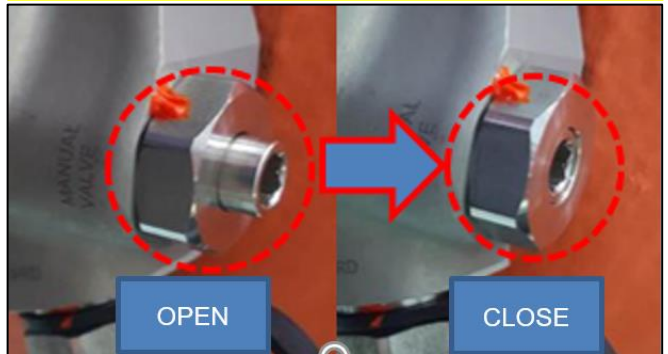
- Close the manual valves on all **3** hydrogen tanks using a **6 mm** Allen wrench turning the valve clockwise. **DO NOT** tighten past the torque specification.

3.6 – 7.2 lb-ft (4.9 – 9.8 Nm)

Some components of the manual valve may be damaged if over-torqued.

Manual valves must be closed before performing release of residual hydrogen in the fuel supply piping.

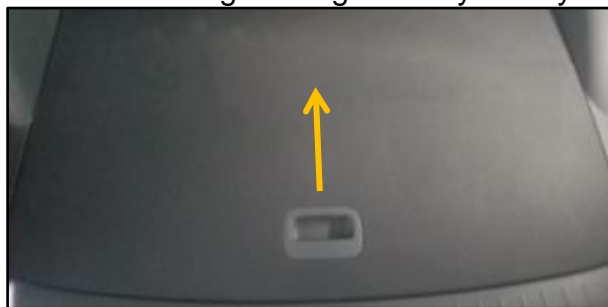
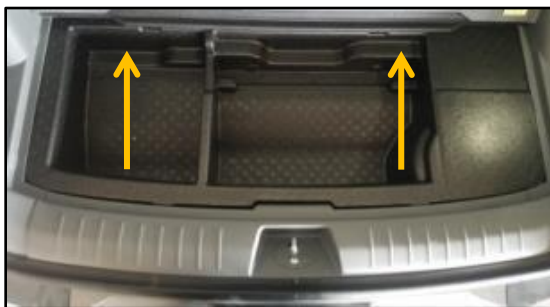
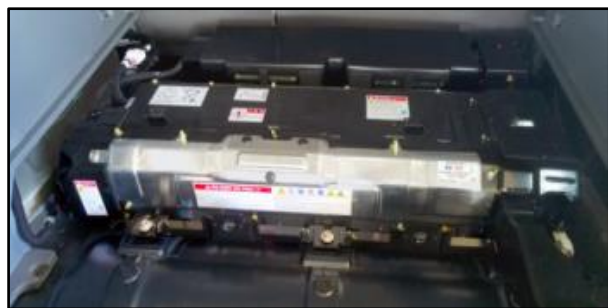
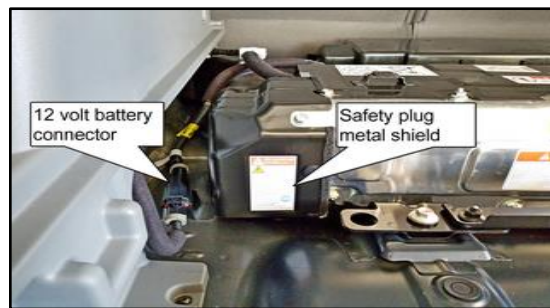
1. In the rear cargo area, remove the floorboard and cargo tray to access the 12 volt battery connector and high voltage battery Safety Plug.

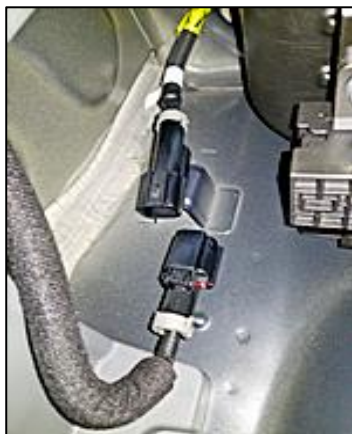
2. Disconnect the 12 volt battery negative (-) connector.

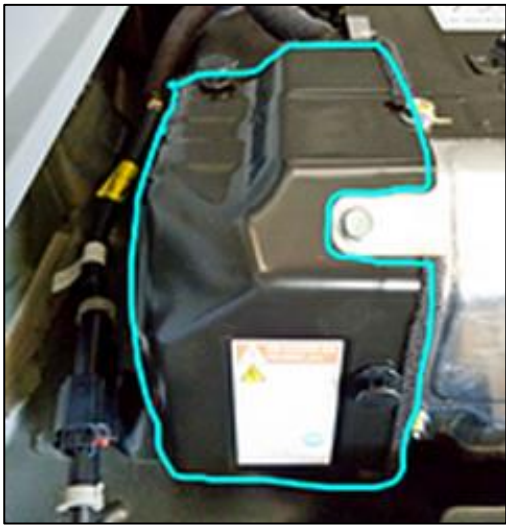
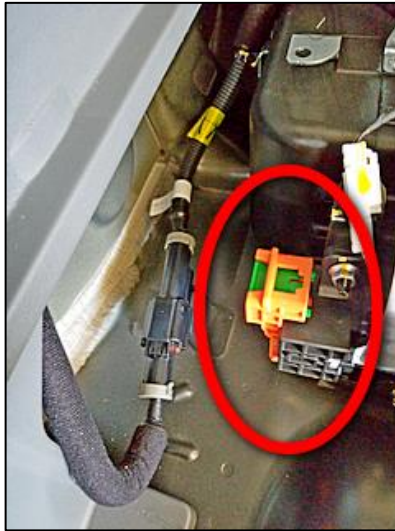
- Remove the metal shield to access the High Voltage Safety Plug.

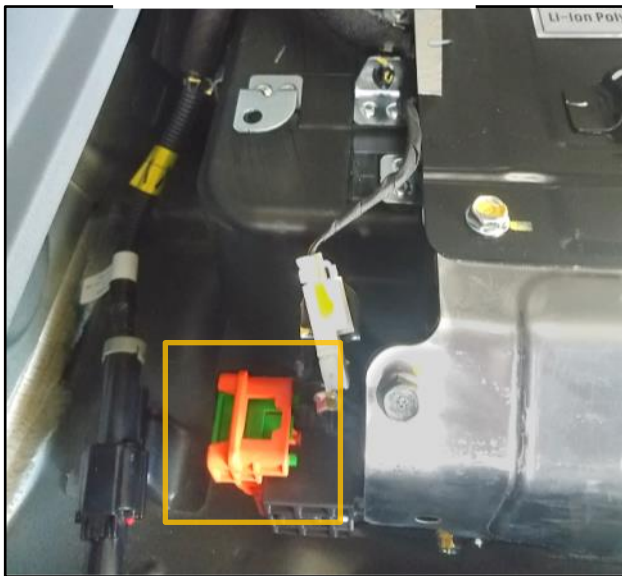
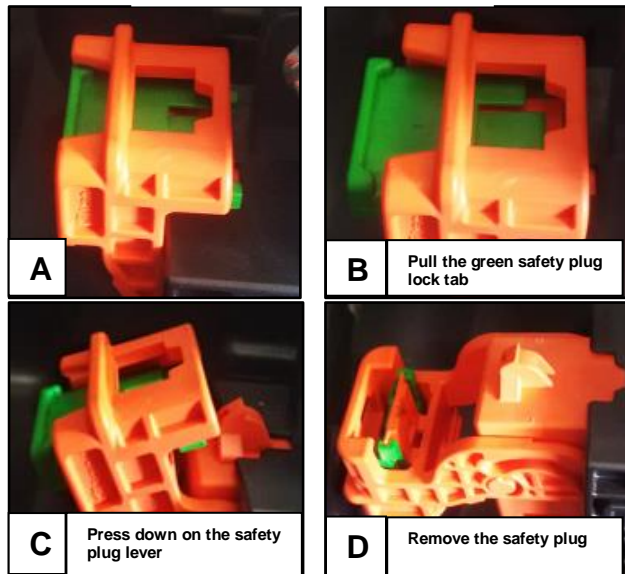
Safety Plug Removal

- Follow A-D below to remove the orange high voltage safety plug. Store the removed safety plug in a secure location outside and away from the vehicle.

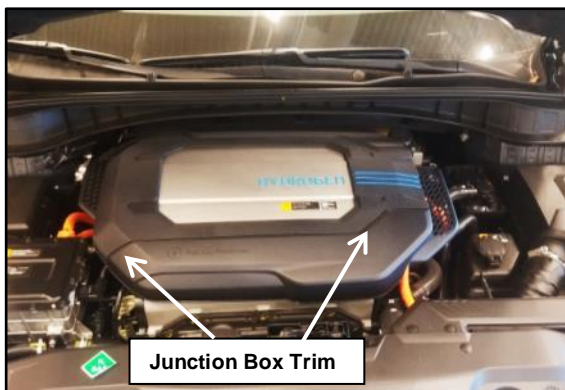
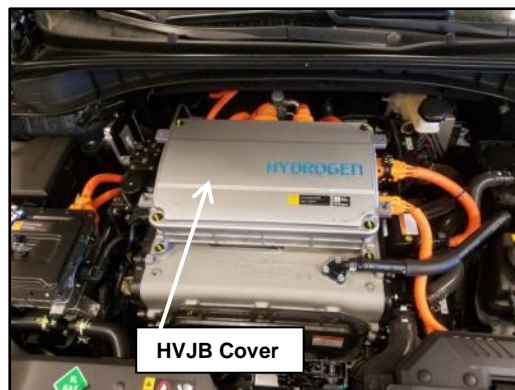
5. Wait 5+ minutes to allow the high voltage system capacitor to discharge.
6. Open the hood. Remove the junction box trim and cover.

High voltage junction box cover: Assembly bolt torque. 9.8 - 11.8 N.m (1.0 - 1.2 kgf.m, 7.2 - 8.7 lb-ft)

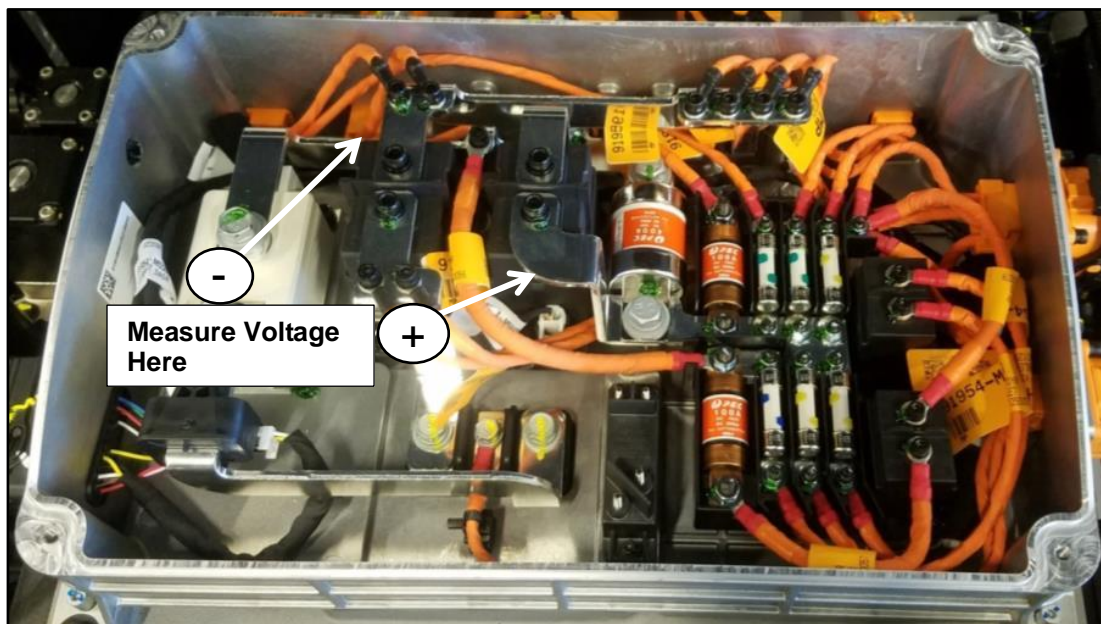
7. Using a Digital Volt Ohm Meter (DVOM), measure the voltage across the inverter positive and negative bus bar terminals to inspect for capacitor discharge. If the measured voltage is below 30V, the High Voltage Circuit is properly shut down.

The High Voltage Junction Box (HVJB) may be electrically energized up to 450 volts.

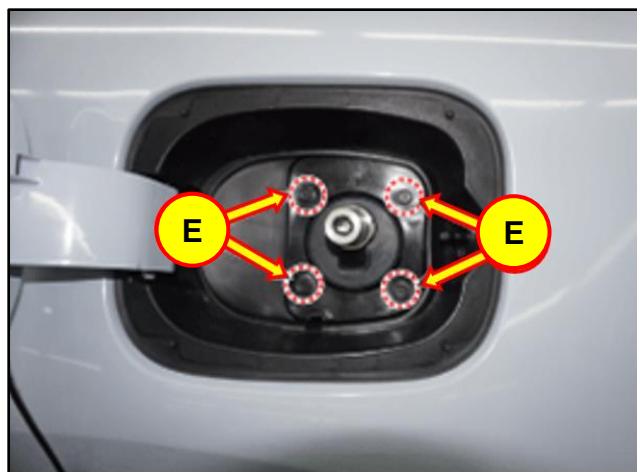
1. Open the fuel charging door and remove the inlet receptacle assembly mounting bolts (E).

5.4 – 7.3 lb-ft (7.4 – 9.9 Nm)

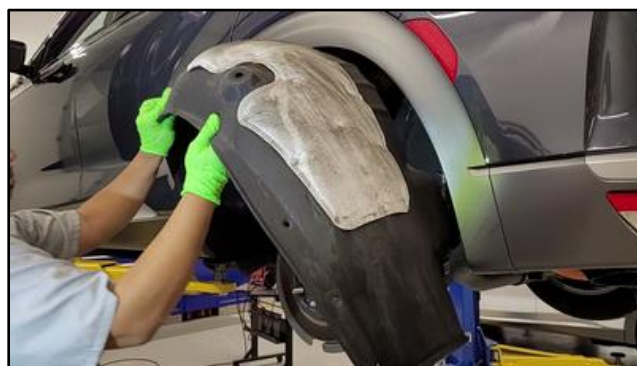
2. Remove the wheel liner to access the receptacle assembly.

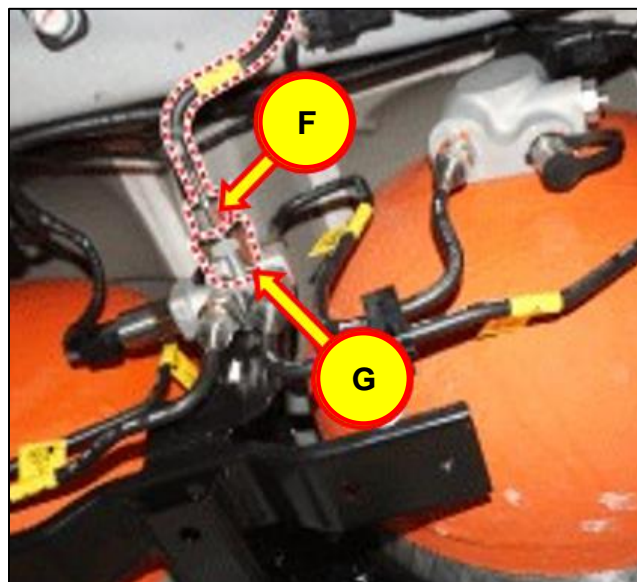
3. Use a wrench to keep the check valve (F) in place and loosen the fuel filler tube flange nut (G).

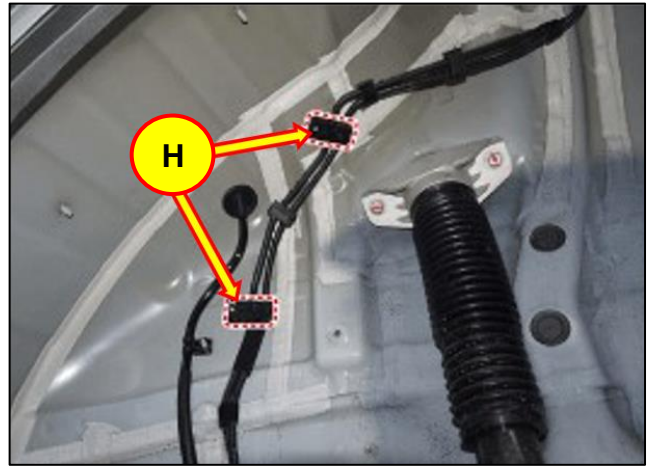
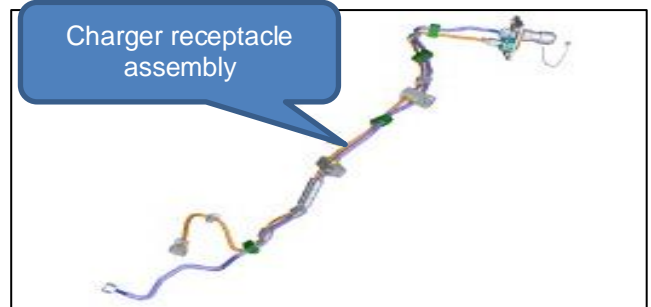
4. Separate the receptacle brackets (H) from their mounting studs, unplug connector, and then remove the charger receptacle assembly from the vehicle.

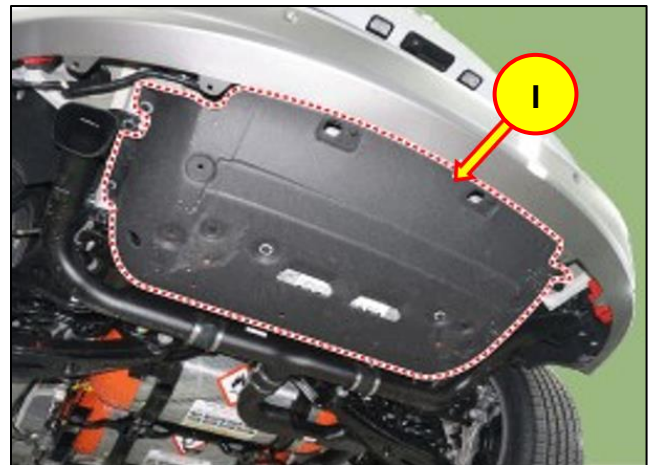
5. Remove the rear vehicle undercover (I).

5.1 – 8.0 lb-ft (6.8 – 10.8 Nm)

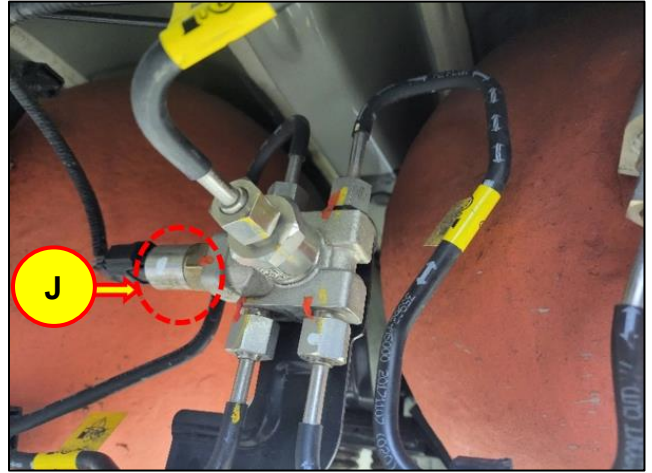
- Remove the high-pressure sensor connector and the high-pressure sensor (J) connected to the manifold.

Tightening Torque High Pressure Sensor:
28.9 - 40.5 lb-ft (39.2 - 54.9 Nm)

High-pressure sensor O-rings must be replaced before reinstalling the high-pressure sensor. Refer to step 15 on page 21.

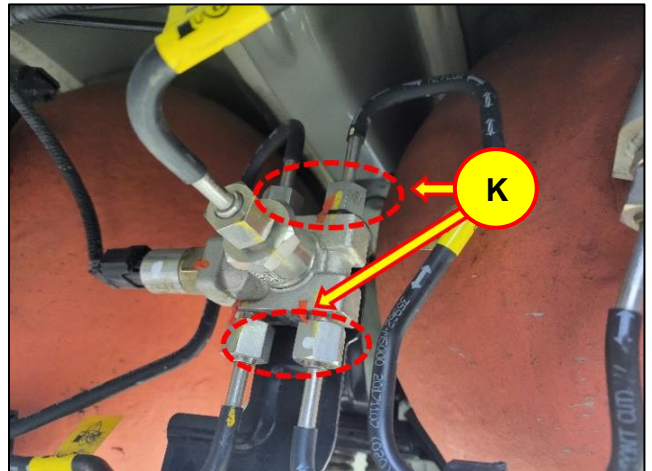
- Loosen the flange nuts on the 4 fuel tubes (K) connected to the check valve manifold and remove the manifold.

Tightening Torque (Manifold Side):
20.3 – 24.6 lb-ft (27.5 – 33.4 Nm)

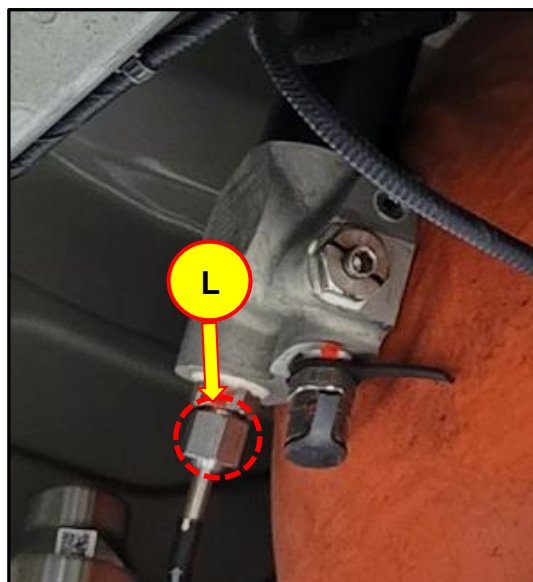
Front Tank

8. Remove the 3 fuel tubes (L, M, and N) connected to each hydrogen tank solenoid valve.

Tightening Torque (Hydrogen Tank Side):
23.9 – 28.2 lb-ft (32.4 – 38.3 Nm)

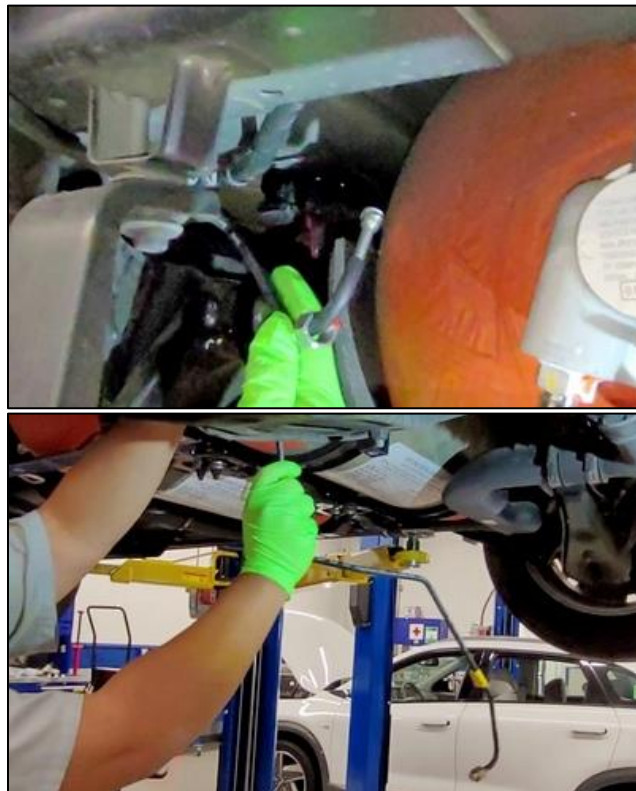
9. Carefully remove the rear tank tube by maneuvering the tube above the rear suspension frame and toward the front of the vehicle.

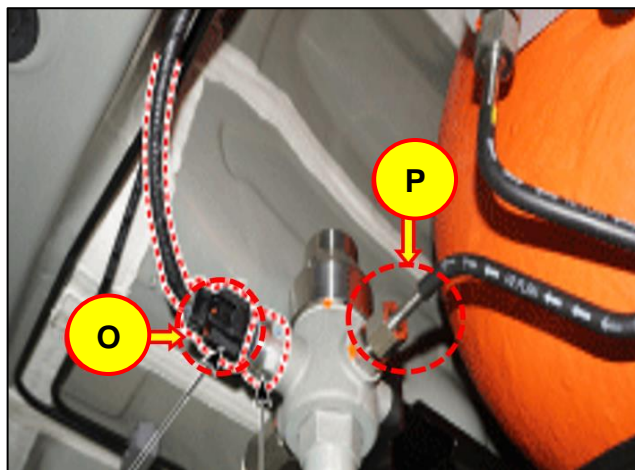
10. Remove the middle pressure sensor connector, the middle pressure sensor (O), and the fuel tube (P).

Tightening Torque Middle Pressure Sensor:
7.38 - 10.27 lb-ft (10.0 - 13.93 Nm)

Middle-pressure sensor O-ring must be replaced before reinstalling the middle-pressure sensor.

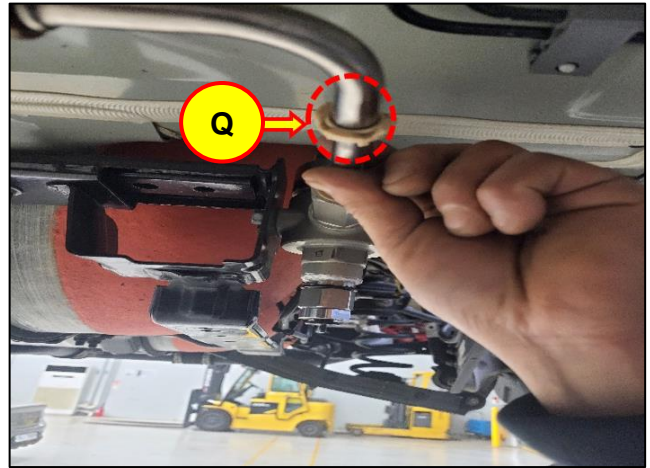
11. Disconnect the middle pressure fuel tube (Q) using the tube remover SST.

Tube Remover SST: 09356-4W110

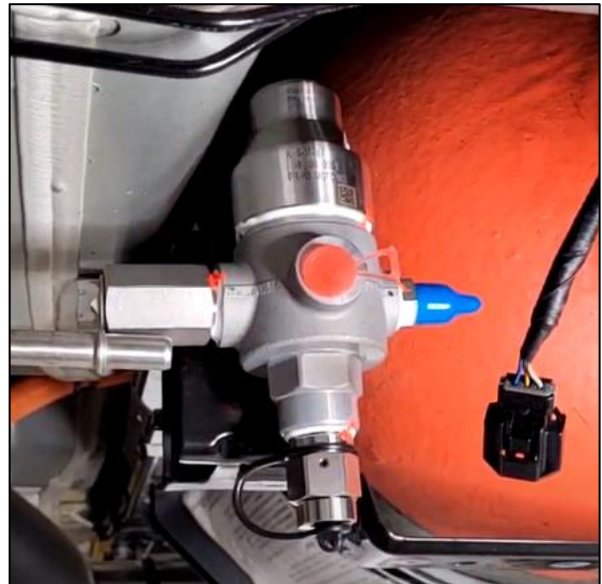
12. Remove the high-pressure regulator assembly.

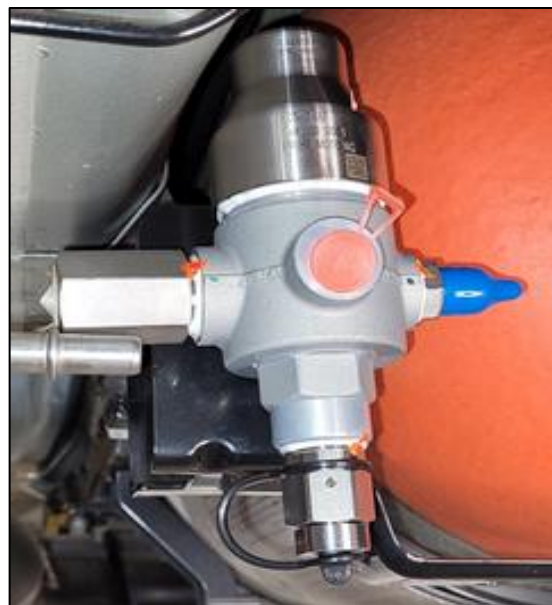
13. Install the supplied high pressure regulator assembly and remaining parts in the reverse order of a removal.

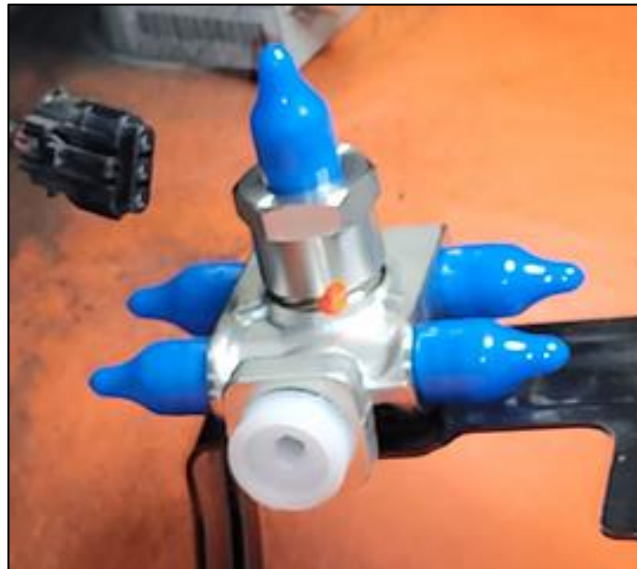
14. To keep the sealing surfaces clean and prevent debris intrusion, keep the protective caps and plugs on the junction block and high-pressure regulator until the moment lines and sensors are connected.

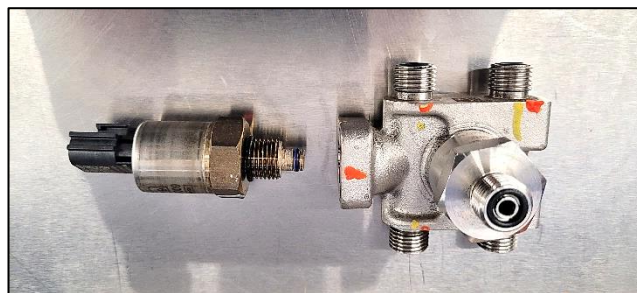
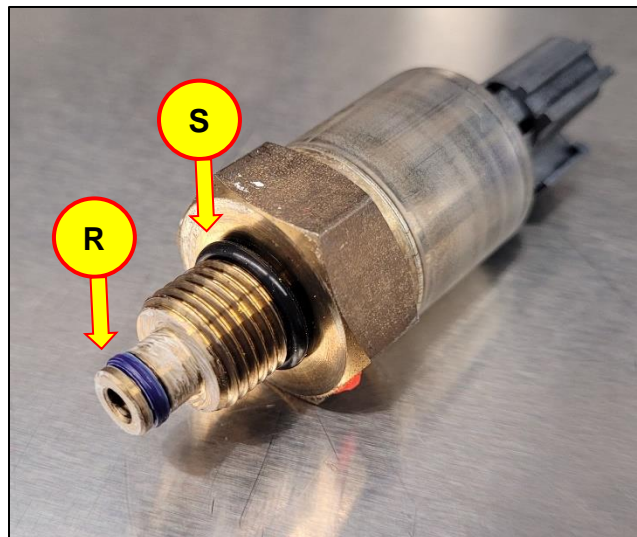
15. **High-Pressure Sensor Installation:**

- I. Replace and lubricate the smaller O-ring (R) with Molykote HP-300.
- II. Replace the larger O-ring (S), but **DO NOT** lubricate.
- III. Refer to Nexo shop manual: NEXO(FE) > 2019 > 113KW > Hydrogen Storage System > Repair Procedures > Hydrogen Storage System O-ring Replacement Procedure

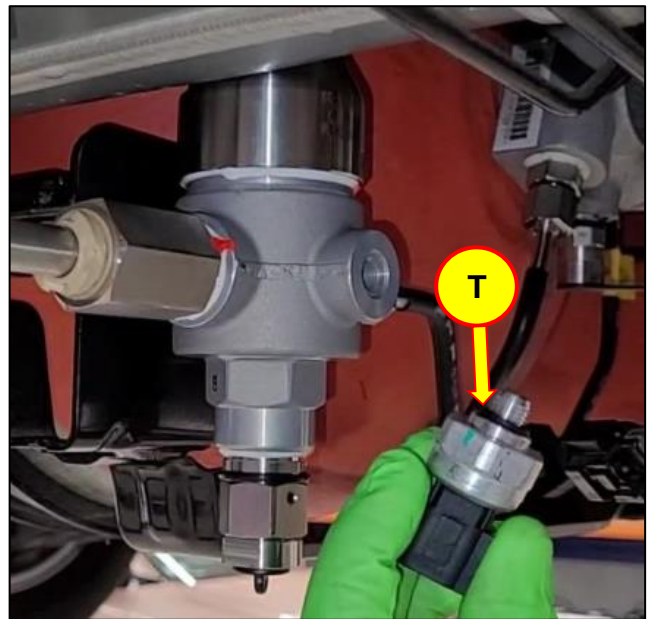
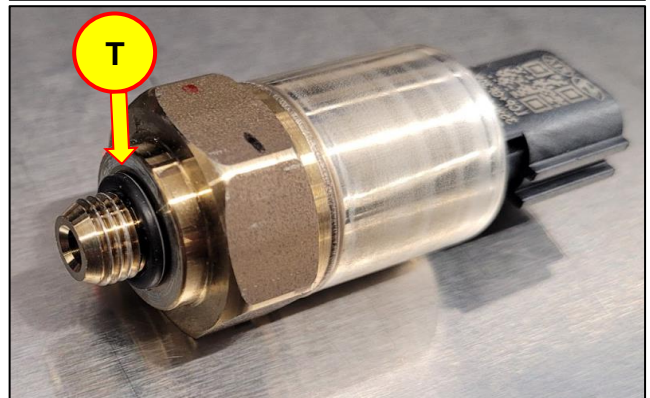
16. Middle-Pressure Sensor Installation:

- I. Replace the O-ring (T) but **DO NOT** lubricate.
- II. Refer to Nexo shop manual: NEXO(FE) > 2019 > 113KW > Hydrogen Storage System > Repair Procedures > Hydrogen Storage System O-ring Replacement Procedure

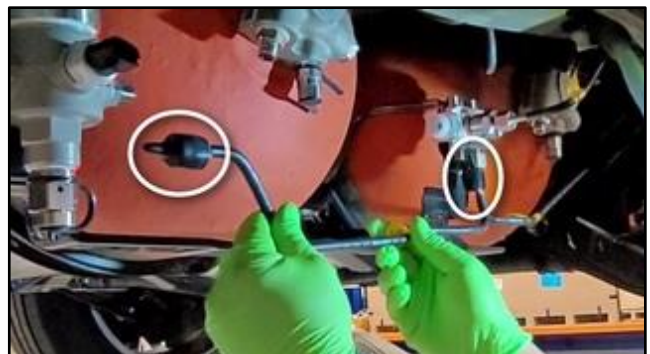
17. To keep the sealing surfaces clean and prevent debris intrusion, ensure the protective caps remain on the fuel lines until the moment they connect.

Ensure all tube nuts are connected and torqued to specification.

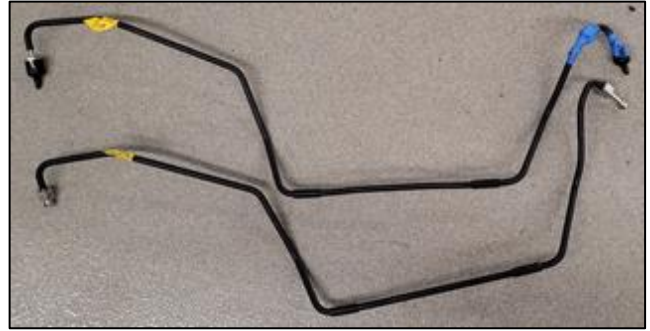
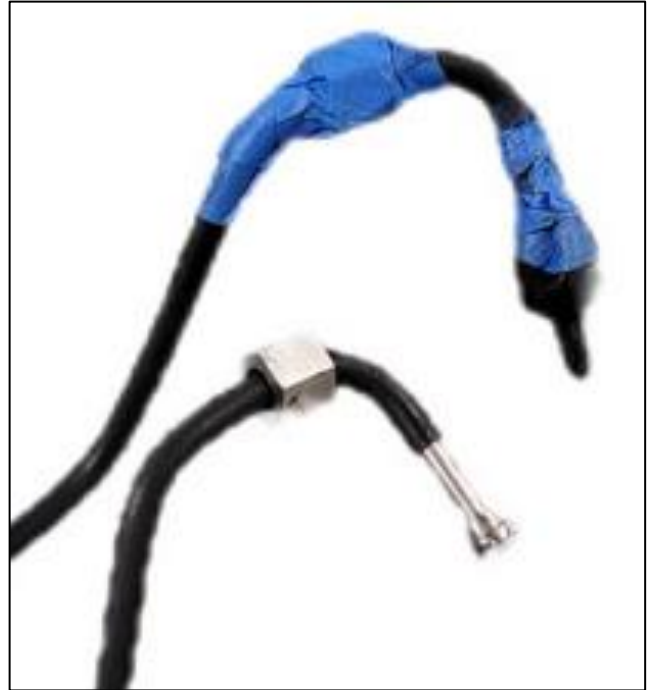
18. Rear Tank Tube Installation:

To install the rear tank tubing, prepare the replacement tube by sliding the tube nut (tank end) approximately 3 inches away from end of tube. Use tape to hold the nut in position and tape the protective cover in position. This will facilitate maneuvering the rear tank tubing around and above the rear suspension. Ensure the rear tank tubing is in the same position as when it was removed.

The images show where to tape the tube nut and end protective cap. The replacement tube is at the top of the image and the removed tube is at the bottom of the image.

DO NOT to force or bend tubing while maneuvering the rear tank tubing into position.

Failure to do so may damage the tubing and make it difficult to attach the tubing to the fitting.

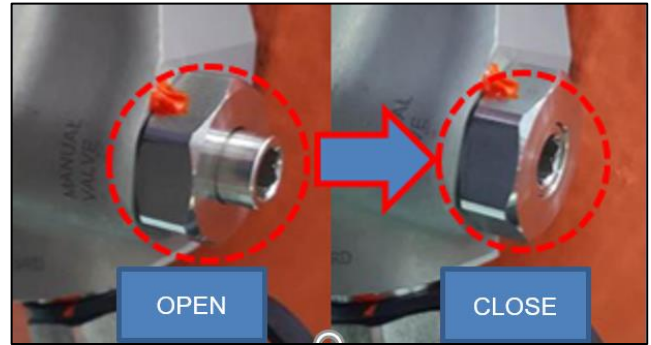
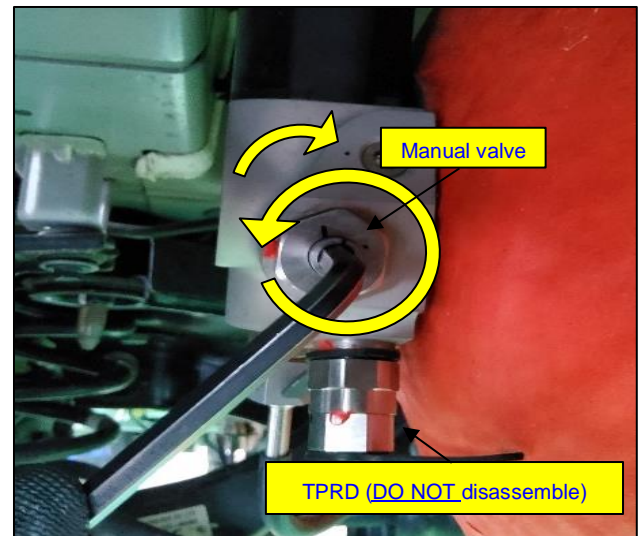
19. Open the manual valves on all **3** hydrogen tanks.

Using a **6mm** Allen wrench turn the manual valve counter-clockwise until it stops then rotate manual valve one half turn clockwise.

Exceeding opening torque specification, may damage the manual valve.

3.6 – 7.2 lb-ft (4.9 – 9.8 Nm)

Some components of the manual valve may be damaged if over-torqued.

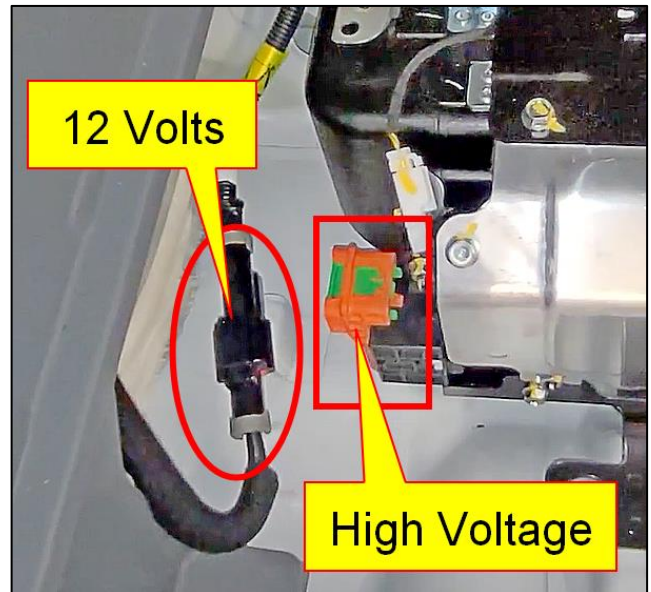
20. Refer to **Preparation for Replacement of Hydrogen Components** on pages 12-13 and follow steps 1-4 in reverse order of disassembly to re-connect the high voltage safety plug and the 12-volt auxiliary battery.

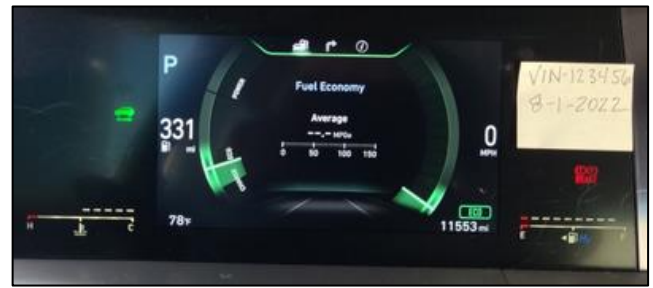
24. After refueling the vehicle, with the key in the ON position, photograph the fuel gauge level and a paper showing the last six digits of the VIN or RO #, and the date of refueling.

Using STUI, photograph the fuel gauge. Include in the photo a piece of paper containing the last 6 digits of the VIN or the RO #, the date of the refueling. Ensure the fuel gauge display, odometer, and note are captured and in focus. Upload the photo to STUI.
