SUBJECT: **NEW VEHICLE DEMONSTRATION / DELIVERY HOLD**
Safety Recall 22S25 - Supplement #1
Certain 2013-2015 Model Year Escape with 2.0L and 2.5 engine
Transmission Shifter Cable Bushing

CERTAIN 2013-2015 MODEL YEAR ESCAPE VEHICLES EQUIPPED WITH A 2.0L ENGINE AND A 6F35 TRANSMISSION — SHIFTER CABLE BUSHING REPLACEMENT AND PROTECTIVE CAP

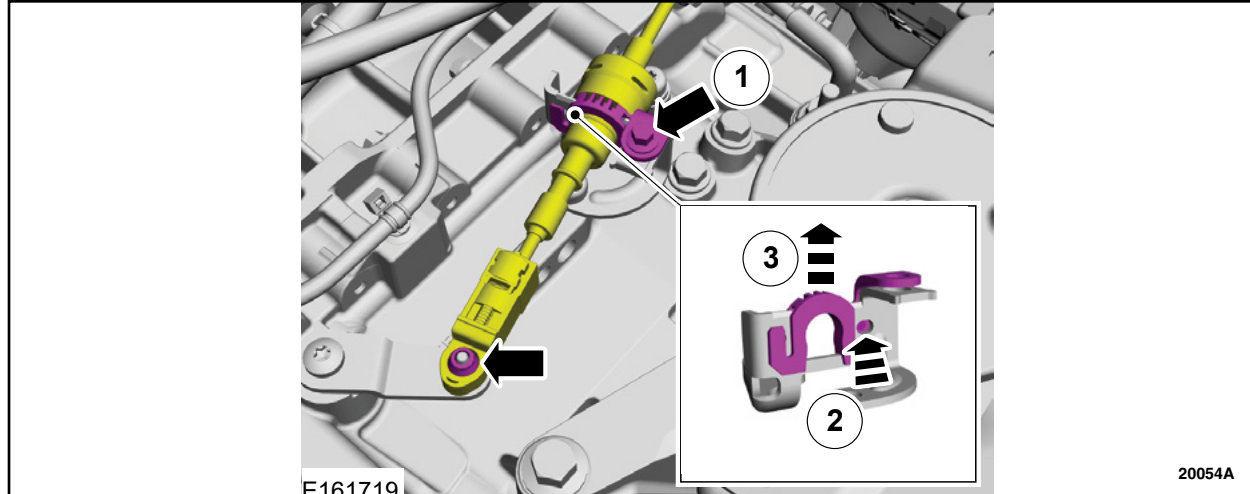
FIGURE 1

1. Apply the parking brake, chock wheels to make sure vehicle does not roll.
2. Position the gear shift lever in Drive (D).
3. Remove the air cleaner assembly. Please follow the Workshop Manual (WSM) procedures in Section 303-12.
4. Remove the air cleaner outlet pipe. Please follow the Workshop Manual (WSM) procedures in Section 303-12.
5. Disconnect the selector lever cable from the transmission manual lever and the bracket. See Figure 1.
 1. Remove the selector lever cable bracket bolt.
 2. Disengage the selector lever cable holding clip.
 - Use caution when removing hold down bracket to avoid damage. Hold down bracket is available separate of shift cable.
 3. Disconnect the selector lever cable.
 - Torque to 62 lb.in (7 Nm).

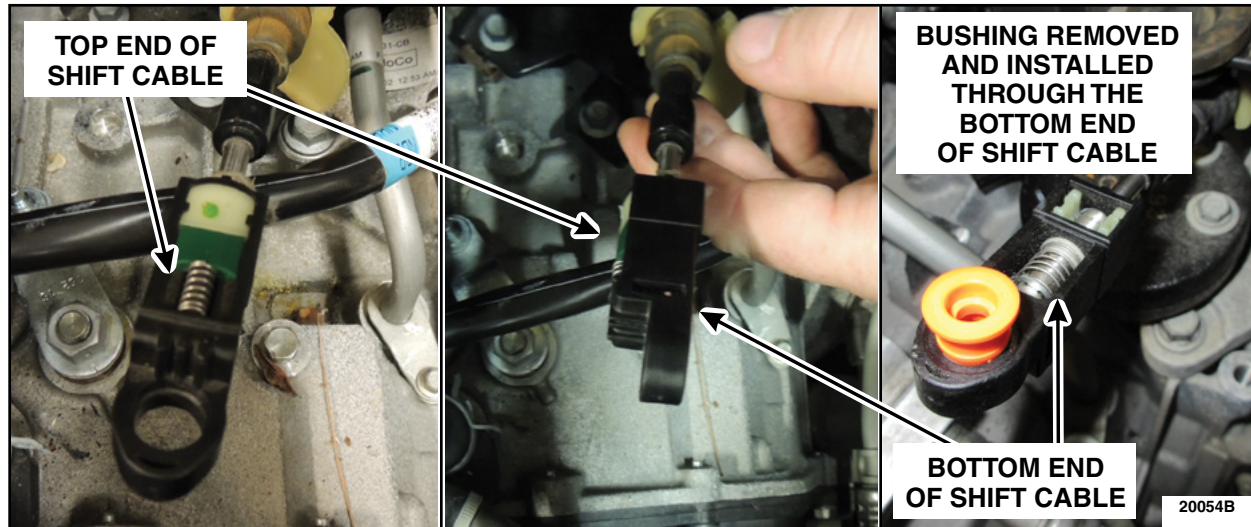
FIGURE 2

NOTE: Selector Lever Cable Bushing Replacement/Orientation. See Figure 2.

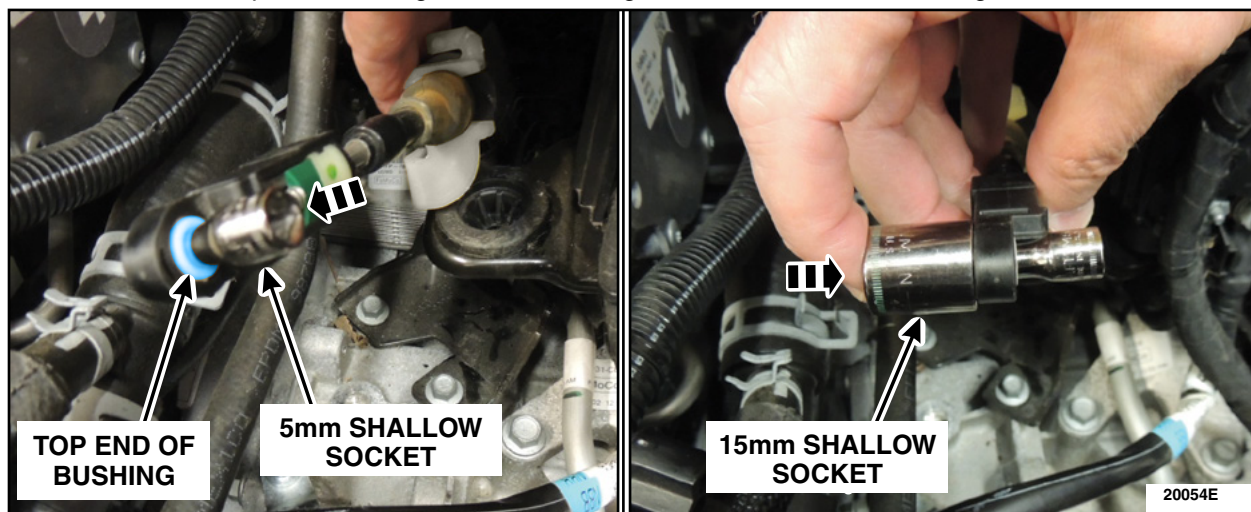
FIGURE 3

6. Press out the shifter cable bushing using one of the two methods below.

- Using a 5mm and a 15mm socket with Straight Jaw Adjustable pliers the bushing can be pressed out of the shifter cable end. The 5mm socket will fit into the small part of the bushing on top, the 15mm will go against the bottom of the shifter cable end, make sure to have socket centered with the bushing to allow clearance of the bushing shoulder as it is being pressed out. See Figures 3 and 4.
- Using a tool such as a Lisle 38350 - Exhaust Hanger Removal plier to press bushing out. By viewing Figure 5 the shoulder of bushing is positioned upward, small end of plier is pressing bushing out. Proceed to Step 7.

- Use caution not to damage the shifter cable during this procedure.
- Inspect for damage before installing the new shifter cable bushing.

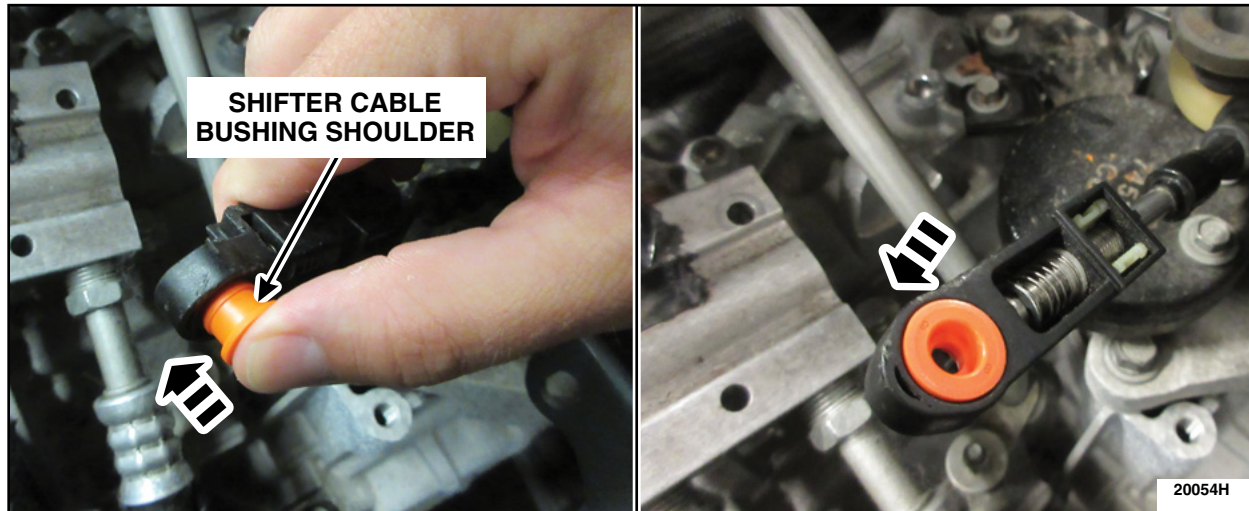
FIGURE 6

7. Using your hands only, install the new selector lever cable bushing. Do not use any grease to install, the bushing and cable end should be dry. See Figure 6.

- Visually check shifter cable end for any signs of damage. If damage to the shifter cable end is found, please call the Special Service Support Center (SSSC).

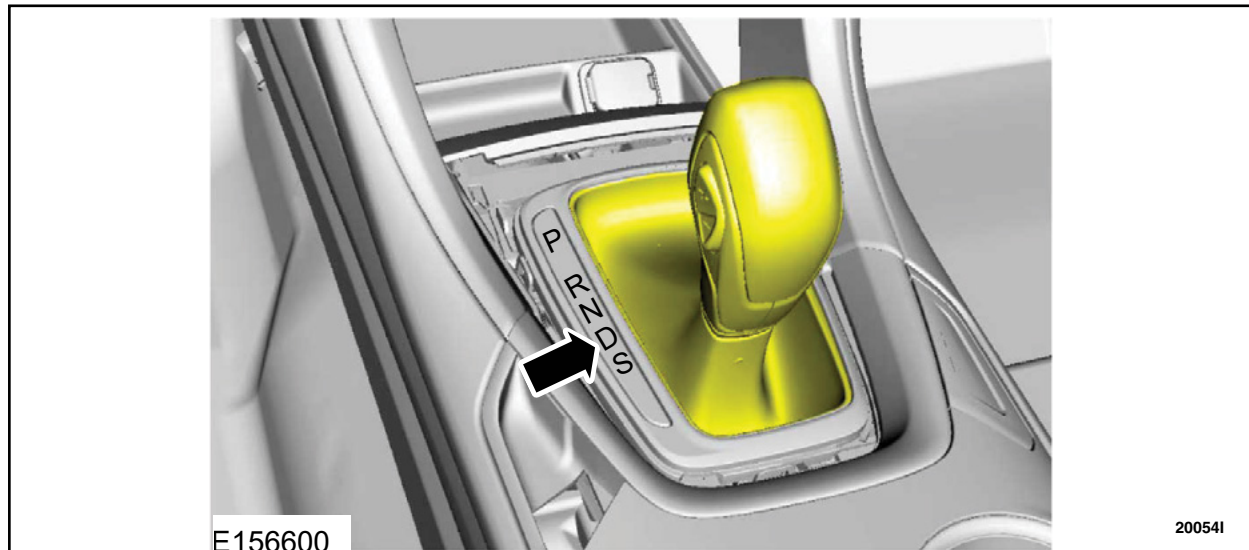
FIGURE 7

8. The vehicle's transmission gear selector lever should be in Drive position from Step 2, if not, position the selector lever to Drive (D). See Figure 7.

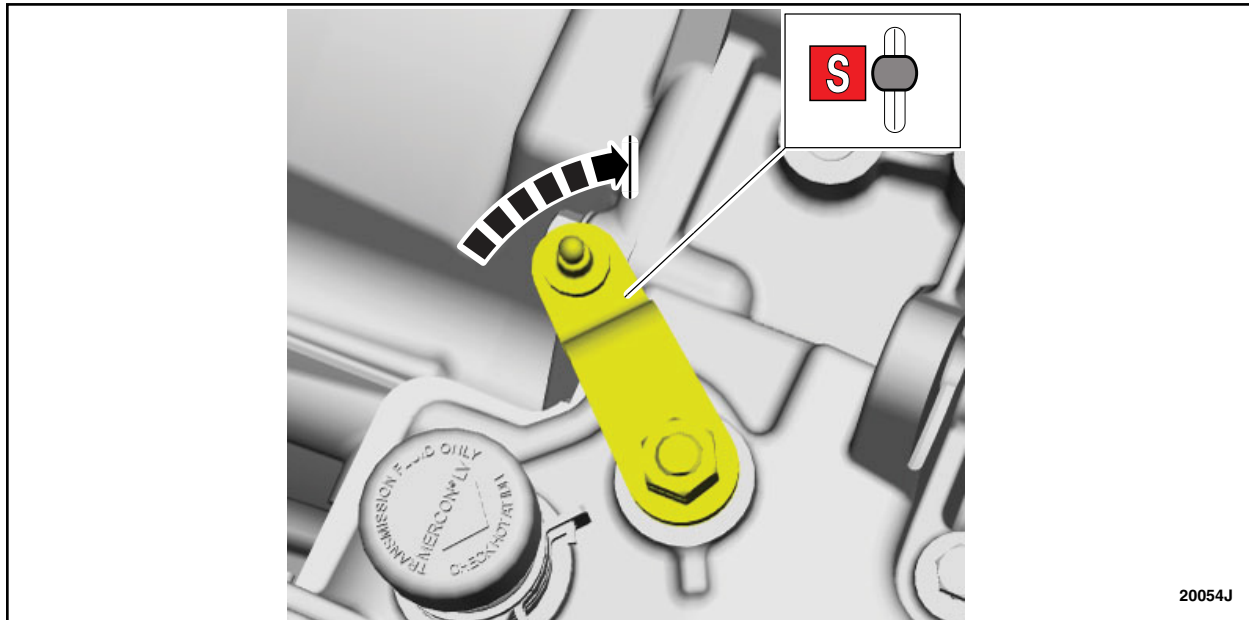
FIGURE 8

9. Rotate the manual control lever clockwise until it stops. See Figure 8.

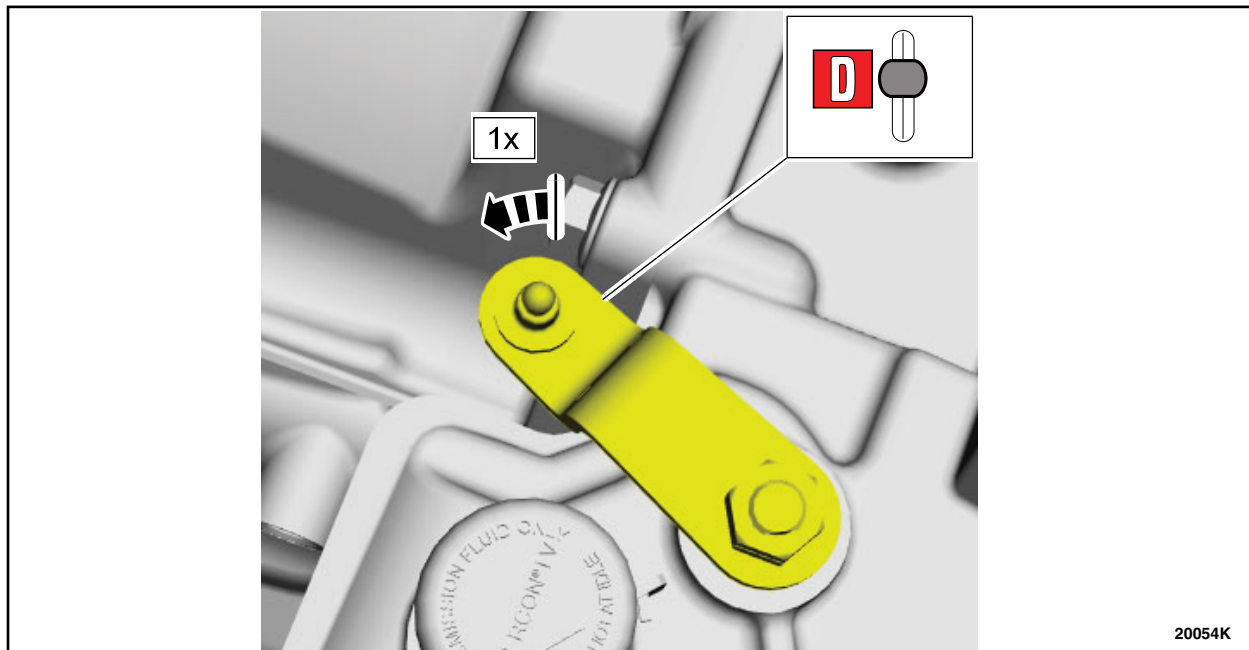
FIGURE 9

10. Rotate the manual control lever counterclockwise 1 detent into Drive (D). See Figure 9.

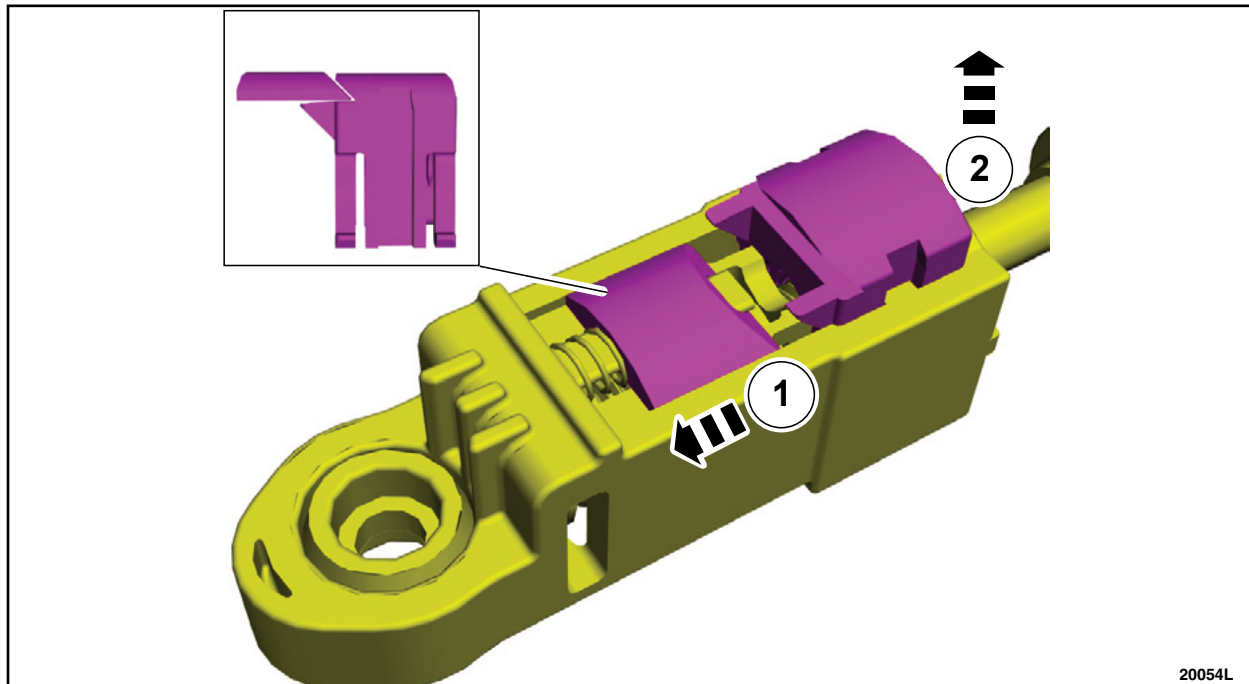
FIGURE 10

11. Release the selector lever cable adjuster lock. See Figure 10.

1. Carefully pry the adjuster lock tabs outward.
2. While holding the adjuster lock tabs outward, slide the lock out to unlock the selector lever cable.

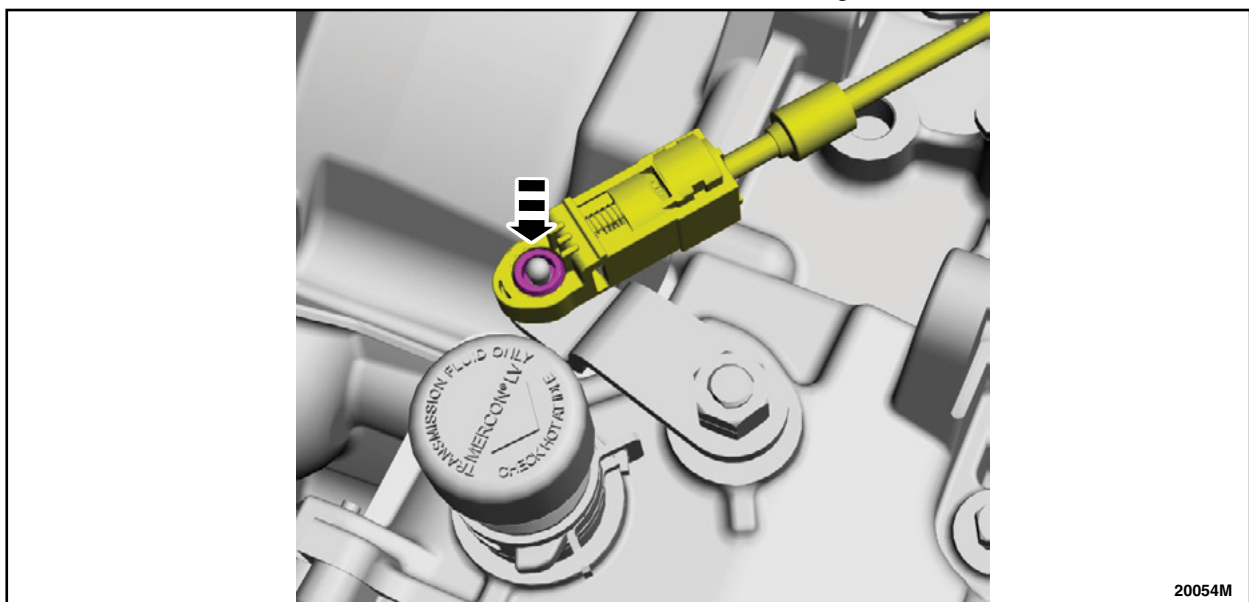
FIGURE 11

12. Connect the selector lever cable to the manual control lever. See Figure 11.

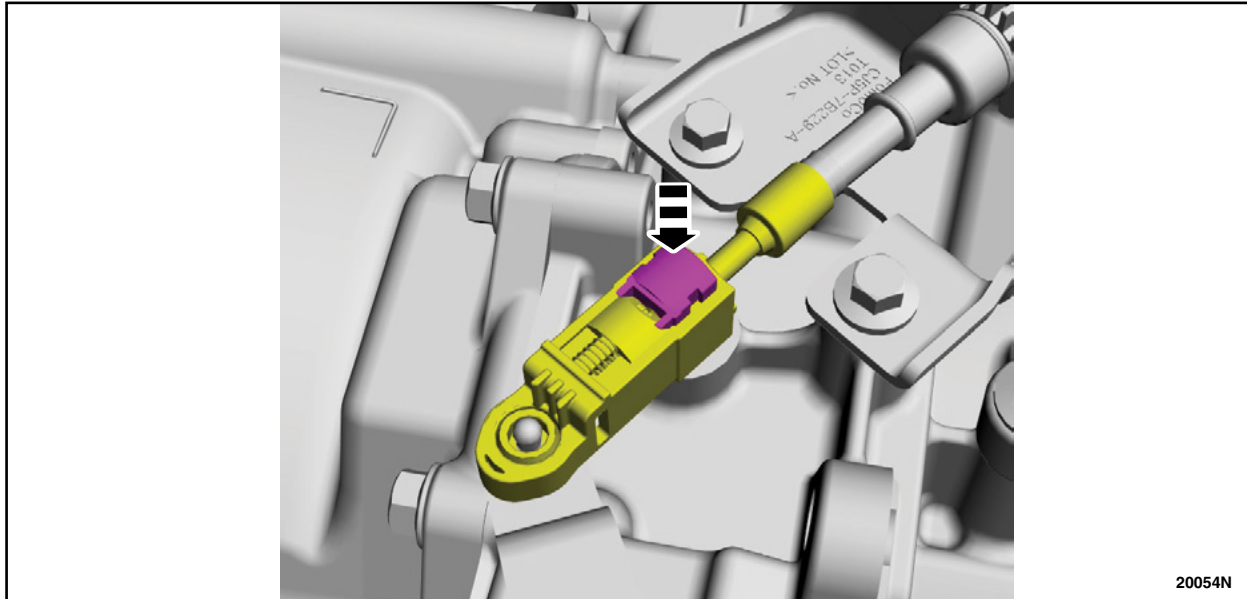
FIGURE 12

13. Slide the adjuster tab in place to lock the selector lever cable. See Figure 12.

NOTE: Visually inspect cable end and give a slight pull up to verify the bushing is fully seated.

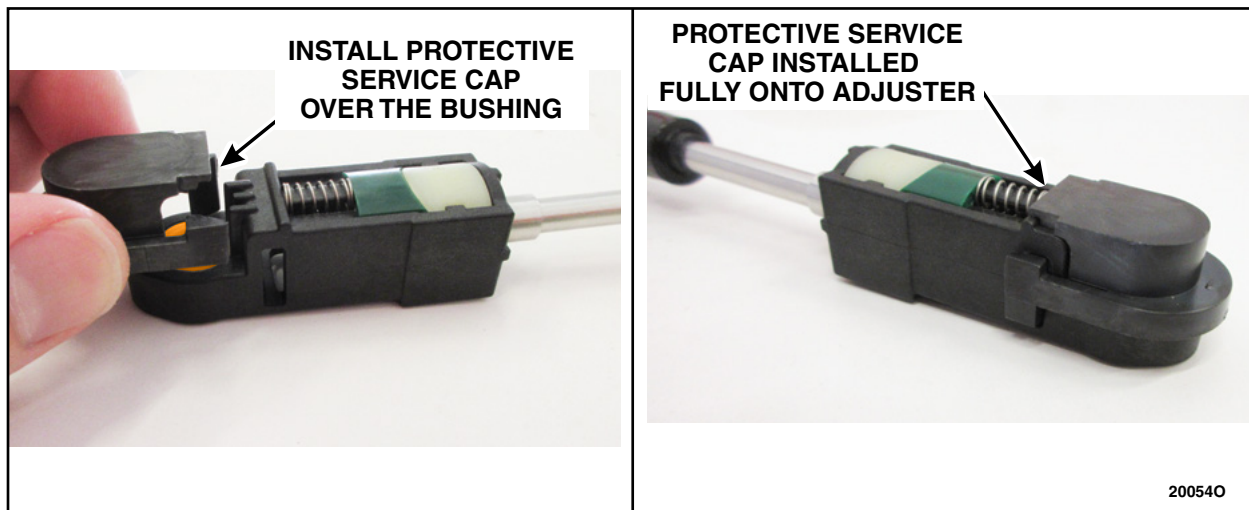
FIGURE 13

14. Install the new cap onto the selector lever cable adjuster. Clip one side into the adjuster body and then slide the other onto the housing until it snaps into place. The protective cap should cover the bushing and the terminal end of the adjuster. See Figure 13.

15. Verify installation by checking the cap is retained by the adjuster body.

NOTE: Selector lever cable removed for clarity.
