HYUNDAI Technical Service Bulletin	GROUP RECALL	NUMBER 22-01-055H
	DATE June 2022	MODEL(S) Elantra (CN7/CN7a), Elantra N (CN7 N), Elantra Hybrid (CN7 HEV), Accent (HC)
SUBJECT:	FRONT SEAT BELT PRETENSIONER PROTECTION CAP INSTALLATION (RECALL 229)

Description: The front seat belt pretensioner may deploy abnormally in the vehicles described below, causing the MGG (Micro Gas Generator) to detach from the assembly. This bulletin describes the procedure to install front seat belt pretensioner anti-separation protection caps.

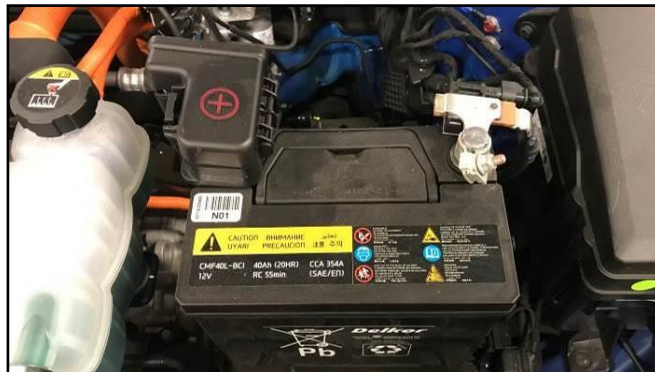
1. If applicable, record the customer's radio preset stations for AM / FM / SXM.
2. Disconnect the negative (-) battery terminal.

Negative Battery Terminal Tightening Torque:
7.8 – 9.8 Nm (0.8 – 1.0 kgf.m, 5.8 – 7.2 lb-ft)

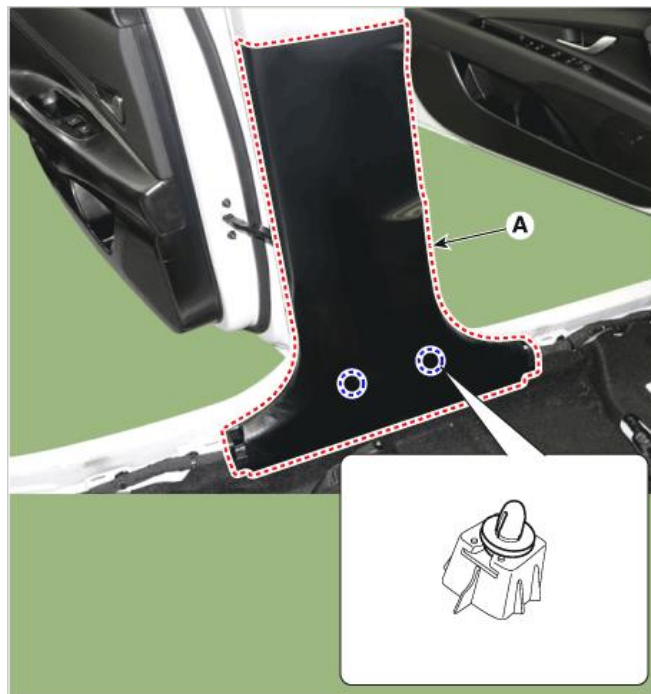
3. Remove the center pillar lower trim.

Take care not to damage the pretensioner when removing or installing the seat belt.

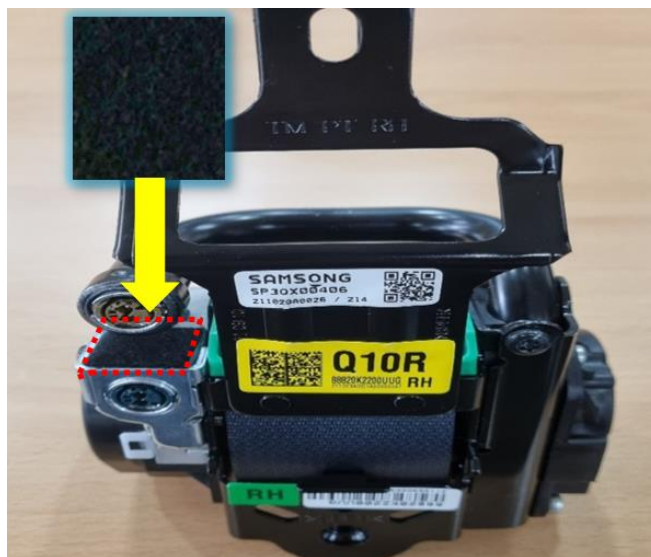
6. Attach the pad.

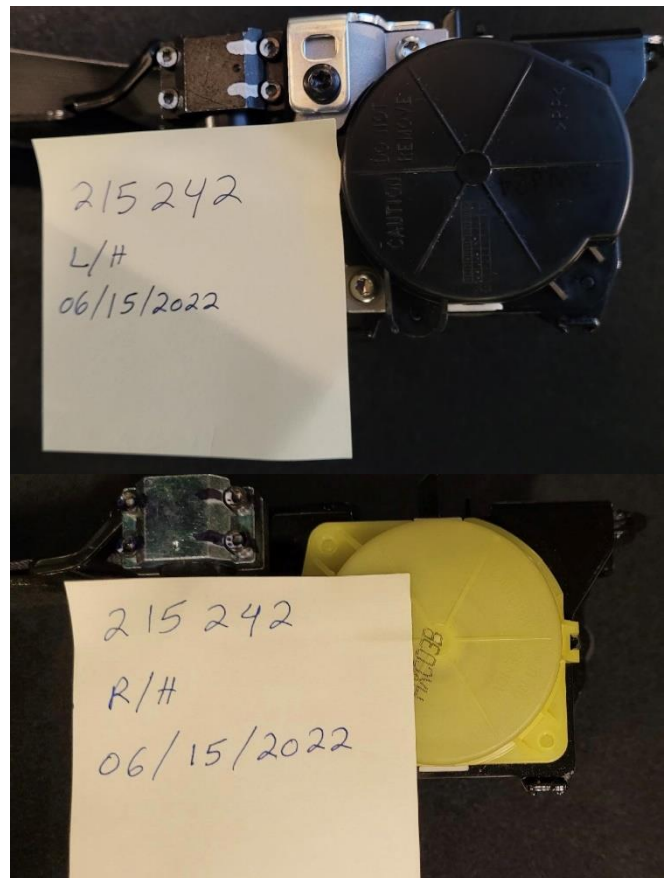
11. Mark all 4 screws with paint after installing screws. Using STUI, please take a photo of the completed pretensioner assembly with the caps installed. Within the picture, include a piece of paper with the last 6 digits of the VIN # or the RO, LH or RH side, and date of repair.

Upload the photo to STUI of LH pretensioner, **AND** RH pretensioner (when applicable).

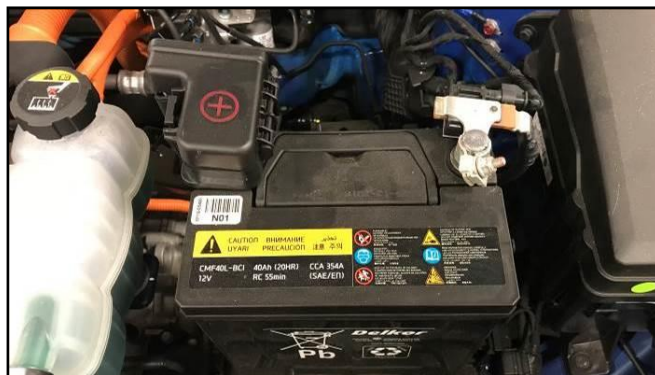
1. If applicable, record the customer's radio preset stations for AM / FM / SXM.
2. Disconnect the negative (-) battery terminal.

Negative Battery Terminal Tightening Torque:
7.8 – 9.8 Nm (0.8 – 1.0 kgf.m, 5.8 – 7.2 lb-ft)

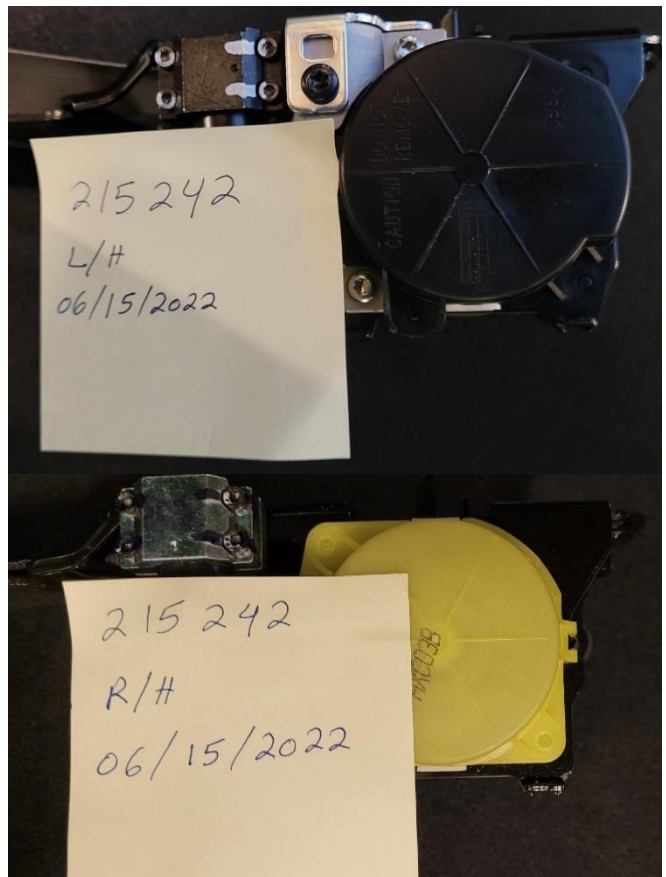
10. Mark all 4 screws with paint after installing screws. Using STUI, please take a photo of the completed pretensioner assembly with the caps installed. Within the picture, include a piece of paper with the last 6 digits of the VIN # or the RO, LH or RH side, and date of repair.

Upload the photo to STUI of LH pretensioner, **AND** RH pretensioner (when applicable).
