July 23, 2022

Version 2

Safety Recall: 2006–14 Ridgeline Rear Frame Repair

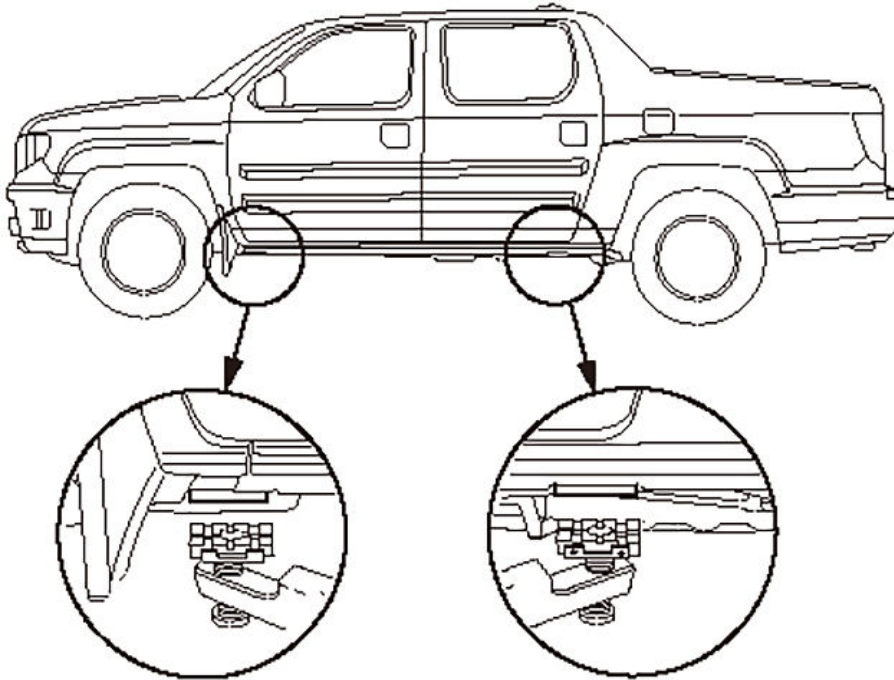
1. Lift the vehicle on the hoist from the jacking points. Position the lift pads under the vehicle's front support points and rear support points.

NOTE: If the vehicle's support points are compromised due to corrosion, please use best shop practices to lift the vehicle.

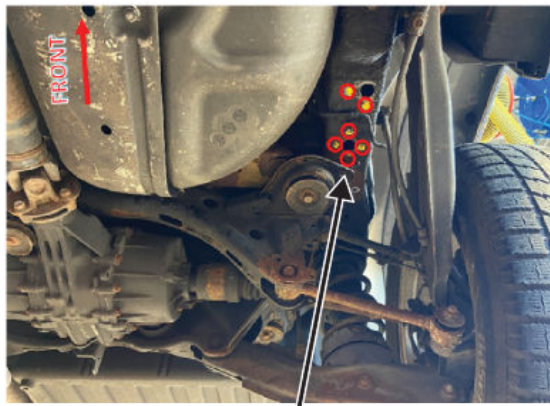
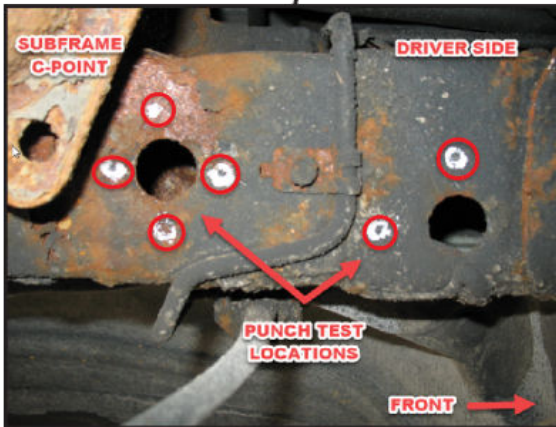
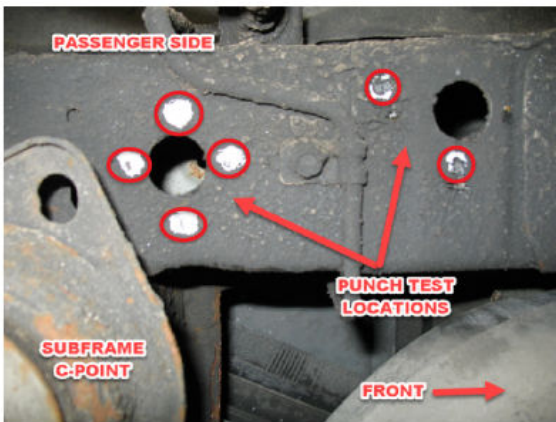
2. Use the frame inspection tool (07AAJ-SJCA100) to do a punch test on both the left and right rear frame rails in the following locations.
3. Place the punch on each of the indicated points on the rear frame rail indicated below with a red circle, then strike that point **3 times** with the frame inspection tool.

4. Make sure to check all **6 areas** on both sides of the frame rails.

Did the punch pierce the rear frame rail at any of the inspection points?

YES – Inform your Service Manager and/or Shop Foreman that the vehicle has pierced through the rear frame rail. Take the required photos of the vehicle as shown in the PHOTOGRAPH REQUIREMENTS section below. You will need to submit the photo files along with the warranty claim. The vehicle is not eligible for the repair, and the Subframe Casting and Crossmember kit cannot be installed on the vehicle. Contact Honda Tech Line with the inspection results

NO – Take the required photos of the vehicle as shown in the PHOTO REQUIREMENTS section below. Then go to REPAIR PROCEDURE A.

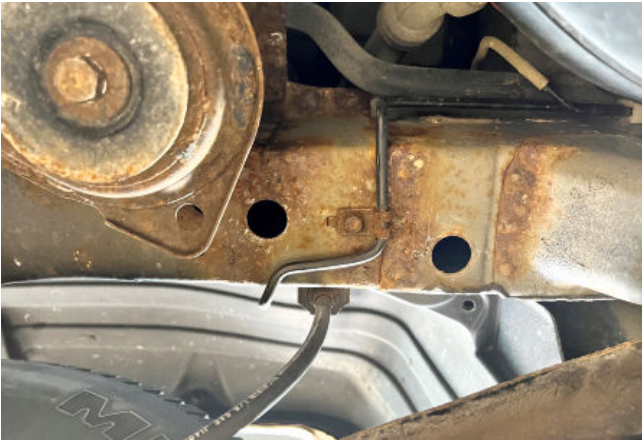
3. Photo of the left rear frame rail after the punch test.

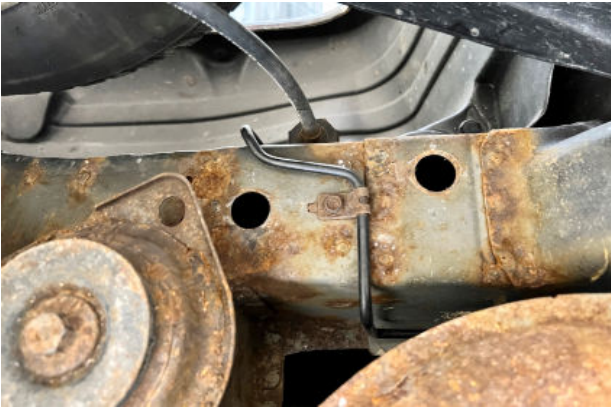
4. Photo of the right rear frame rail after the punch test.

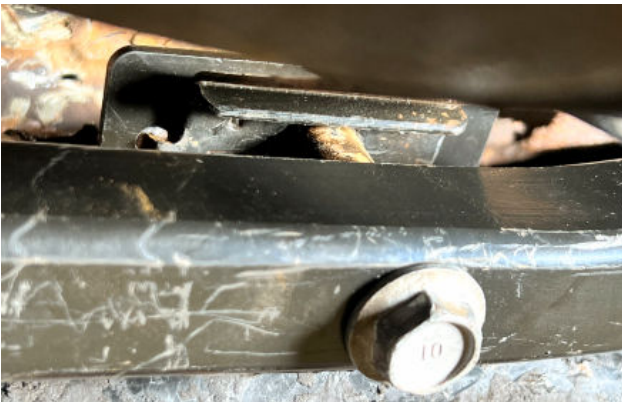
5. Photo of the fuel tank band attachment point (if REPAIR PROCEDURE B was completed).

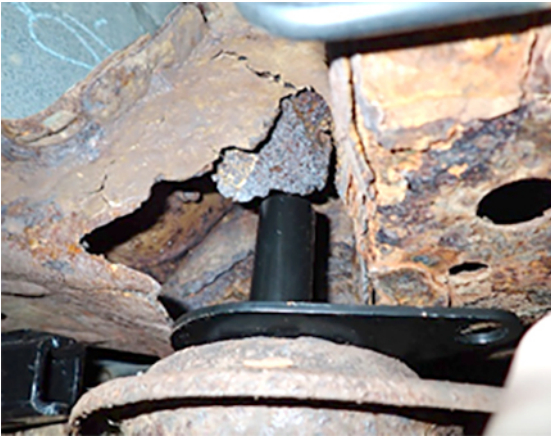
6. Photo of the C-point subframe mount attachment point (if REPAIR PROCEDURE C was completed).

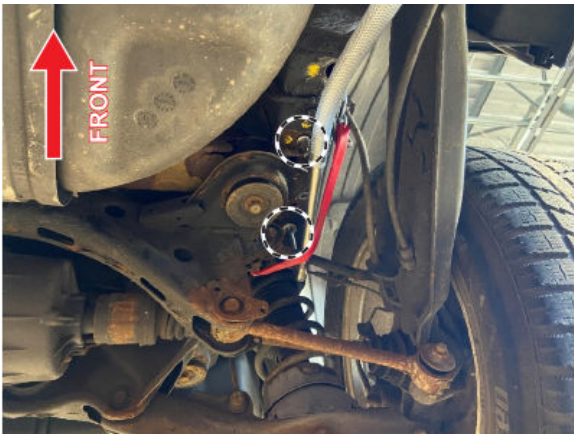
1. Insert the wash hose nozzle into the following locations as shown below.

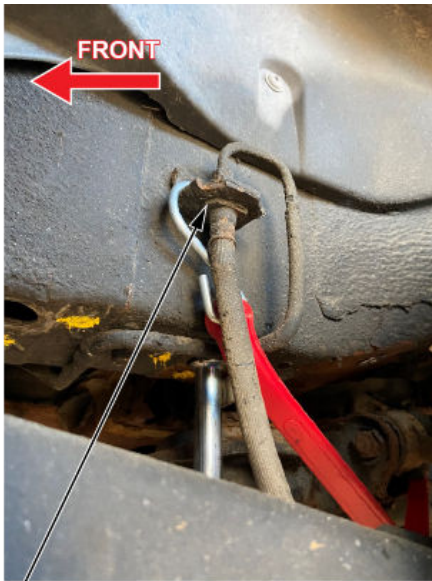
BRAKE HOSE
BRACKET

2. Secure the flush hose using the provided bungee cords as shown below.

NOTE: One end of the bungee cord is hooked on the brake hose bracket and the other end is hooked on the wheel speed sensor bracket.

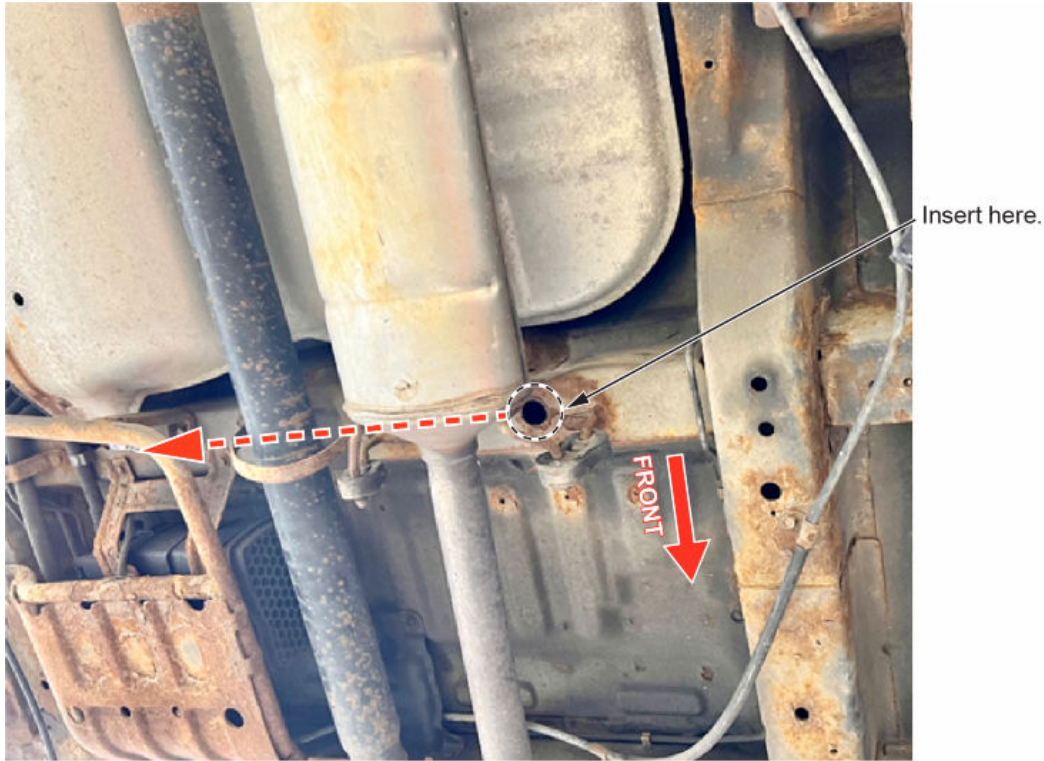
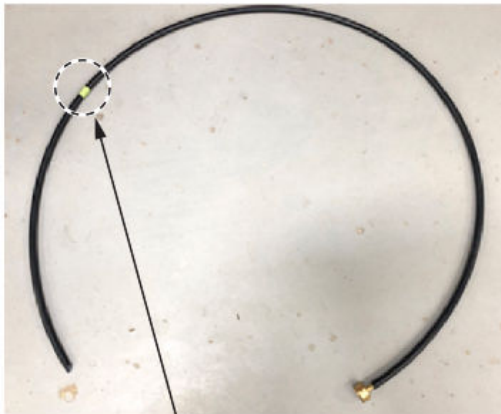
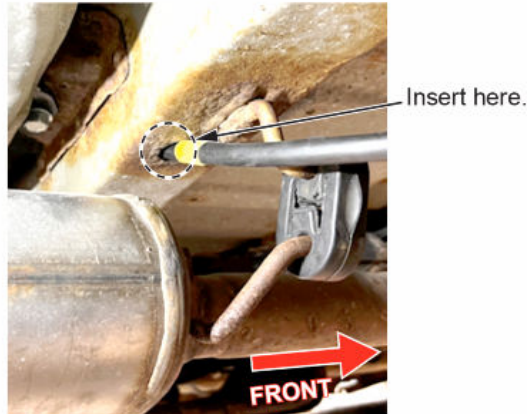
3. RIGHT SIDE ONLY: Insert the additional black flush hose **530 mm (21 in)** into the frame opening located above the exhaust silencer. Once inserted, push the hose in the direction shown below in red.

NOTE: The hose supplied should already be marked with a yellow indicator at **530 mm(21 in)** from the tip. However, if this mark is missing, please measure **530 mm (21 in)** from the tip of the hose and mark this location with a piece of tape or permanent marker.

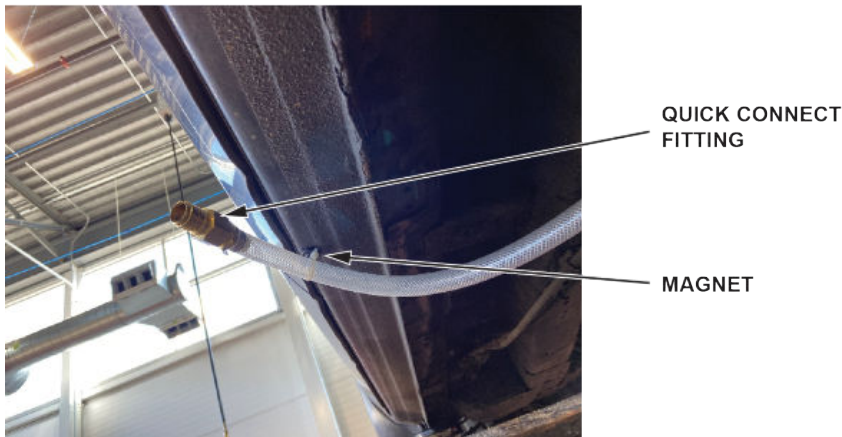
- Position the quick connector fitting on the outside of the vehicle and secure it by placing the magnet on the outer sill.

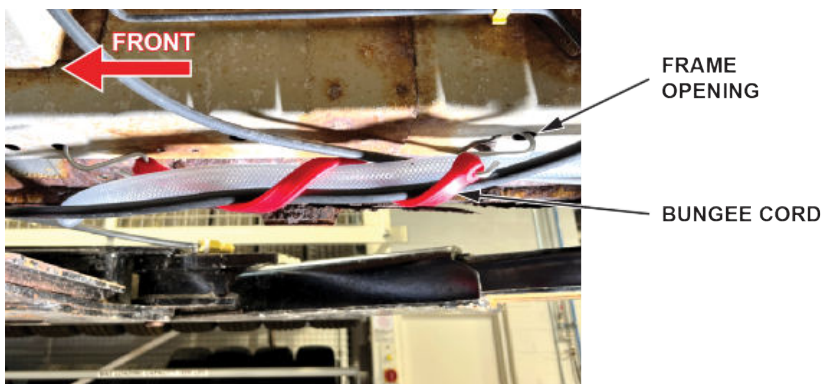
- Wrap the second bungee cord around the flush hose(s) and place the hooks into any available vehicle frame openings.

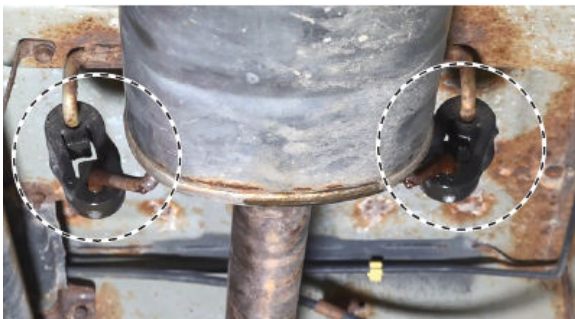
14.2. Remove the 6 acorn nuts holding the heat shield onto the fuel tank support bands.

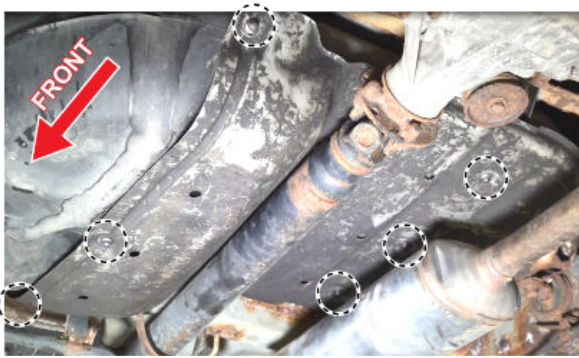
14.3. Remove the right side fuel tank support band rear bolt and discard the bolt.

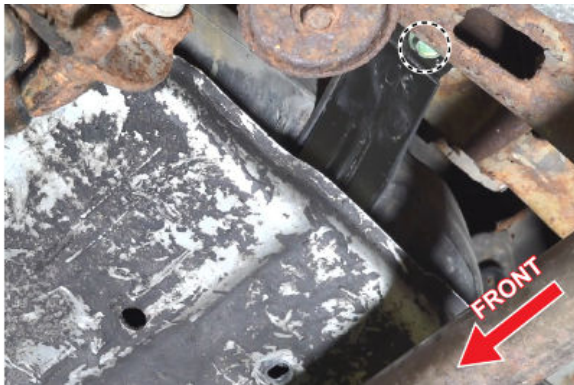
- If the crossmember body crumbles and separates at any of the rear band bolt locations, refer to REPAIR PROCEDURE B for additional instructions.
- If the rear bolt does not come out, attempt to use heat to assist in removing it. An induction heating tool is recommended. If the bolt spins freely and does not come out, refer to REPAIR PROCEDURE B for instructions.
- If REPAIR PROCEDURE B is not required, the fuel tank band repair plates can be discarded.

DO NOT USE AN OPEN FLAME TOOL TO REMOVE ANY CORRODED BOLTS LOCATED IN CLOSE VICINITY TO THE FUEL TANK. An induction heating tool is recommended.

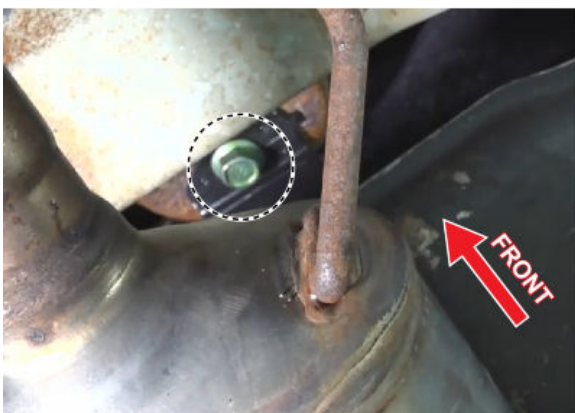
14.4. Remove the right side fuel tank support band front bolt, slide the support band out, discard the support band and bolt.

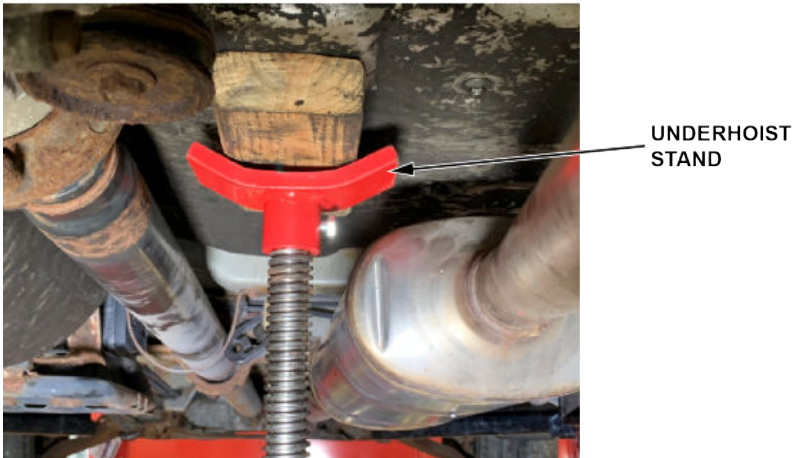
14.7. Support the fuel tank with an underhoist stand.

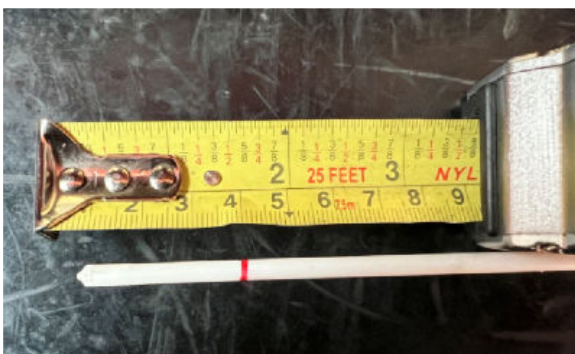
14.10. Using a ruler, measure **40 mm (1.5 in)** from the tip of the wax canister spray tube, mark the wax canister spray tube at this point with a red permanent marker.

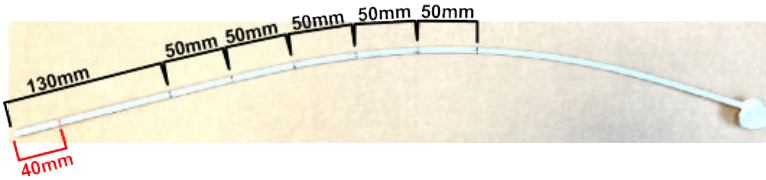
14.11. Make additional line marks at **130 mm (5 in)** from the tip and at five additional marks at **50 mm (2 in)** apart using a black permanent marker. There should now be seven marks in total.

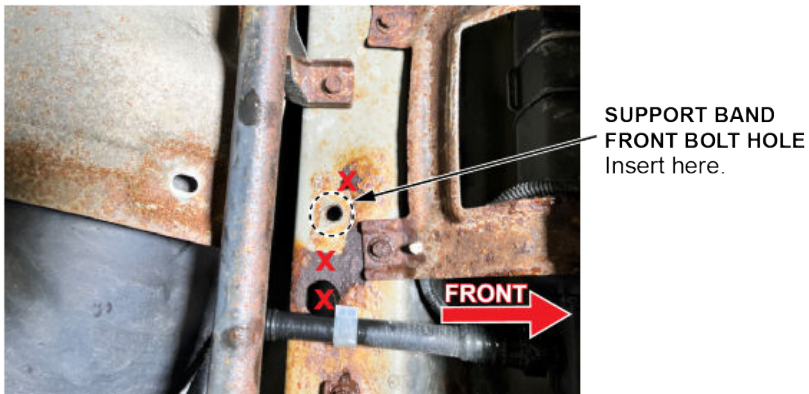
14.13 Insert the wax spray tube through the left side fuel tank support band front bolt hole outlined until it reaches the first red mark.

NOTE: Make sure the spray tube is inserted into the support band front bolt hole and not the hole next to it.

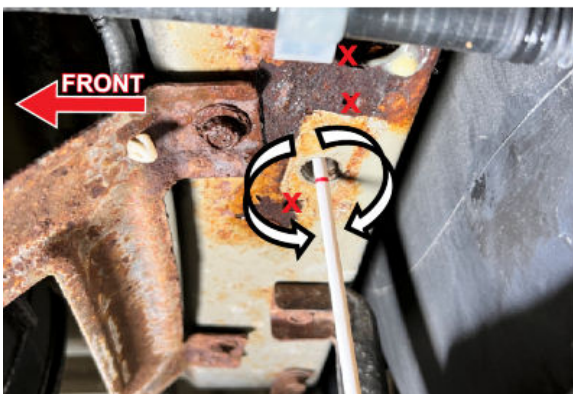
14.14 Spray the wax for **5 seconds** while rotating the tube in a circular motion.

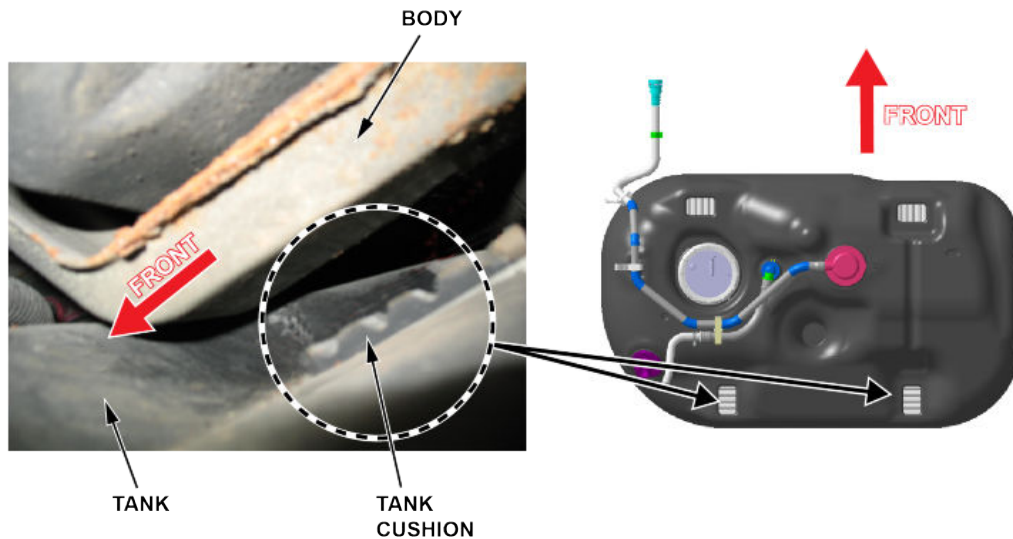
15.1. To access to the upper side of the fuel tank, slightly lower the fuel tank with the underhoist stand while still supporting the fuel tank. Remove the existing rear fuel tank cushions from the top of the tank.

- The rubber cushions are secured with an adhesive and can be peeled off.
- Make sure that both rear cushions are removed, one from each of the rear sides.
- Discard the original cushions.

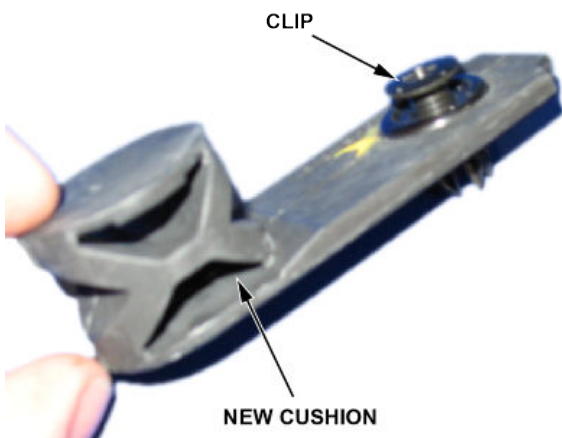
DRIVER'S SIDE

15.2. Install the new fuel tank cushions included in the parts kit by using the clips to secure them to the upper panel on both sides as indicated below.

NOTE: Make sure the new cushion is lined up with the groove in the fuel tank and the flat edge is lined up with body panel flange.

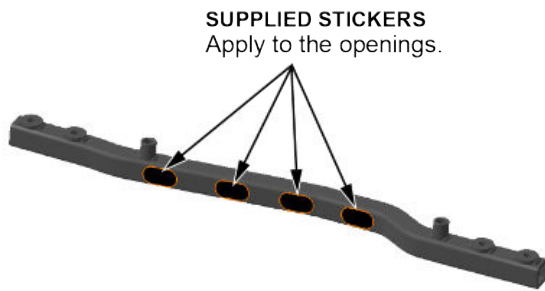
16. Install supplied stickers on the openings of the crossbar.

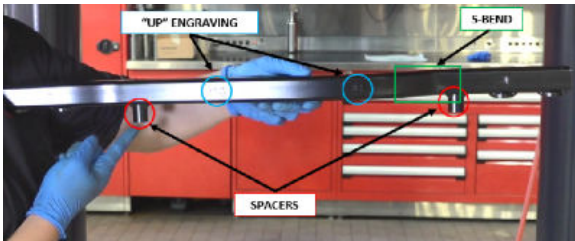
17.2. Insert the new crossbar from the passenger side by holding the bar with the S-bend on the passenger side, the spacers facing down, and the "UP" engravings facing the rear of the vehicle.

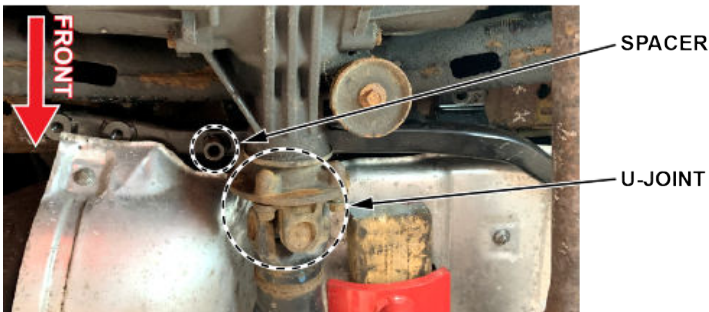
17.3. Insert the crossbar over the rear propeller shaft u-joint. Once the first crossbar spacer is over the u-joint, rotate the crossbar **180 degrees** so that both spacers are facing up.

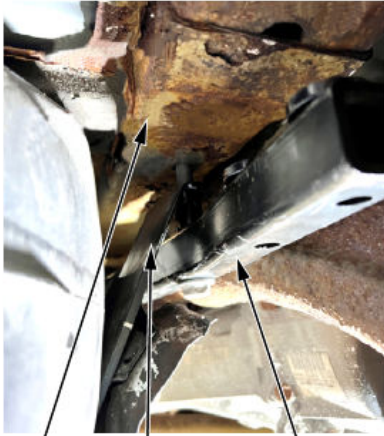
LEFT SIDE

17.7. The fuel tank support bands are to be pressed between the crossbar and the frame body as shown below.

FRAME BODY
FUEL TANK SUPPORT BAND
CROSSBAR

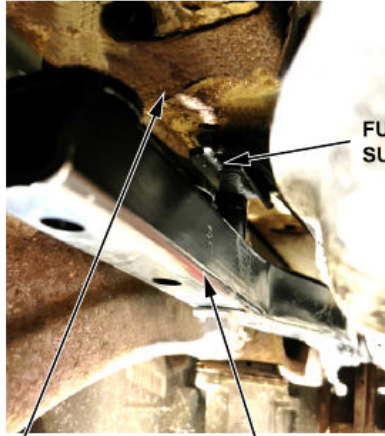
RIGHT SIDE

FRAME BODY
CROSSBAR
FUEL TANK SUPPORT BAND

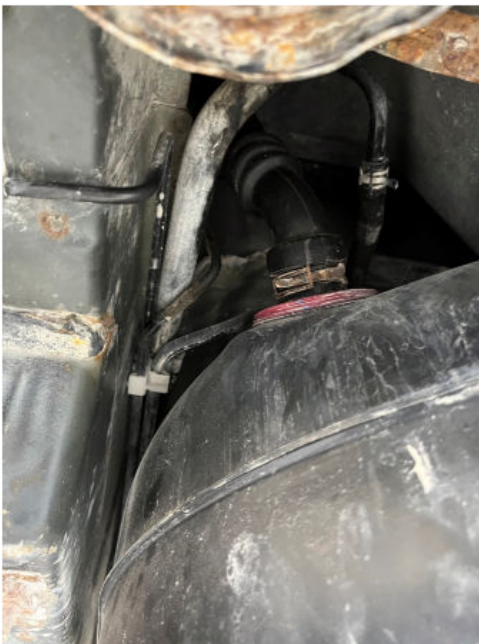
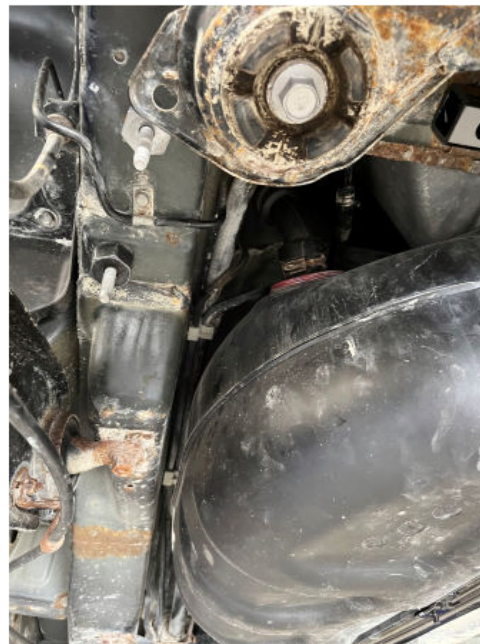
17.9. Check and make sure that the fuel filler neck tube is properly attached.

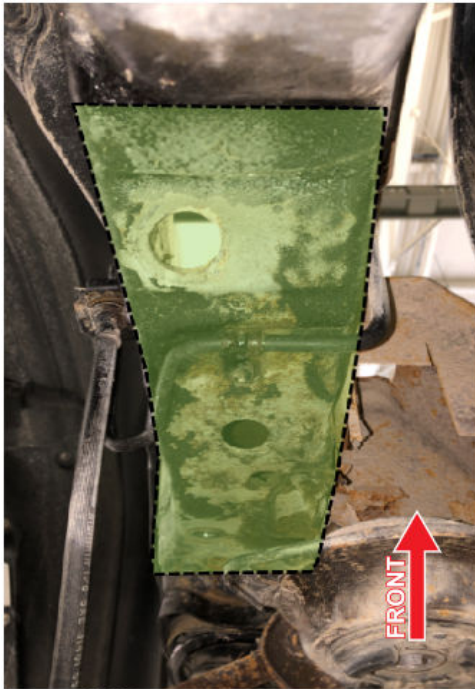
18. Prepare the frame rail on both sides for the underbody coating application which is to be applied later. [Click Here for Video.](#)
 - 18.1. Clean any loose dirt and/or rust from the lower surface of the frame rail where the new casting is going to mount to the body.
 - 18.2. Clean the surface using a nylon brush. Use brake cleaner as needed and wipe dry afterwards.

= CLEANING AREA

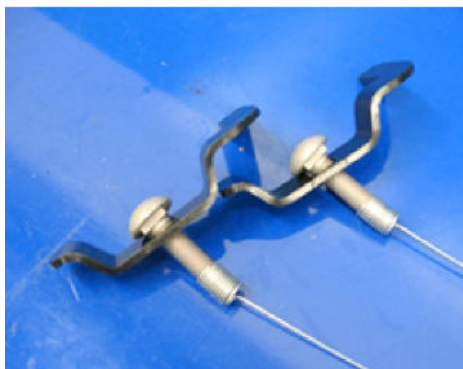
- Make sure the guide wires are fully attached to the bolts.
- Make sure the engraving "THIS SIDE UP" on the washer is facing up.

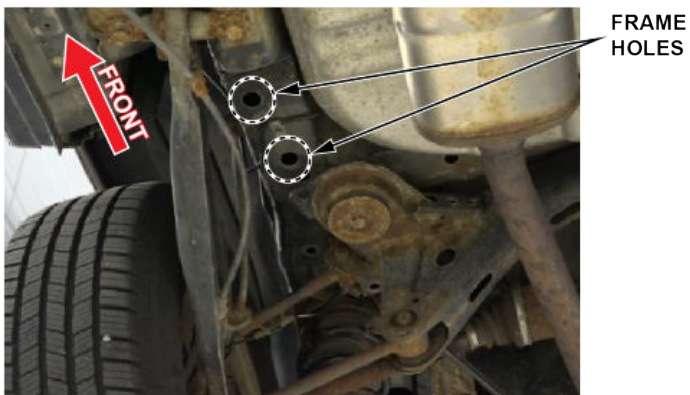
21. Insert the washers and carriage bolts into the existing frame holes shown below.

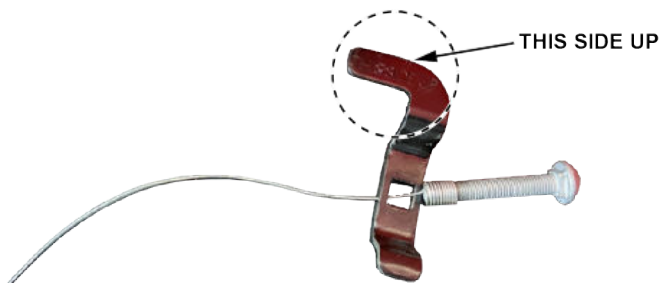
22. Use the guide wires to push the carriage bolts into the holes first and then insert the washers.

NOTE: Make sure the engraving "THIS SIDE UP" on the washer is facing up.

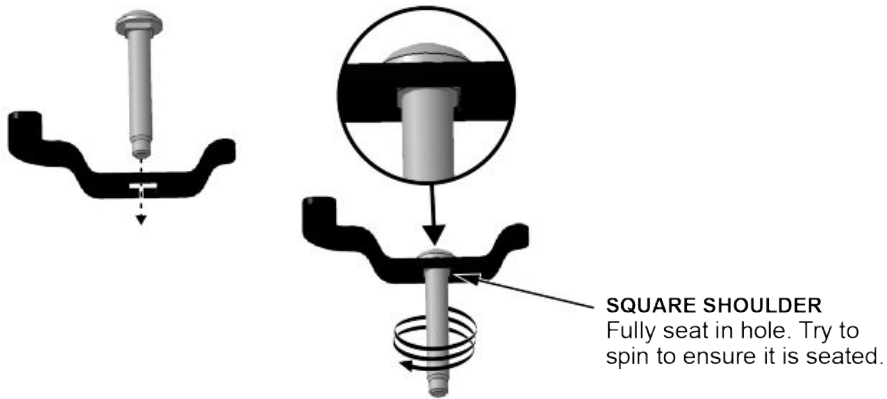
23. Once the washer is fully seated in the frame cavity, carefully pull the carriage bolt back down through the washer and the hole using the guide wire.

- The flat part of the washer must face down and sit on the floor of the frame cavity.
- Try to spin the carriage bolt in order to ensure the square shoulder is seated into the square hole of the washer.

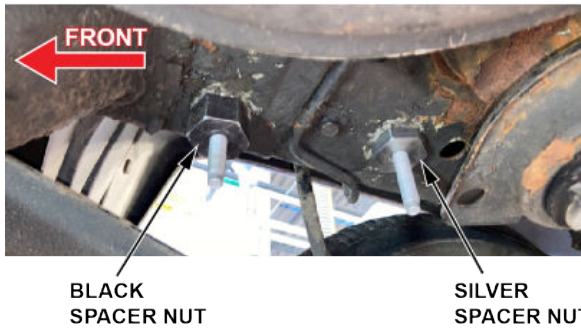
25. Thread the black spacer nut (thicker) onto the front carriage bolt. Thread the silver spacer nut (thinner) onto the rear carriage bolt closer to the subframe mount.

NOTE: Make sure the circular lip of the spacer nut faces up and aligns with the holes in the frame.

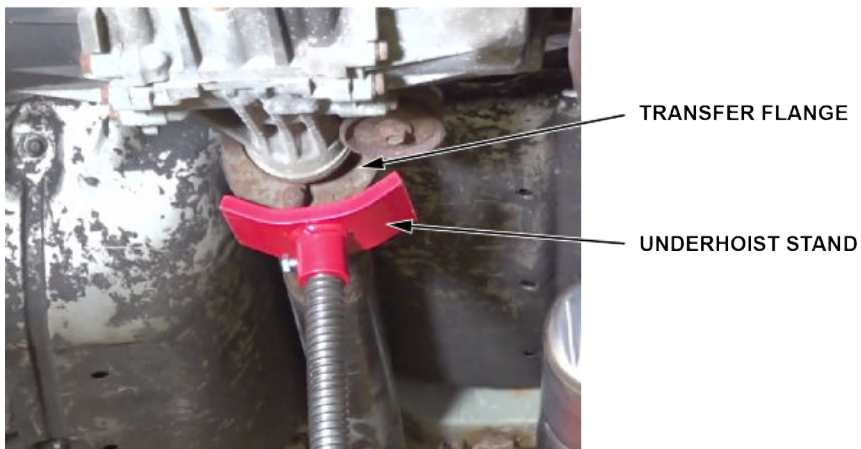
26. Tighten both nuts to **35 N.m (26 lb-ft)**.
27. Repeat steps 19 through 26 on the opposite side of the vehicle.
28. Support the rear differential at the transfer flange using an underhoist stand.

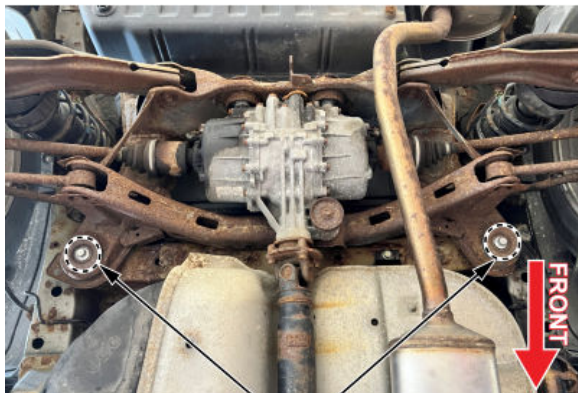
C-POINT SUBFRAME MOUNT BOLTS

29. Remove both of the C-point subframe mounting bolts.

- Discard the original C-point subframe bolts and washers.
- If any of the bolts appears to be visually separated from the body, attempt to remove that bolt first.
- If the bolt does not come out, attempt to use heat to assist in removing the bolt. An induction heating tool is recommended.
- If the subframe bolt breaks, or if the body breaks during removal, allowing the collar to spin, refer to REPAIR PROCEDURE C for additional instructions.

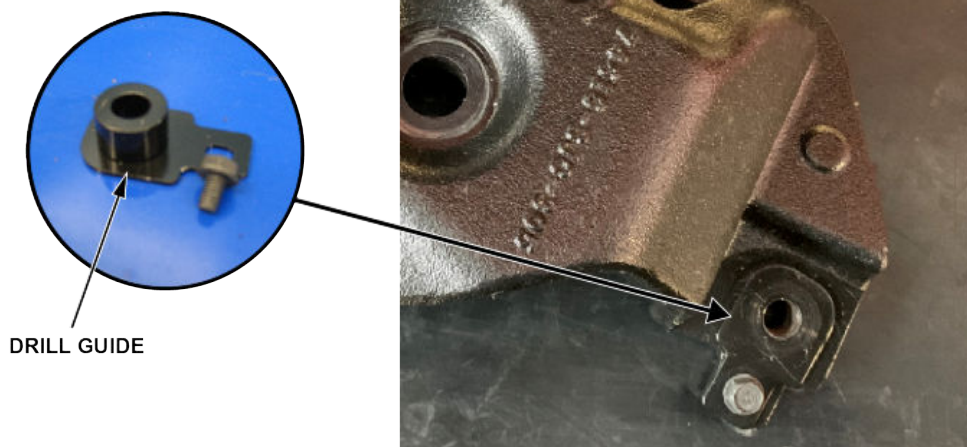
DRILL GUIDE

30. Secure the supplied drill guide into the hole on the subframe casting using the supplied bolt.

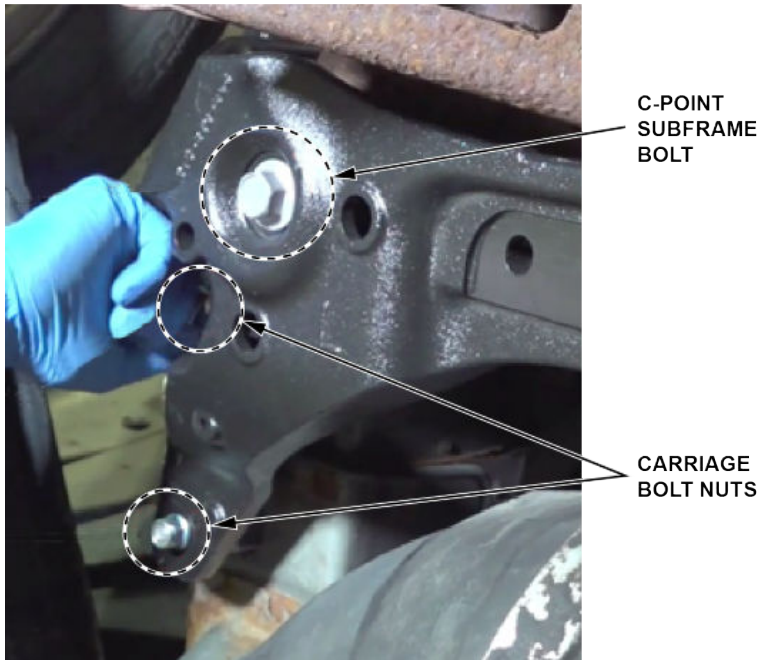
31. Install the subframe casting and hand tighten the new C-point subframe bolt and carriage bolt nuts. Do not torque the fasteners at this time.

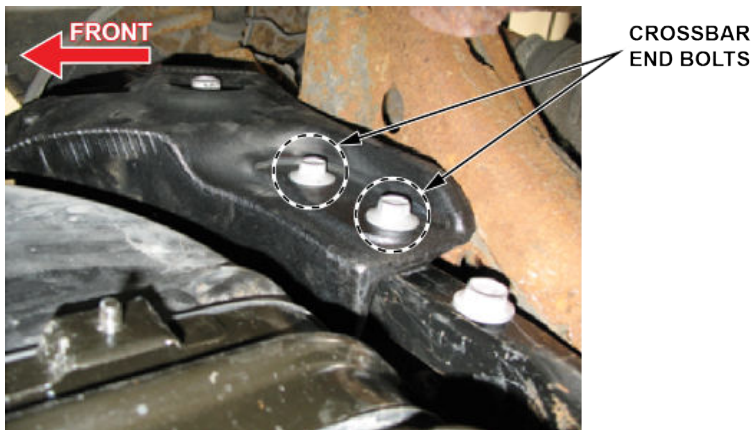
32. Install the crossbar end bolts by hand. Do not torque the bolts at this time.

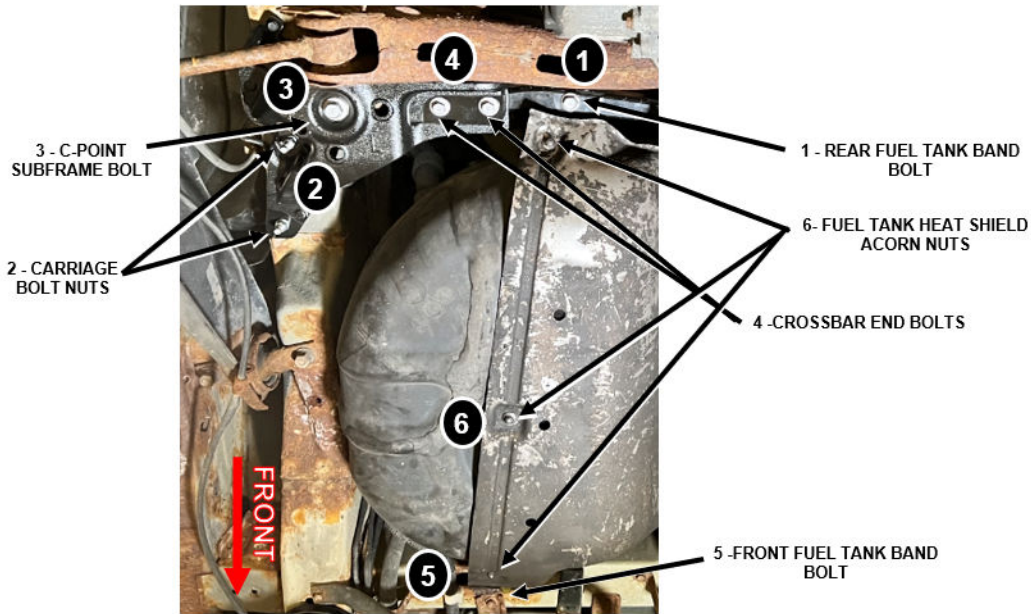
Left side shown

1. Rear fuel tank band bolts (33 Nm, 24 ft lb)
2. Carriage bolt nuts (33 Nm, 24 ft lb) .
3. C-point subframe bolts (95 Nm, 70 ft lb).
4. Crossbar end bolts (33 Nm, 24 ft lb) .
5. Front fuel tank band bolts (65 Nm, 48 ft lb).
6. Fuel tank heat shield acorn nuts (9.8 Nm, 7.2 ft lb)

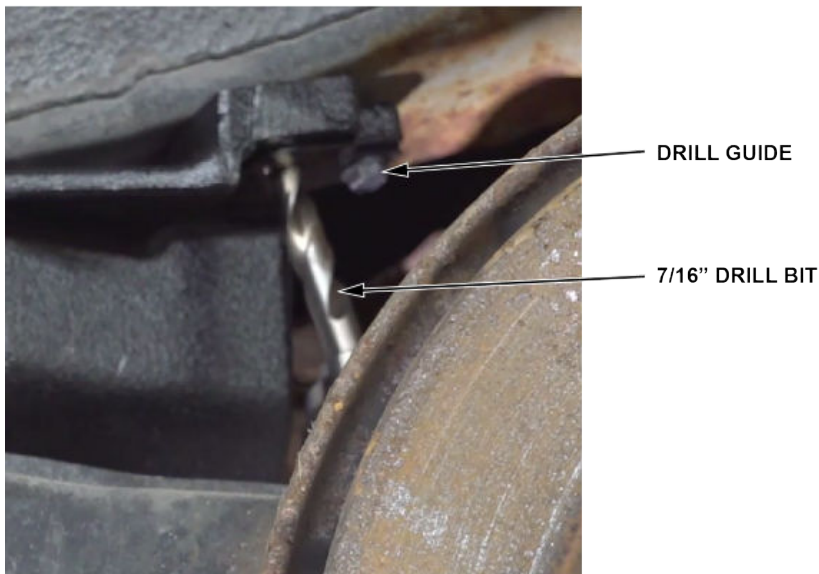
NOTE: Make sure the drill guide is installed prior to drilling.

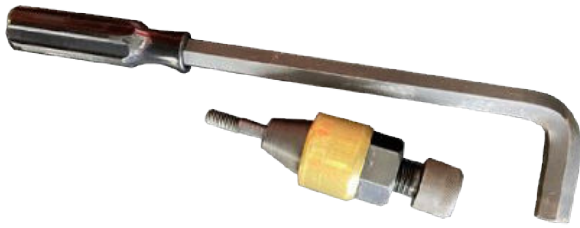
36.3. Setup the rivnut installer (T/N 07AAE-SJCA100).

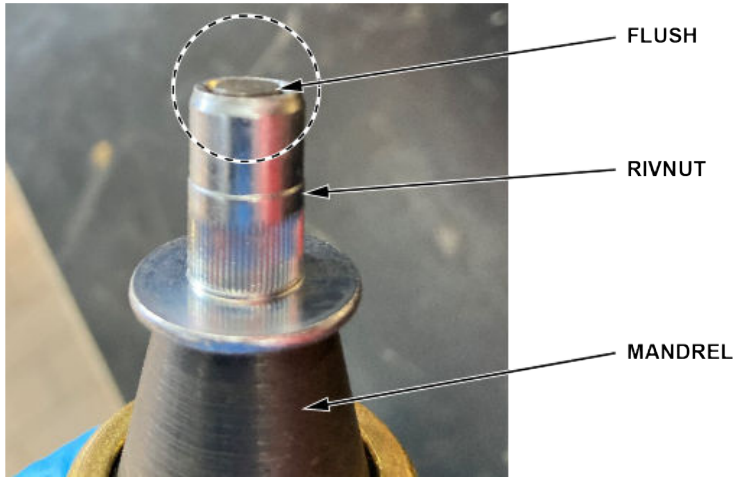
36.4. Thread the rivnut onto the mandrel until the threads are flush with the tip of the rivnut.

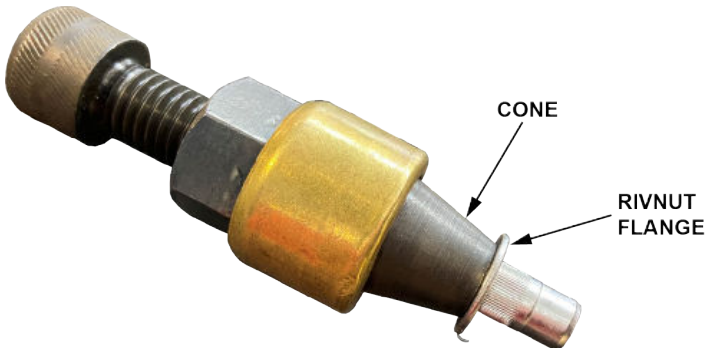
36.5. Tighten the cone of the tool until it contacts the rivnut flange.

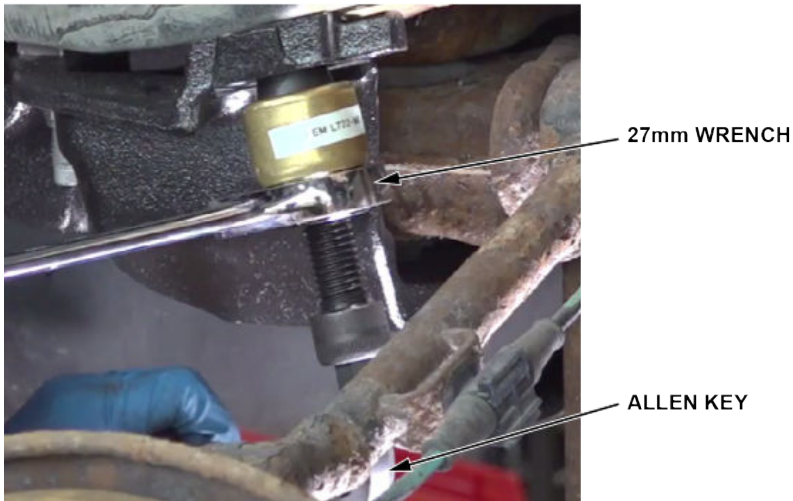
- Make sure not to overtighten the large nut as it may result in damage to the inner threads of the rivnut.
- Make sure the rivnut is seated completely into the hole prior to tightening the nut on the rivnut tool.

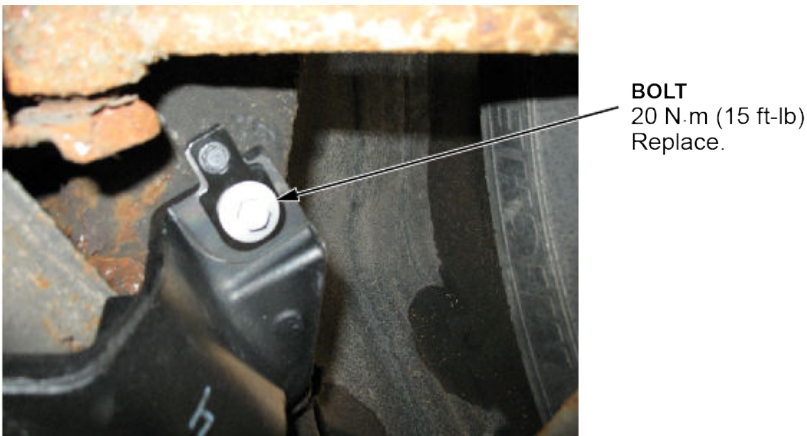
NOTE: If the bolt continues to spin when attempting to torque it to specification, continue tightening the bolt as the rivnut may not have been completely seated during installation. Tightening the bolt will allow the rivnut to completely set into the frame allowing the bolt to reach it's torque specification.

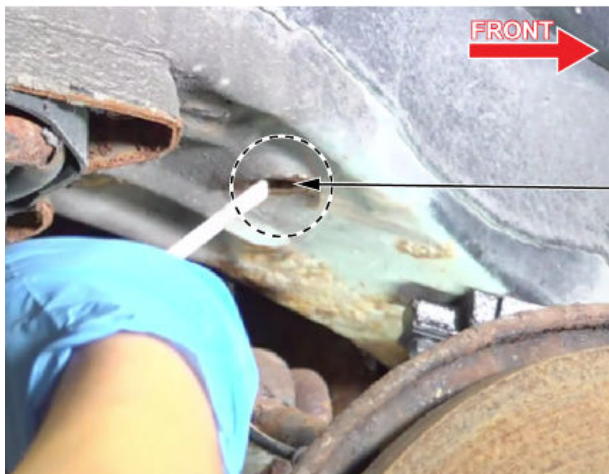
Insert here.

- Insert the tube from the wheel well horizontally and push it towards the front of the vehicle.
- If there is any resistance felt when inserting the spray tube, the tube may be wedging against the inner sides of the frame rail. Remove the spray tube and re-insert until there is no resistance felt.

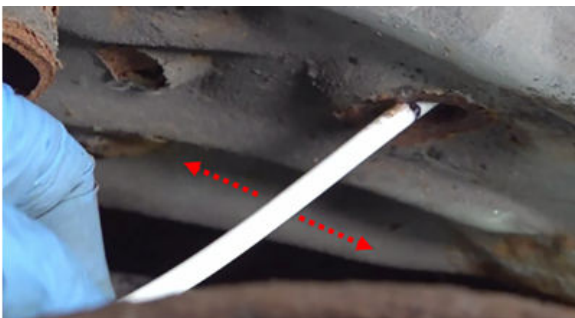
40. Spray the wax for **5 seconds** while swaying the tube side to side within the slot.

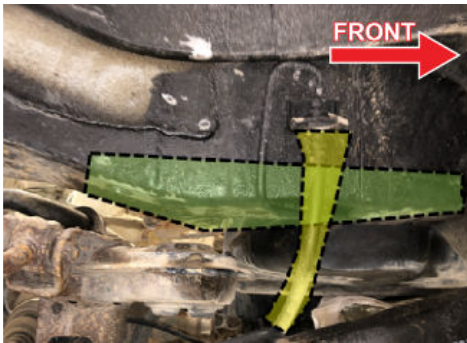
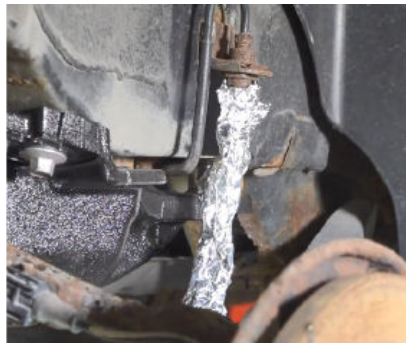
47. Using aluminum foil, cover the rubber brake hose to protect it from any possible over spray. [Click Here for Video.](#)

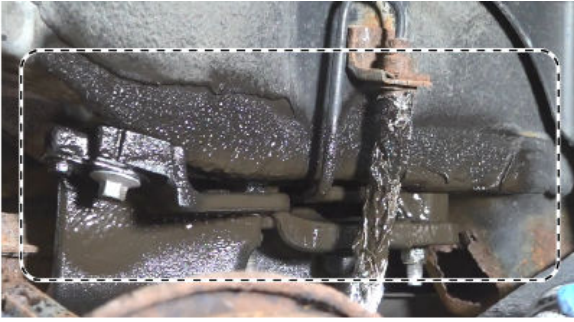
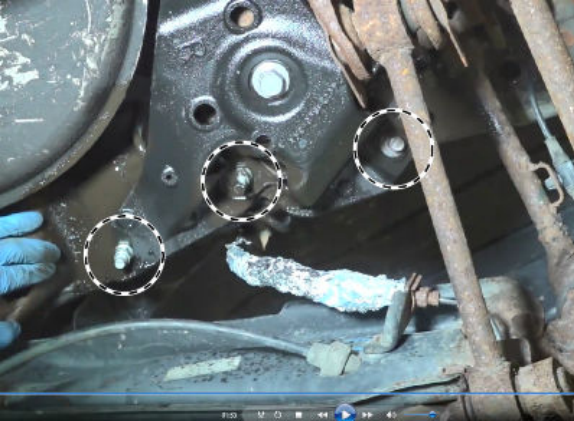
48. The UBC has to seal the contact surface between the casting and the frame rail. The coating will be applied around the casting as shown below in red. Clean these areas with compressed air.

49. Spray the UBC from both angles, the side and bottom of the frame rail, to get sufficient coverage between the casting and body panel.

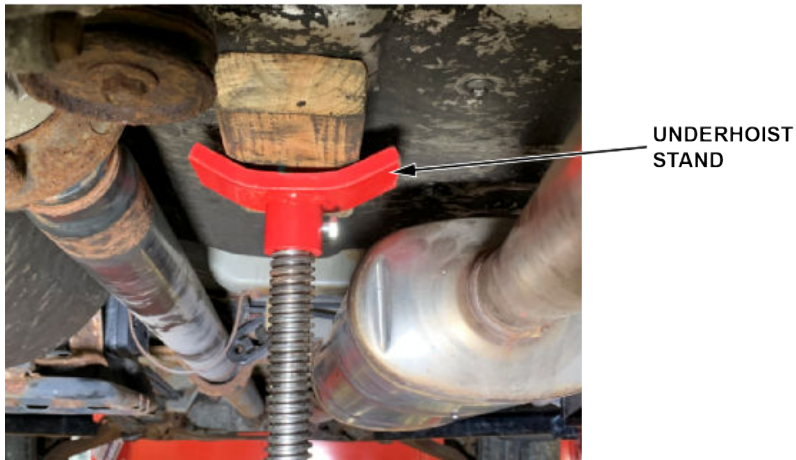
1. Support the fuel tank using an underhoist stand between the propeller shaft and exhaust silencer.

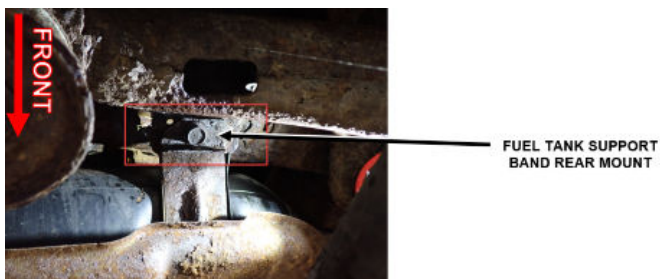
2. Using a body-saw or chisel, remove the crossmember body portion outlined in red from around the fuel tank support band rear mount.

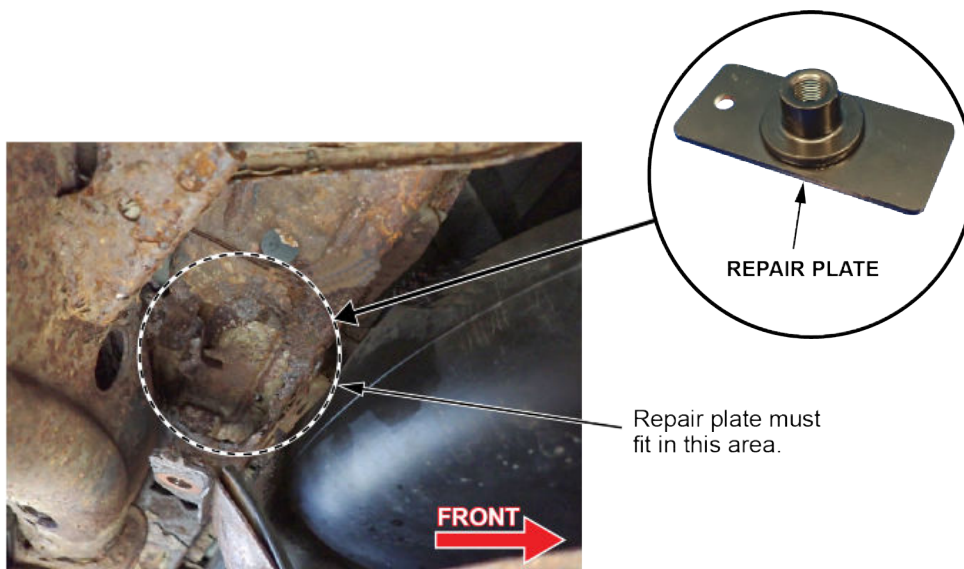
3. Clear enough space to allow the tank band repair plate to fit within the frame.

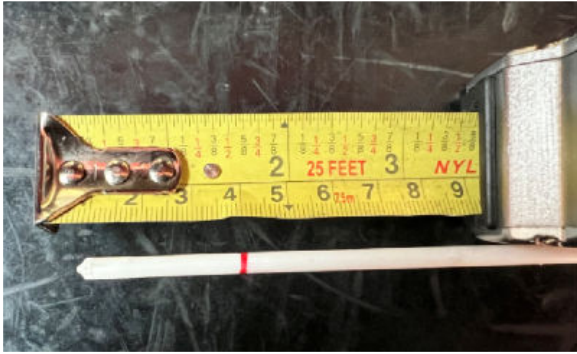
- Remove the fuel tank support bands front bolts and slide the support bands out.
- Using a measuring tape or ruler, measure **40 mm (1.5 in)** from the tip of the wax canister spray tube and mark the wax canister spray tube at this point with a red permanent marker.

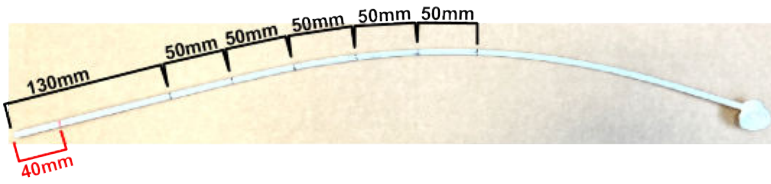
- Make additional line marks at **130 mm (5 in)** from the tip and at five additional marks **50 mm (2 in)** apart using a black permanent marker. There should now be seven marks in total.

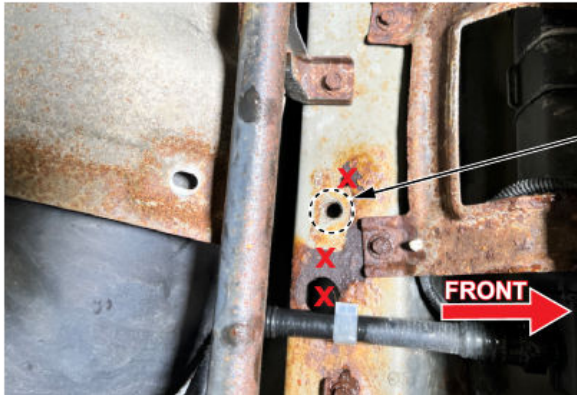
SUPPORT BAND
FRONT BOLT HOLE
Insert here.

9. Insert the wax spray tube through the left side fuel tank support band front bolt hole until it reaches the red mark.
NOTE: Make sure the spray tube is inserted into the support band front bolt hole and not the hole next to it.

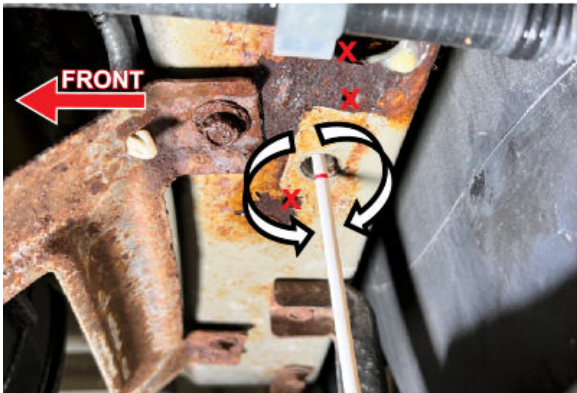
10. Spray the wax for **5 seconds** while rotating the tube in a circular motion.

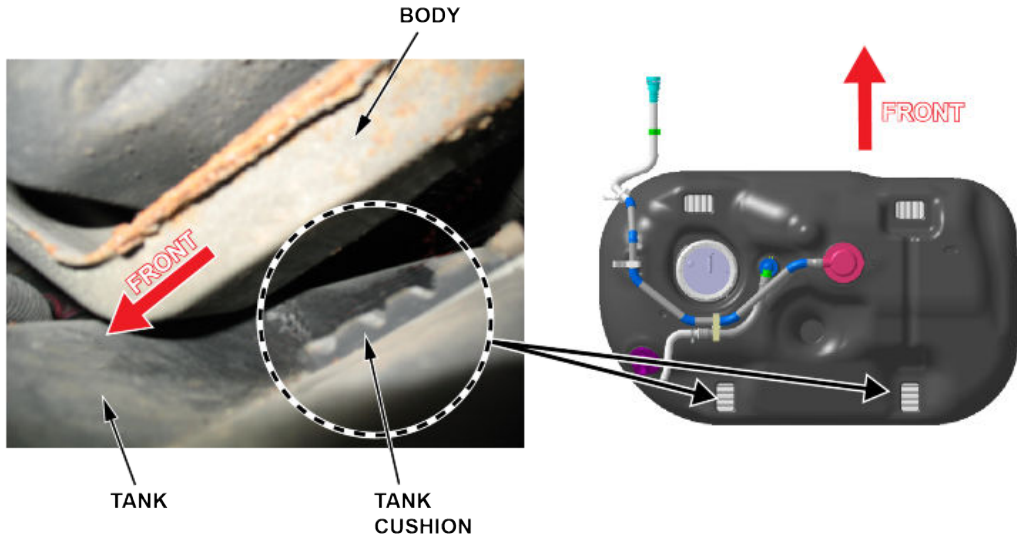
- The rubber cushions are secured with an adhesive and can be peeled off.
- Make sure both rear cushions are removed, one from each of the rear sides.
- Discard the original cushions.

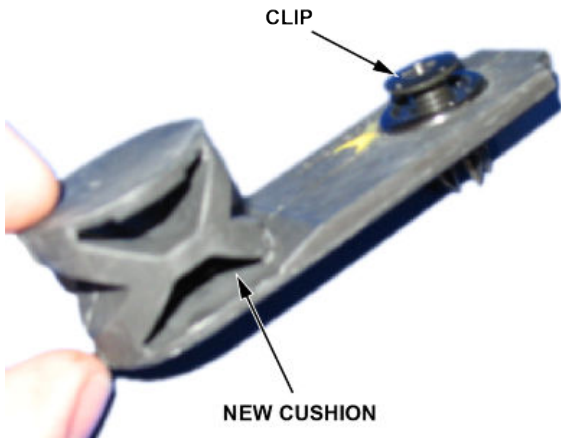
DRIVER'S SIDE

14. Install the new fuel tank cushions included in the parts kit by using the clips to secure them to the upper panel as indicated below.

NOTE: Make sure the new cushion is lined up with the groove in the fuel tank and the flat edge is lined up with body panel flange.

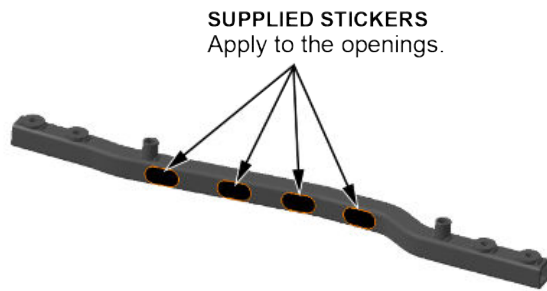
18. Install supplied stickers on the openings of the crossbar.
