July 23, 2022

Version 2

Safety Recall: 2006–14 Ridgeline Rear Frame Repair

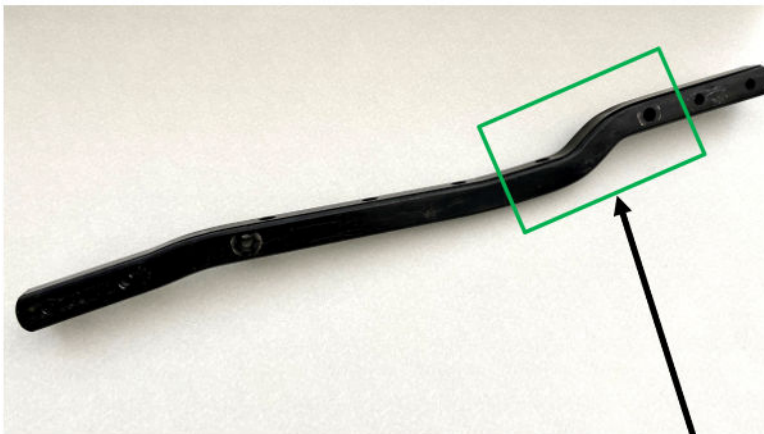
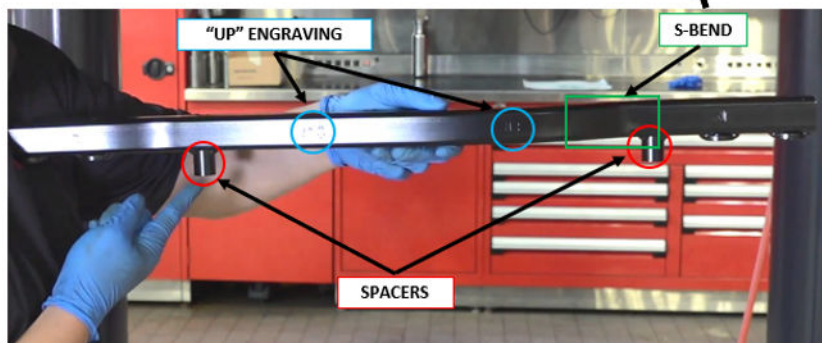
19.2. Insert the new crossbar from the passenger side by holding the bar with the S-bend on the passenger side, the spacers facing down, and the "UP" engraving facing the rear of the vehicle.

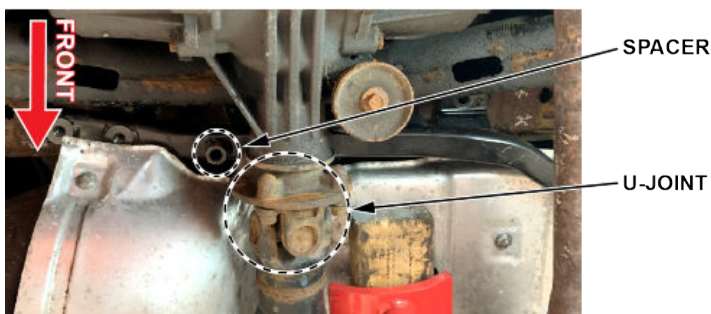
19.3. Insert the crossbar over the rear propeller shaft u-joint. Once the first crossbar spacer is over the u-joint, rotate the crossbar **180 degrees** so that both spacers are facing up.

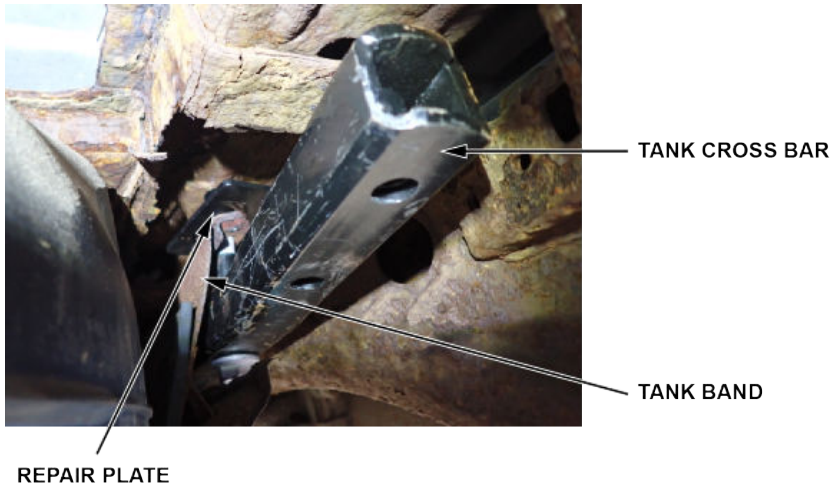
19.7. The fuel tank support bands are to be pressed between the crossbar and the repair plate as shown below.

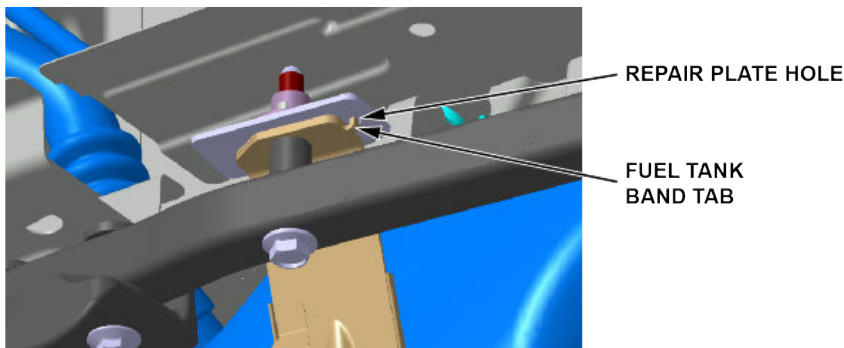
- Make sure the fuel tank band tab is set into the repair plate hole and the bolt is snug. This prevents the repair plate from spinning when tightening the bolt later.
- Tighten the bolts and then back them off half a turn. Do not tighten the bolts to specification at this time.

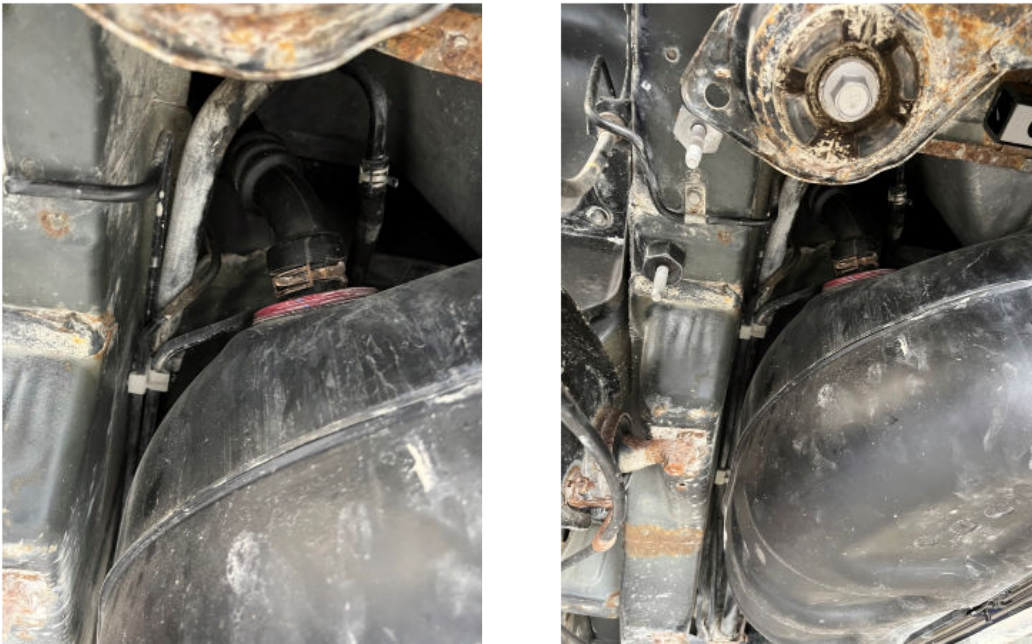
19.10 Make sure that the fuel filler neck tube is properly attached.

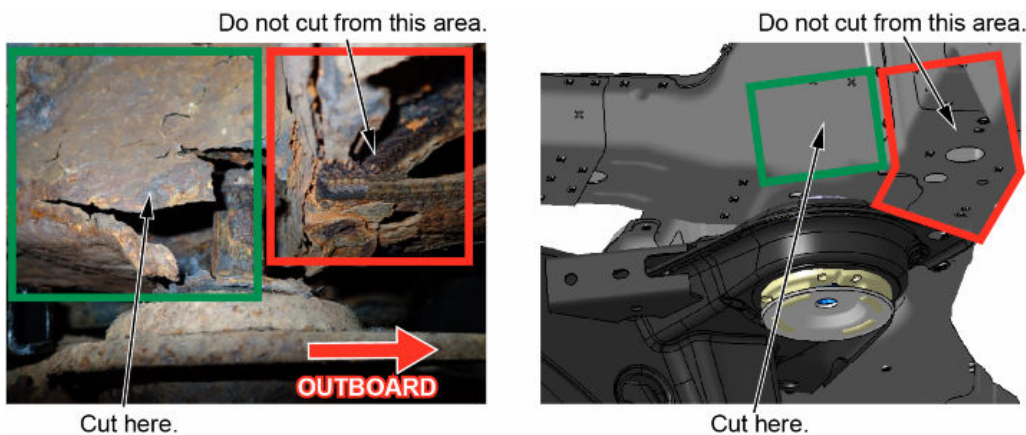
- This repair should only be performed if the C-point subframe mount is partially or completely dislodged from the body or when the C-point subframe mount bolt spins and cannot be removed or torqued to specification.
 - This sequence should be done before installing the subframe casting.
 - Prepare the specific body panel area to allow for the repair plate addition.
1. Using an air chisel or air saw, remove a portion of the body panel as indicated in green to allow access to the bolt top end and its frame collar.

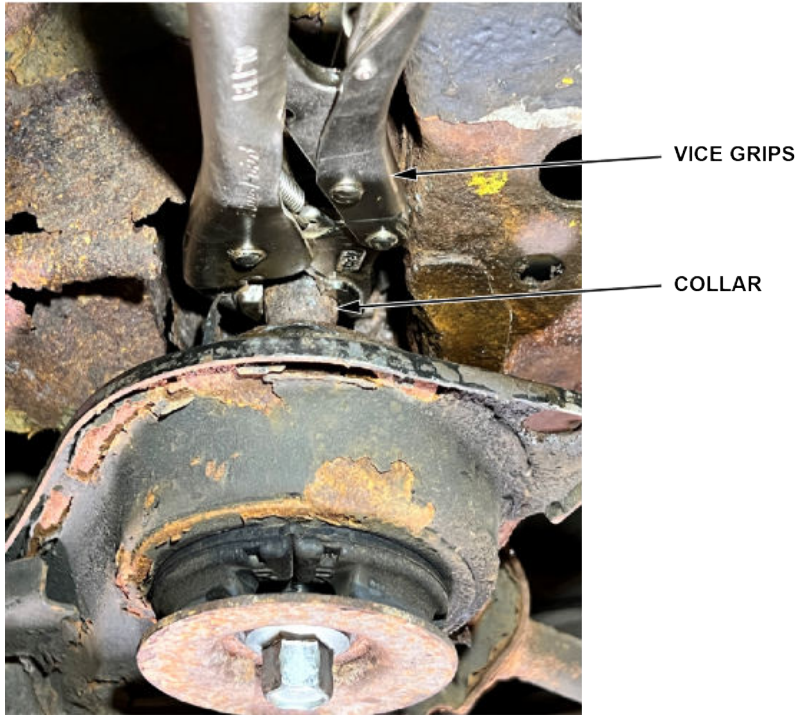
2. Once the collar is exposed, use Vice Grips to hold the collar and unscrew the bolt.

WARNING: DO NOT USE AN OPEN FLAME TOOL TO REMOVE ANY CORRODED BOLTS LOCATED IN CLOSE VICINITY TO THE FUEL TANK. An induction heating tool is recommended.

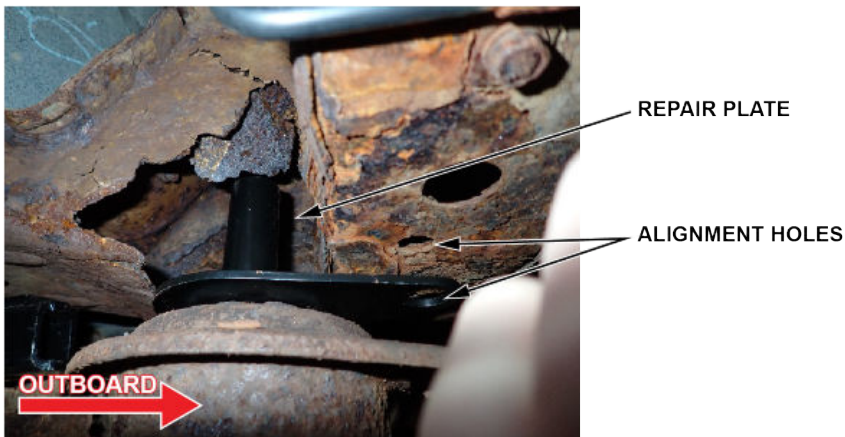
- 3.2. Fit the C-point repair plate in the body.

NOTE: Orient the alignment hole on the repair plate towards the outside of the vehicle.

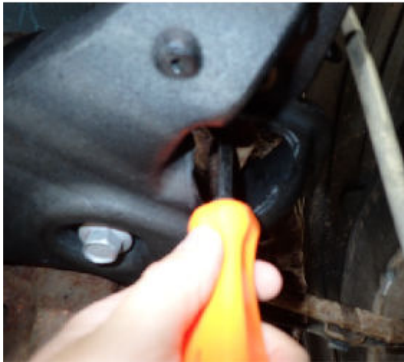
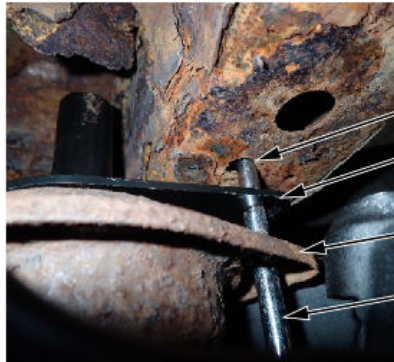
- When tightening the C-point subframe mount bolt, use a ratchet extension or similar through the alignment holes on the subframe, the repair plate, and the body datum to keep the repair plate from spinning.
- You can clamp a vise grip on the ratchet extension to hold it in place.

BODY DATUM

REPAIR PLATE
