<b>HYUNDAI</b> <b>Technical Service Bulletin</b>	GROUP <b>RECALL</b>	NUMBER <b>22-01-057H</b>
	DATE <b>July 2022</b>	MODEL(S) <b>Venue (QX)</b>
<b>SUBJECT:</b>	FRONT SEAT BELT PRETENSIONER PROTECTION CAP INSTALLATION (RECALL 231)

**Description:** The front seat belt pretensioner may deploy abnormally in the vehicles described below, causing the MGG (Micro Gas Generator) to detach from the assembly. This bulletin describes the procedure to install front seat belt pretensioner anti-separation protection caps.

- Certain 2020-22MY Venue (QX) produced from 07/19/2019 – 05/31/2022

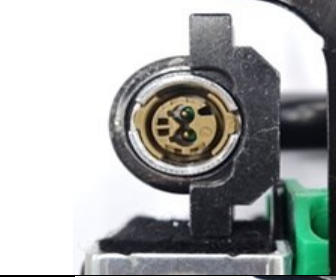
TYPE	PART NAME	IDENTIFICATION METHOD		REMARKS	
		BEFORE INSTALLATION	AFTER INSTALLATION		
SWLL	CAP A

Caps (A/B) are classified by type according to the marking groove position of the cap.
	CAP B

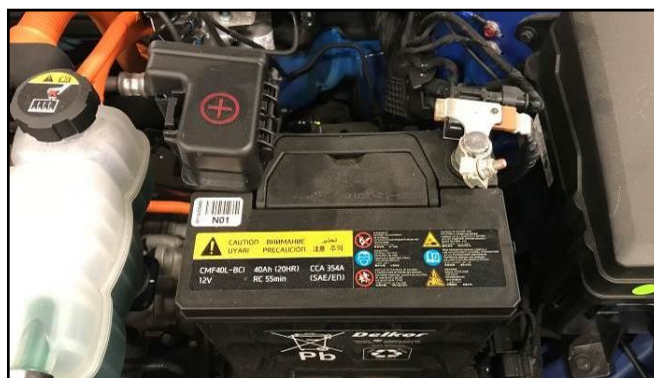
1. If applicable, record the customer's radio preset stations for AM / FM / SXM.
2. Disconnect the negative ( - ) battery terminal.

**Negative Battery Terminal Tightening Torque:**  
**7.8 – 9.8 Nm (0.8 – 1.0 kgf.m, 5.8 – 7.2 lb-ft)**

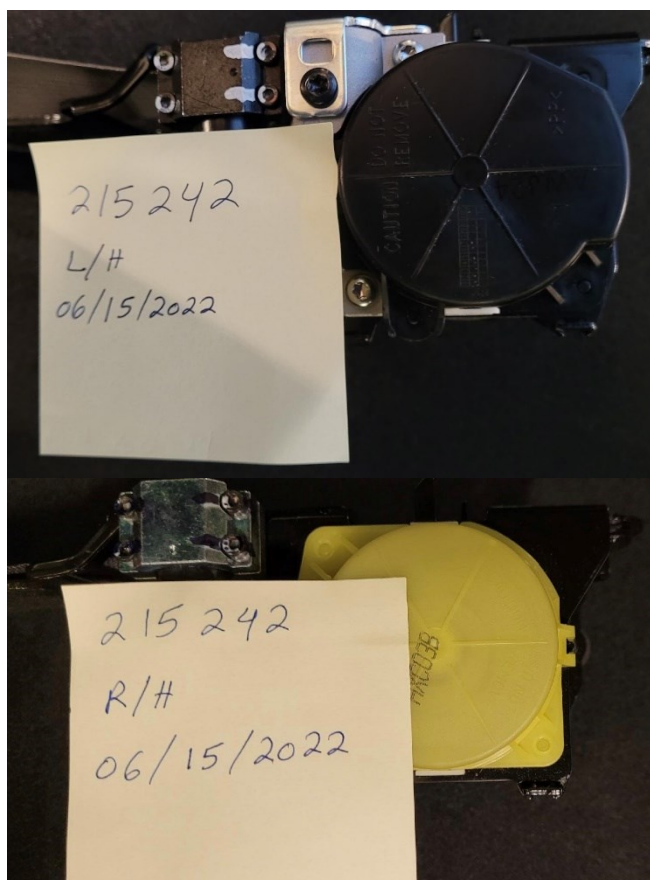
13. Mark all 4 screws with paint after installing screws.

Using STUI, please take a photo of the completed pretensioner assembly with the caps installed. Within the picture, include a piece of paper with the last 6 digits of the VIN # or the RO, LH or RH side, and date of repair.
