GROUP	MODEL
Safety Recall Campaign	2022MY Sorento (MQ4a) Telluride (ON)
NUMBER	DATE
SC244	July 2022

SUBJECT: **SPARE TIRE INSPECTION & REPLACEMENT (SC244)**

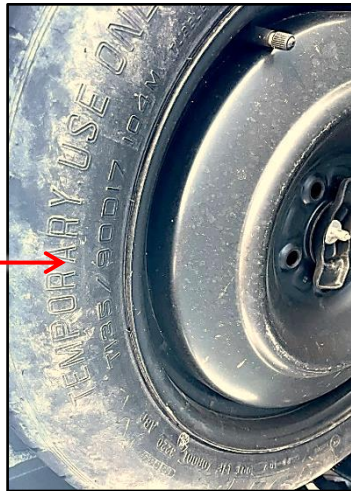
**Sorento (MQ4a):**  
**17" in. Spare Tire**  
Size: T135/90D17

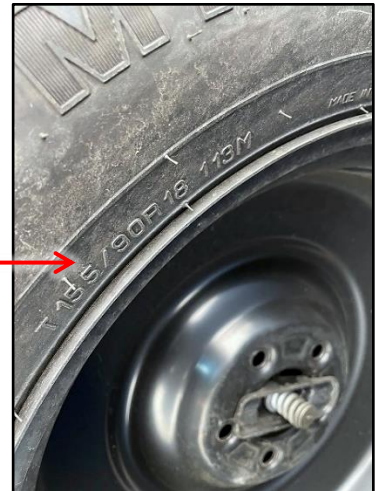
**Telluride (ON):**  
**18" in. Spare Tire**  
Size: T155/90R18

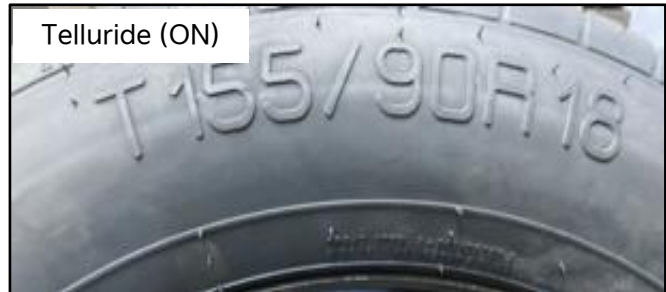
1. Locate the spare tire underneath the rear of the vehicle.
2. Confirm that the correct tire size is equipped on the vehicle.
  - **Sorento (MQ4a): T135/90D17**
  - **Telluride (ON): T155/90R18**

**Note:** Tire size should match the stated number on the door jamb label.

2. Is the vehicle equipped with the correct spare tire size applicable for that model?
  - **YES:** It is the correct tire. No further action is needed.
  - **NO:** It is the incorrect tire. Order the correct spare tire using the part number provided in the 'Required Part's table on page 3 and replace it.
