IMPORTANT SAFETY RECALL
See enclosed VIN list

September 2022
FL948
NHTSA #22V-532 (School Bus)

Subject: Thomas Built Bus Minotour Incorrect Tire Label

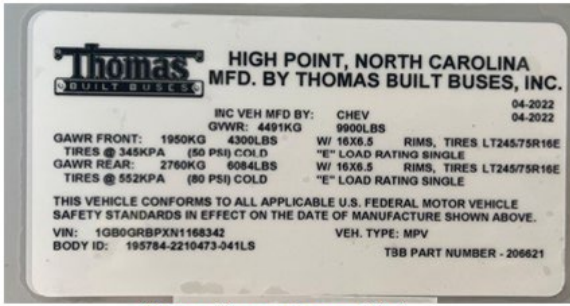
Vehicle data label

Shown: Correct data on label

1. Park the vehicle on a level surface. Shut down the engine, place the bus in park, and set the parking brake.
2. The replacement label(s) has been included in your customer notification letter. Please refer to fig.1 for installation locations.
3. Locate the Tire and Loading Information Label on the driver doorpost shown in Fig. 1.
4. Remove existing clear Cover. Start in one corner. Carefully, remove "VOID" remains with razor blade. Fig. 2.
5. Remove any leftover adhesive with an adhesive remover.
6. Apply the new label using a squeegee to remove any air bubbles.
7. Locate the Vehicle Data Label on the front bulkhead shown in Fig. 1.
8. Repeat steps 4, 5, and 6 for additional label replacement.
9. Return the vehicle to service.

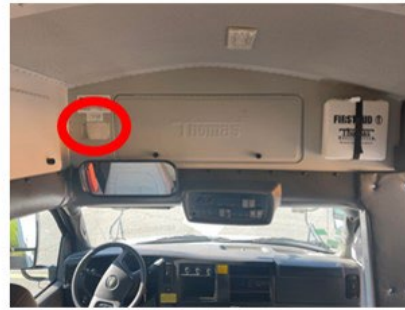
Applied to the Front Bulkhead

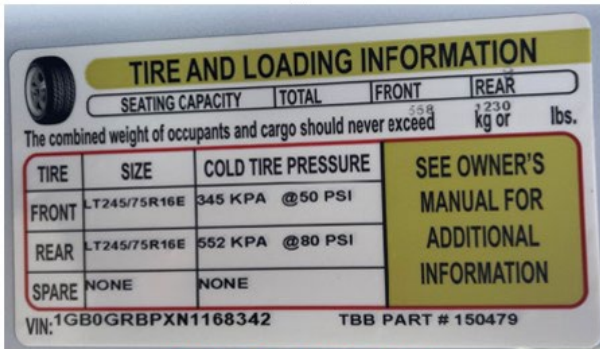
Tire and Loading Information

Shown: Correct data on label

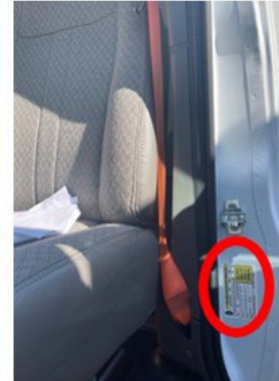
Fig. 1.

Applied to driver door post
