SIB 61 14 22

RECALL 22V-541: HIGH-VOLTAGE BATTERY

E-Series	Model Description	Production Date
G26 BEV	i4 Gran Coupe	November 10, 2021 – October 21, 2022

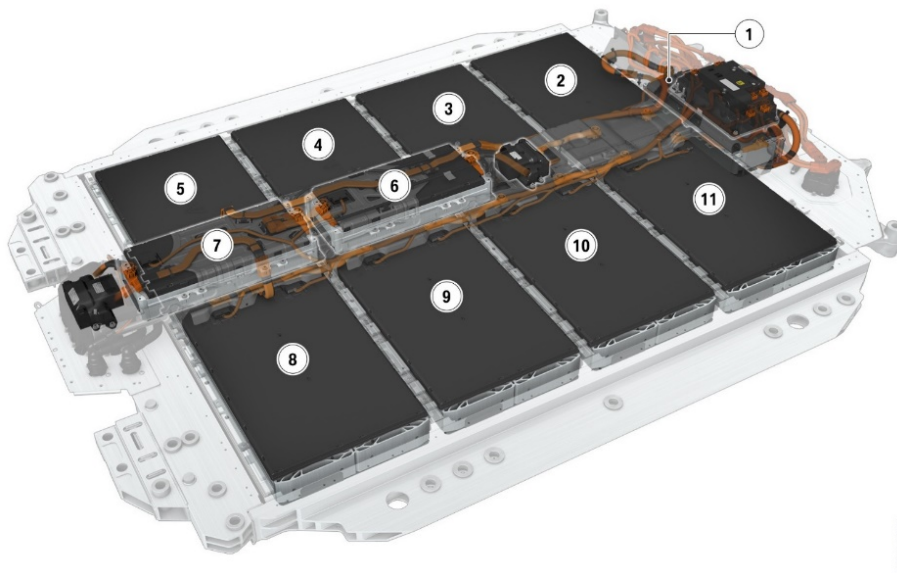
G26 BEV SE27 HB Battery module locations shown below-

3. Replace the defective high-voltage cell modules using repair instructions **61 27 703** to **61 27 877** depending on the affected cell module location.
