AMENDED: Recall Bulletin 220809REV
Leveling Jack Hoses

**RECALL
BULLETIN:
220809REV**

SUBJECT:
Hydraulic Hose
Routing

The purpose of this Product Recall Bulletin is to inform REV dealers of the need to inspect and, if necessary, correct the routing of Lippert hydraulic hoses on certain model year 2018-2023 Fleetwood and Holiday Rambler brand gas motorhomes and 2021-2023 Fleetwood and Holiday Rambler brand diesel motorhomes.

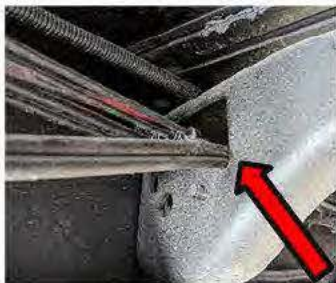
Figure 1

- A. Start at the rear of the coach and inspect **ALL** hydraulic leveling hoses from the rear to front, side to side, & along the frame rails, looking for any hydraulic hoses that are at risk of damage due to chaffing or heat or bubbling. (See Figure 1)

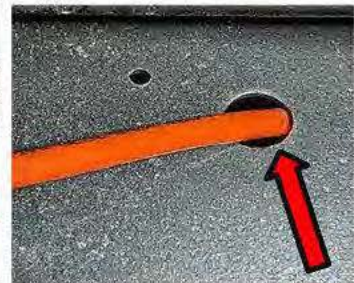
Figure 4

- D. Look for any hoses that may be passing through a hole in the frame rail. Mark any areas with colored tape for reference to be used during the repair portion of this bulletin. (See Figure 4)

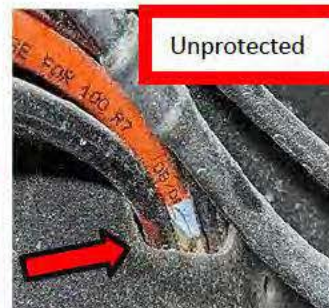
Figure 11

- B. Hoses that route through larger holes/openings in the frame rails where grommets will not fit, install nylon protective material onto the hose to prevent abrasion. **See Figures 11 and 12.** If hoses are leaking, investigate the root cause and record the date code of the hose. See Step 12 for the hose replacement procedure for details.

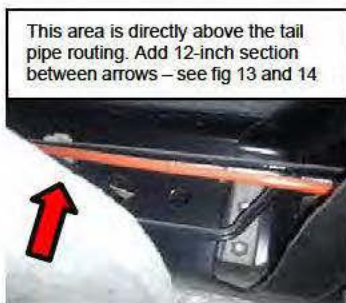
Figure 12

- A. In the driver's side rear exhaust tail pipe area, inspect the hose for blistering or heat related issues. If a hose is blistered it will need to be replaced. See Step 12 for hose replacement guidance.
- B. If the hose is not damaged, install a (2) 12-inch sections of silver heat reflective material to cover the (2 or on some models 3 hoses) located in that area. Take one section and wrap 2 hoses followed by using the other section for the remaining hose if applicable. Make sure the heat reflective material completely surrounds all three hoses. The cut edges of the reflective material should overlap each other before added white heat resistant wire ties. Add 4 white heat resistant wire ties to each of the 12-inch sections of silver heat reflective material. You must use the white heat resistance ties that are located in the Recall Parts Kit See Figures 12, 13 & 14

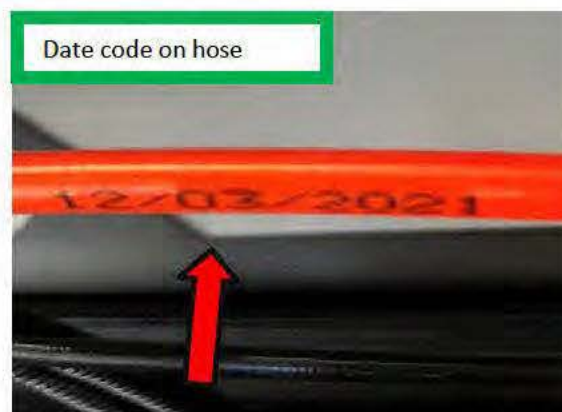
- A. **REQUIRED** notations for pre-authorization/claim: In the rare event a damaged hose is discovered, take a photo clearly showing the issue and root cause. Also, make a specific notation of the damaged hose date code (see picture below), the color of the hose, which jack it operates, as well as the hose length. This information will assist your parts department when ordering a replacement hose. **NOTE: Do not order a whole replacement hose kit!**

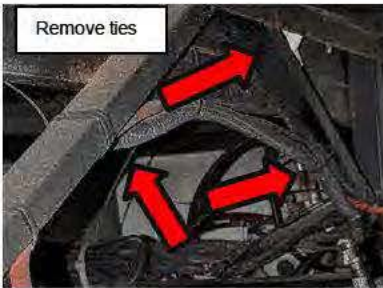
Figure 17

- A. Hoses that are secured **with nylon wire ties to the truss** will need to have the ties removed and insulated loop clamps added. Insulated loop clamps and screws are located in the Recall Parts Kit. **See Figure 17**
- B. Hoses that are not secured within 1-2 inches of the bottom of the floor will need to be repositioned and secured to the steel truss. This may require cutting wire ties and repositioning the hose(s). If loop clamps are too low, remount them closer to the floor. **See Figure 18**

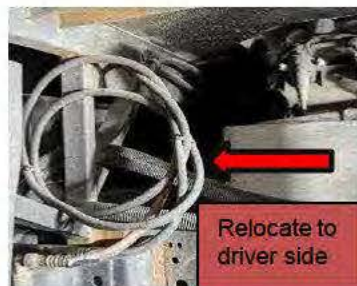
Figure 19

If a coiled loop of hose is found in the passenger side wheel well area, it will need to be relocated (Do not disconnect).

- A. To relocate, cut the wire ties holding the hoses in the passenger wheel well area. **See Figure 19**
- B. Fish the previously coiled hose excess through the 2 loop clamps located near the bottom of the floor and attached to the steel truss. Create a similar coil of excess hose near the driver's side jack area behind the driver side mud flap. Add nylon protective material on the hoses prior to attaching the hose with a black nylon wire tie to the steel structure in that area.

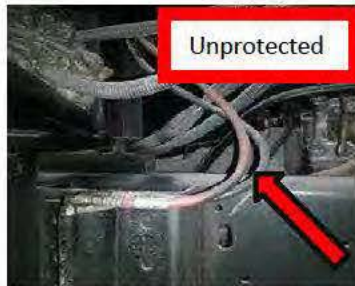
Figure 20

- The passenger wheel well area leveling jack hoses must be protected with heat reflective material.
- Locate the hydraulic hoses (typically 1 black and 1 orange) that are attached to passenger front jack that cross over to the driver side jack. **See Figure 20**

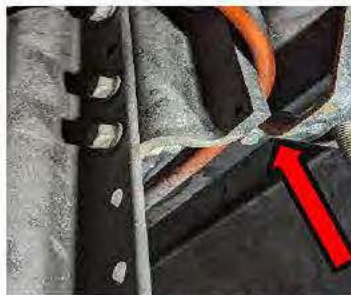
Figure A

- A. Start at the front of the coach and inspect **ALL** hydraulic leveling hoses from the front to rear, side to side, & along the frame rails, looking for any hydraulic hoses that are at risk of damage due to chaffing or leaking.
- B. Look for hoses that are making contact with any corners or edges of the steel frame rail and/or attached brackets. Mark these areas with colored tape for reference to be used during the repair portion of this bulletin. **See Figure A**

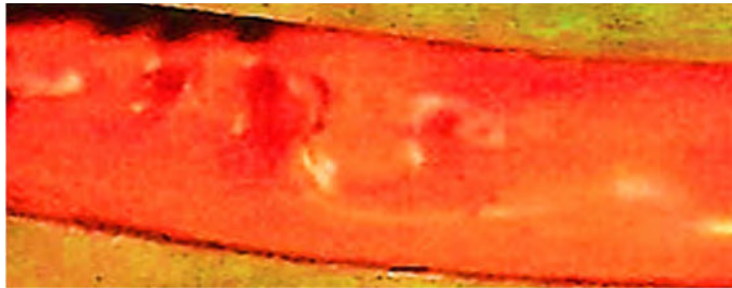
Figure 1

- D. Look for any hoses that may be passing through a hole in the frame rail. Mark any areas with colored tape for reference to be used during the repair portion of this bulletin. **For example, see Step 4 Figure 10 in Repair Section**
- E. Determine if any hydraulic hoses appear to be wet from hydraulic fluid (ATF). You must verify wetness is hydraulic fluid. Wipe the hose off and visually look for signs or possible reasons for the leak. Make sure all information is clearly documented on the work order/claim.
- F. Inspect the jacks for leaks at the hose fittings.
- G. Carefully inspect the leveling jack hoses for wetness/fluid. Verify any wetness is hydraulic fluid, and not something unrelated. If hydraulic fluid is found to be present, determine root cause if possible.
- H. Inspect hydraulic hoses for any blisters, pin holes, bubbles, or any other issues.

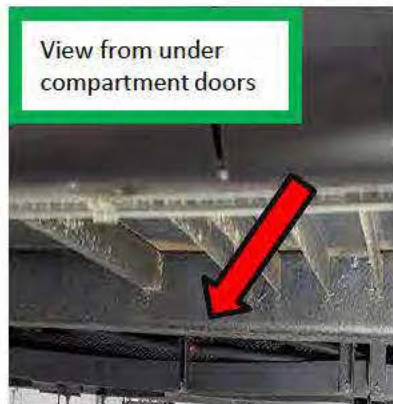
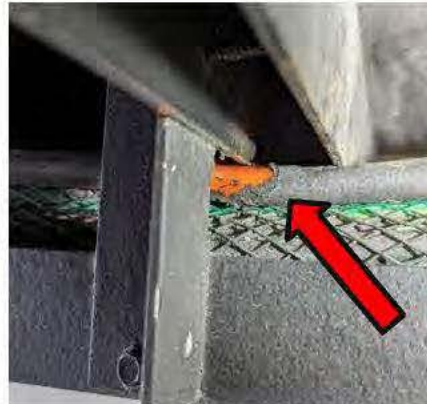
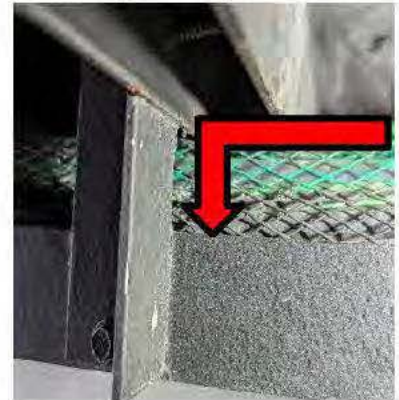
- F. Hoses running from front to back may be located in a fixed raceway under of the chassis frame. Inspect hoses to ensure they are not binding or pinched. Simply pull the hoses that are in contact with the subframe over to side of raceway which will relieve any pressure points. If needed add nylon protective material if necessary due to risk of possible abrasion. See figures 6, 7 and 8

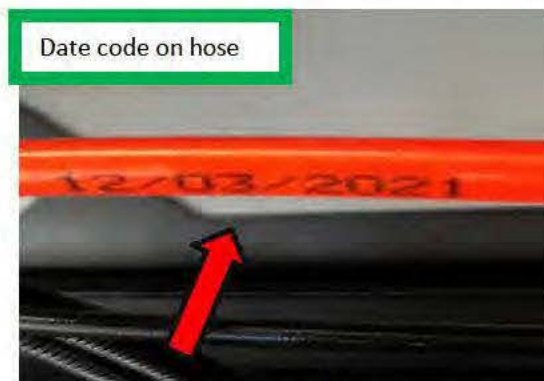
Figure 12

- A. **REQUIRED notations for authorization:** In the rare event a damaged hose is discovered, take a photo clearly showing the issue. Also, make a specific notation of the damaged hose date code, the color of the hose, which jack it operates, and the hose length. This information will assist your parts department when ordering a replacement hose. **NOTE: Do not order a whole hose kit!** Hoses that will need to be replaced will need to be purchased through **REV RV PARTS DEPT (800) 509-3417**, and pre-approved by **REV RV DEALER TECHNICAL SUPPORT AT (800) 591-0628** if any hose is leaking.
