## Refrigerator LP Gas Line Routing

<b>Bulletin Type:</b>	Recall	<b>Publication Date:</b>	September 2022
<b>Bulletin #(s):</b>	22V-659 US 2022-491 Canada	<b>Make(s):</b>	Jayco
<b>Job Code(s):</b>	9901579	<b>Model(s):</b>	White Hawk
<b>Flat Rate(s):</b>	9901579A .10 Inspection 9901579B .50 Inspection and Repair	<b>Model Year(s):</b>	2022-2023

<b>Incident:</b>	Refrigerator LP gas line routed inside underbelly
<b>Affected Units:</b>	Certain 2022-2023 Jayco White Hawk
<b>Parts List:</b>	<u>Shop Supplies:</u> P-clamp and Zip ties Sealant Spray Foam
<b>Misc. Tools &amp; Supplies:</b>	Wrenches and Screw gun
<b>Parts Return Information:</b>	N/A

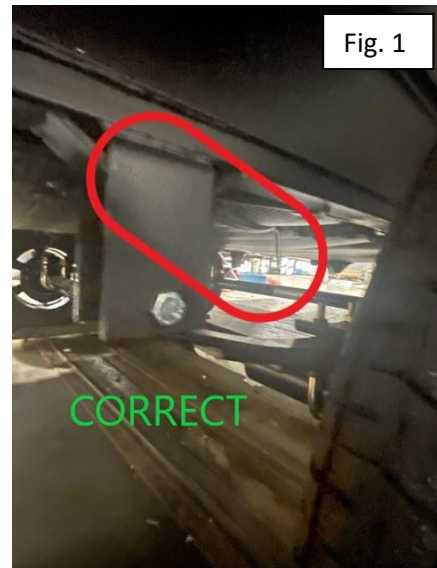
Fig. 1

1. Verify the LP gas line running from the door side LP manifold to the refrigerator is visible outside of the underbelly. Please follow the repair instructions if the LP gas line is not visible. Figure 1 shows the correct routing of the LP gas line.
