Safety Recall

Code: 20DS

Subject	Fuel Tank Internal Vent Pipe															
Revision Date	March 28, 2023															
Revision Summary	Updated loaner claiming instructions (USA ONLY)															
Affected Vehicles

Subject: Safety Recall 20DS - Fuel Tank Internal Vent Pipe

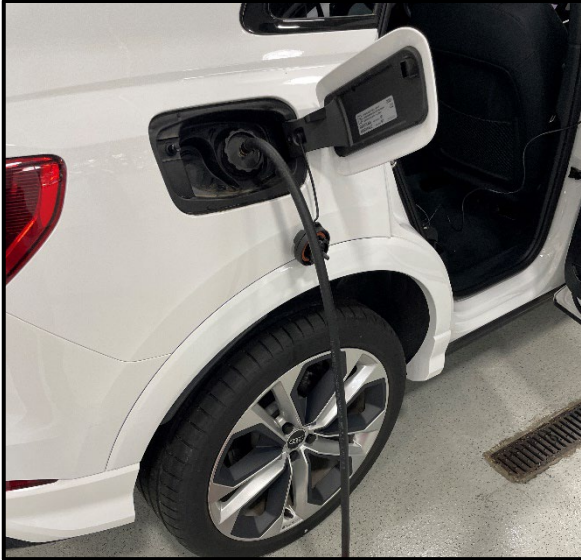
Repair Overview

- Perform test procedure to check for a hole in the fuel tank vent line.
- Replace fuel tank, if necessary.

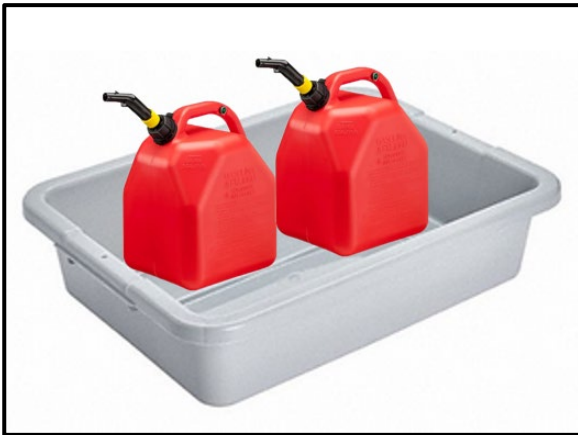
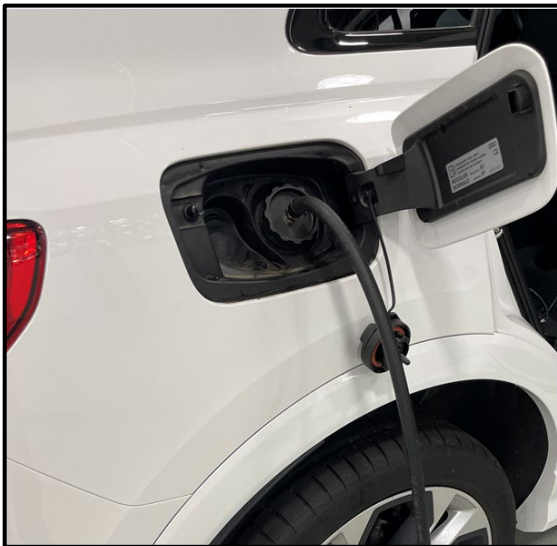
- Place the two fuel cans inside a tub.
- Ground the fuel cans to the vehicle.

Attach the fuel collection cans via a ground cable to a bare area on the body.
