RECALL R22CD

INCORRECT HANDRAIL DIAMETER

Models Affected: It has been determined that certain Model Year 2023 Blue Bird All American (T3FE) and Vision (BBCV) Non-School Buses calling for Handrail Part Number 10075076 may have an incorrectly sized diameter.

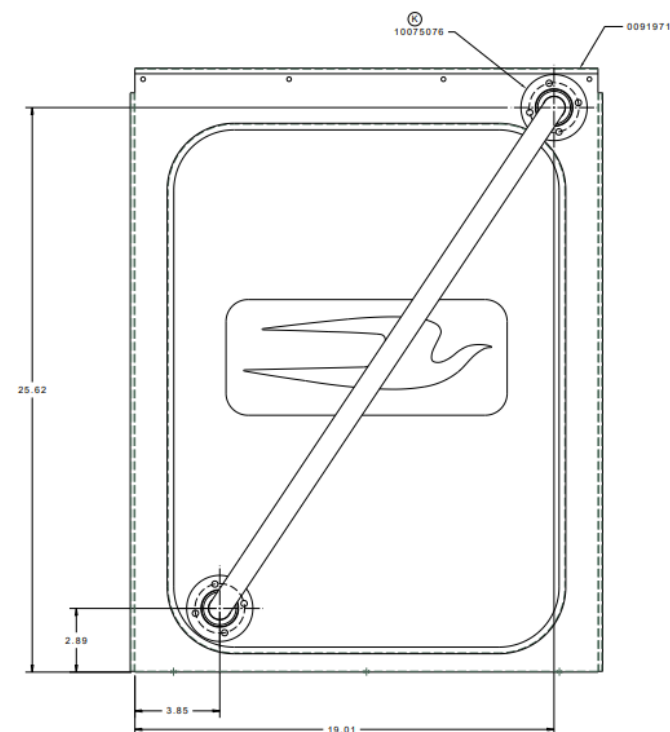
Issue: The stepwell grab rail is 1” and needs to be 1.25”.

Corrective Action: Remove and replace grabrail.

Step 1: Remove grab rail

Step 2: Install grab rail
