SAFETY RECALL BULLETIN

NHTSA RECALL 22V797

AUTOCAR, LLC SAFETY RECALL ACX-2206

STEERING COLUMN BOLTS

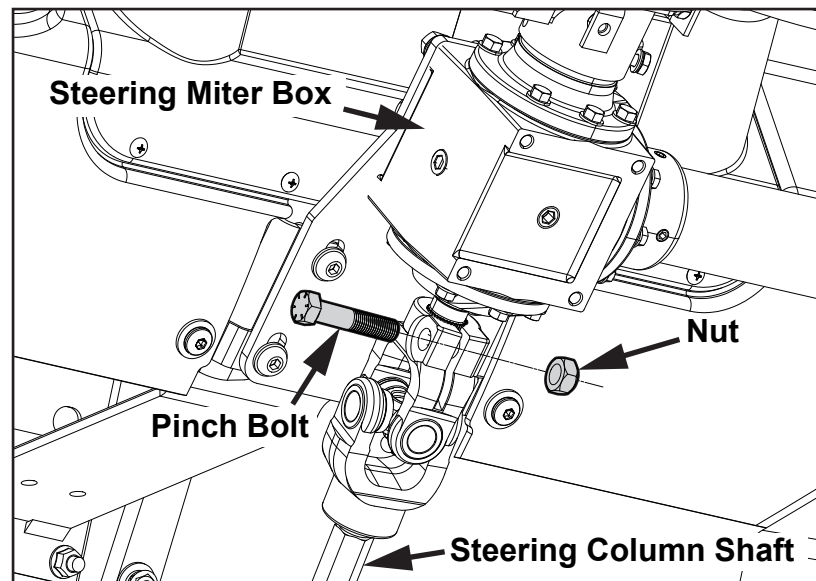
Figure 1, Steering Column Shaft

2. Unlock and open the cab doors and locate the steering column shaft (see Figures 1, 2 and 3).

3. Remove and discard the steering column pinch bolt and nut at the base of the steering column or miter box (see *Figures 1, 2 and 3*).
4. Verify the steering column shaft is fully installed onto the steering column. At the base of the steering column or miter box, install (1) S38100009-001 bolt and nut, verify the bolt passes through the groove of the steering column and tighten to 75 Lbs.-ft. of torque (see *Figure 4*).

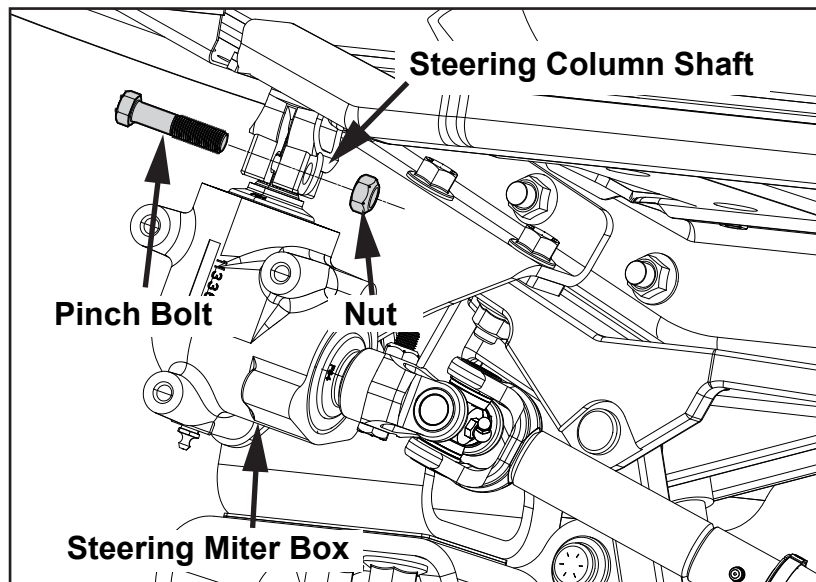
Figure 5

7. Locate the steering miter box and steering column shaft (see Figures 5 and 6).

8. Remove and discard the steering column shaft pinch bolt and nut at the miter box.
9. Verify the steering column shaft is properly installed. Install (1) S38100009-001 Bolt and nut at the steering column miter box, verify the bolt passed through the groove in the miter box shaft and tighten to 75 Lbs.-ft. of torque (see *Figure 4*).
10. Lower the cab.
11. Turn on the battery disconnect or reconnect the battery cables beginning with the positive cables, followed by the negative cables.
12. Repairs are complete.
