# SERVICE PROCEDURE

**SUBJECT:** SAFETY RECALL 22524 Variation 22535  
Hex Flange Lock Nut on certain International® HV™  
Series trucks built 01/21/2022 thru 08/16/2022.

### VEHICLE RECALL 22535

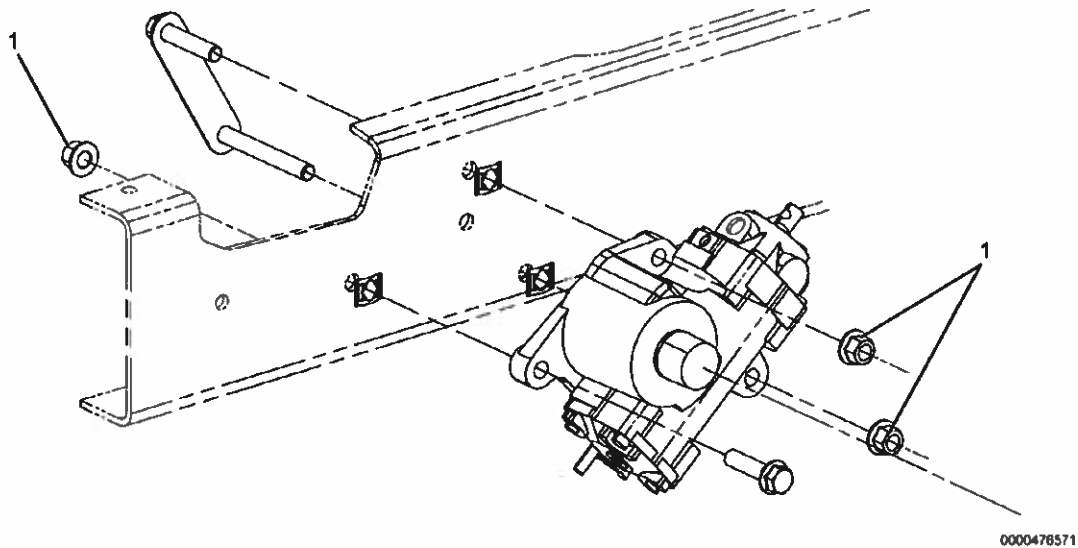
**Figure 1. Sheppard Main Steering Gear Mounting Nuts (Driver-Side)**

1. Main steering gear mounting nut (3)
6. Access main steering gear mounting nuts (Figure 1, Item 1).
7. Remove only one mounting nut at a time. Discard nut.

**NOTE: After installation of each nut, ensure at least one thread is protruding past the top edge of the nut.**

8. Install new mounting nut.
9. Using a torque wrench and backup wrench positioned on bolt, tighten mounting nut to 330 - 370 lb-ft (450 - 500 N·m).
10. Repeat Steps 7-9 for additional mounting nuts.

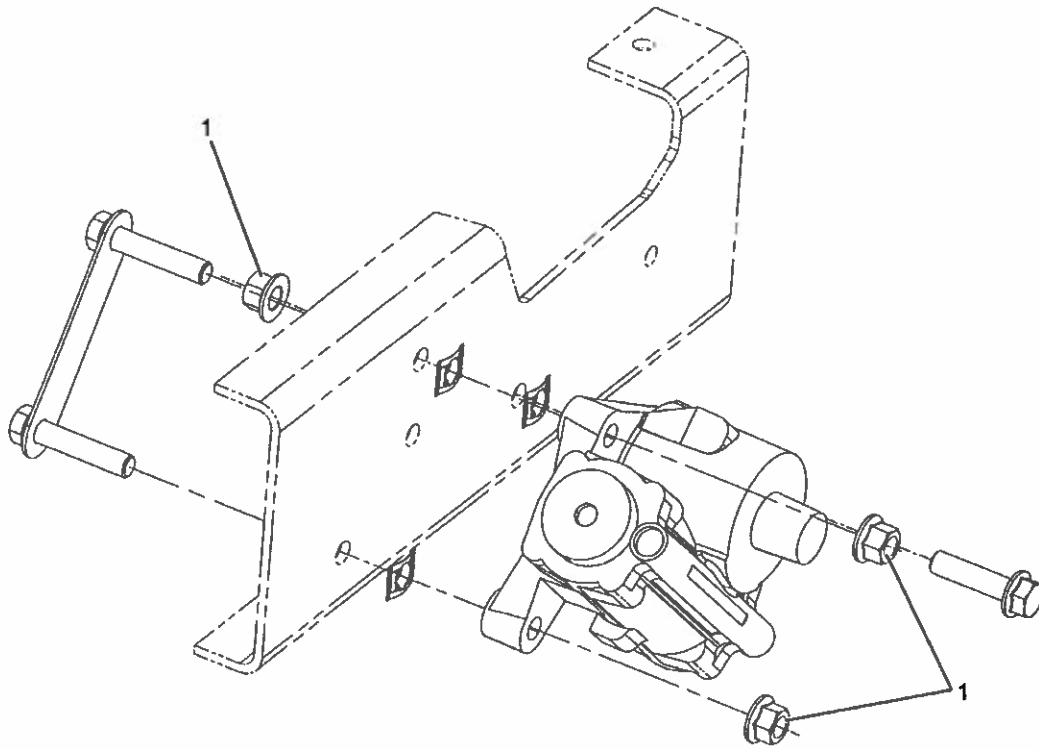
**Figure 2. Sheppard Slave Steering Gear Mounting Nuts (Passenger-Side)**

1. Slave steering gear mounting nut (3)
11. Access slave steering gear mounting nuts (Figure 2, Item 1).
12. Remove only one mounting nut at a time. Discard nut.
13. Install new mounting nut.

**NOTE: After installation of each nut, ensure at least one thread is protruding past the top edge of the nut.**

14. Using a torque wrench and backup wrench positioned on bolt, tighten mounting nut to 330 - 370 lb-ft (450 - 500 N·m).
15. Repeat Steps 12 -15 for additional mounting nuts.
16. Close and latch hood.
17. Remove wheel chocks.
