SERVICE PROCEDURE

22524 / 22539
JANUARY, 2023

SUBJECT: SAFETY RECALL 22524 Variation 22539
Hex Flange Lock Nut on certain International® HV™
Series trucks built 01/28/2022 thru 08/08/2022.

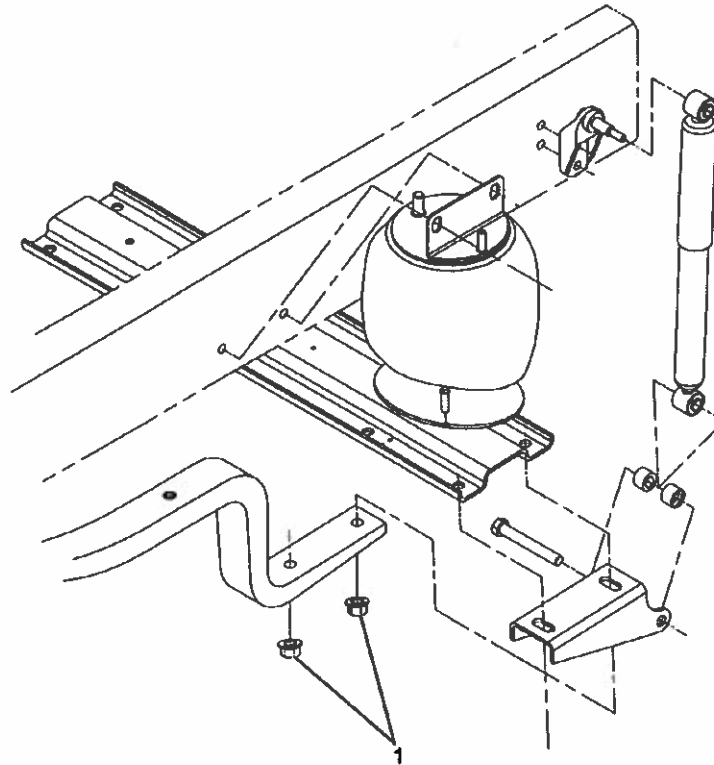
Figure 1. Typical HAS Single Axle Cross Brace

1. Nut (2)

6. Access two nuts (Figure 1, Item 1) securing rear axle(s) to cross brace.

NOTE: After installation of each nut, ensure at least one thread is protruding past the top edge of the nut.

7. Remove and replace nuts one at a time. Using a torque wrench, tighten nuts to 150-205 lb-ft (203-278 N·m).

8. Repeat steps 6-7 for opposite side.
