SERVICE PROCEDURE

22524 / 22553
JANUARY, 2023

DEFECT DESCRIPTION

VEHICLE RECALL 22553

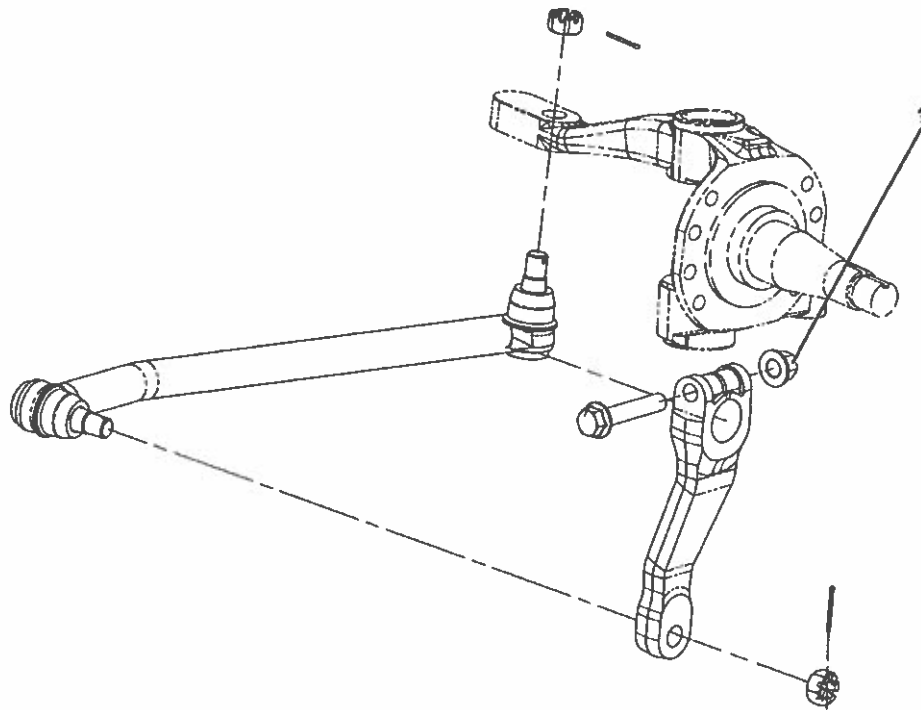
Figure 1. TRW Pitman Arm Nut

1. Nut

6. Access Pitman arm nut (Figure 1, Item 1).

NOTE: After installation of each nut, ensure at least one thread is protruding past the top edge of the nut.

7. Remove and replace nut. Using a torque wrench and backup wrench positioned on bolt, tighten nut to 330 - 370 lb-ft (450 - 500 N·m).
8. Using jack, raise rear axles and support vehicle on jack stands.

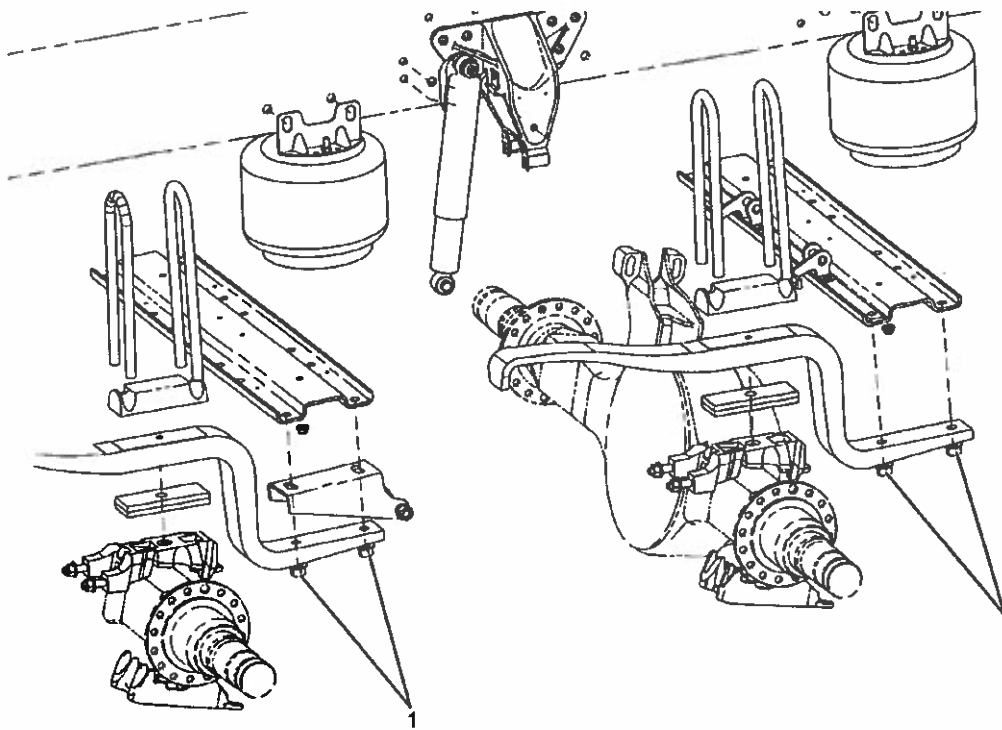
Figure 2. HAS Cross Brace

1. Nut (4)

9. Access four nuts (Figure 2, Item 1) securing rear axle(s) to cross brace.

NOTE: After installation of each nut, ensure at least one thread is protruding past the top edge of the nut.

10. Remove and replace nuts one at a time. Using a torque wrench, tighten nuts to 330 - 370 lb-ft (450 - 500 N·m).

11. Repeat Steps 9-10 for opposite side.
