SERVICE PROCEDURE

SUBJECT: SAFETY RECALL 22524 Variation 22543
Hex Flange Lock Nut on certain International® HV™
Series trucks built 02/21/2022 thru 08/16/2022 and
certain WorkStar® model trucks built 02/21/2022
thru 05/18/2022.

VEHICLE RECALL 22543

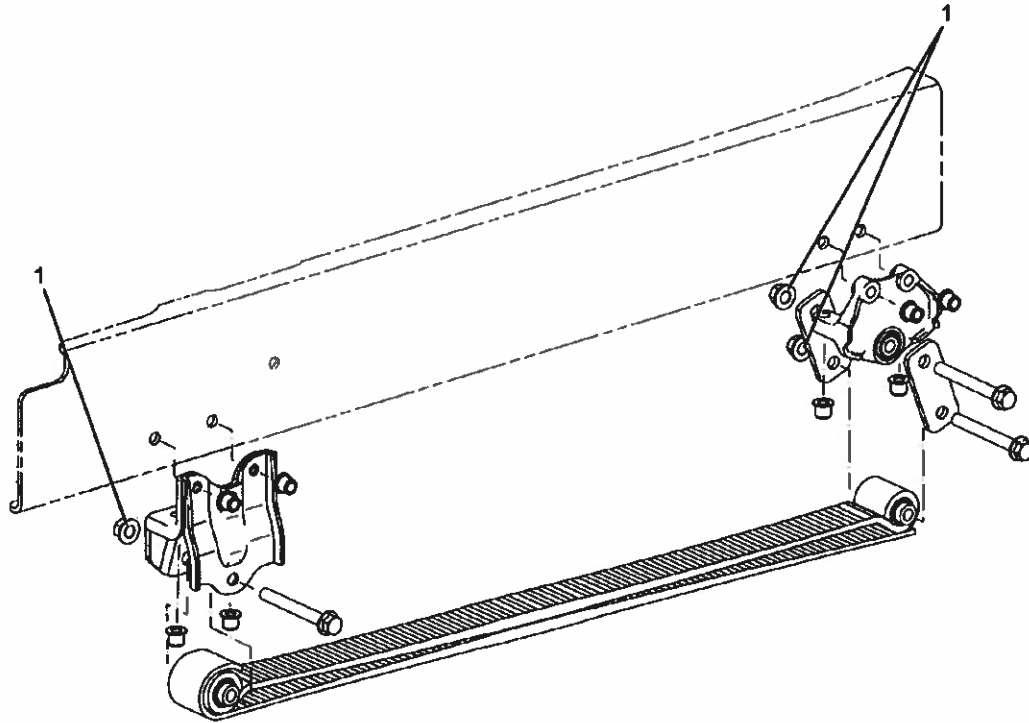
Figure 1. Typical Steer Axle Shackle

1. Nut (3)

7. Access nuts (Figure 1, Item 1) securing the front steer axle shackle.

NOTE: After installation of each nut, ensure at least one thread is protruding past the top edge of the nut.

8. Remove and replace nuts (Figure 1, Item 1). Using a torque wrench, tighten nuts to 330-370 lb-ft (450-500 N·m).

9. Repeat Steps 7-8 for opposite side.

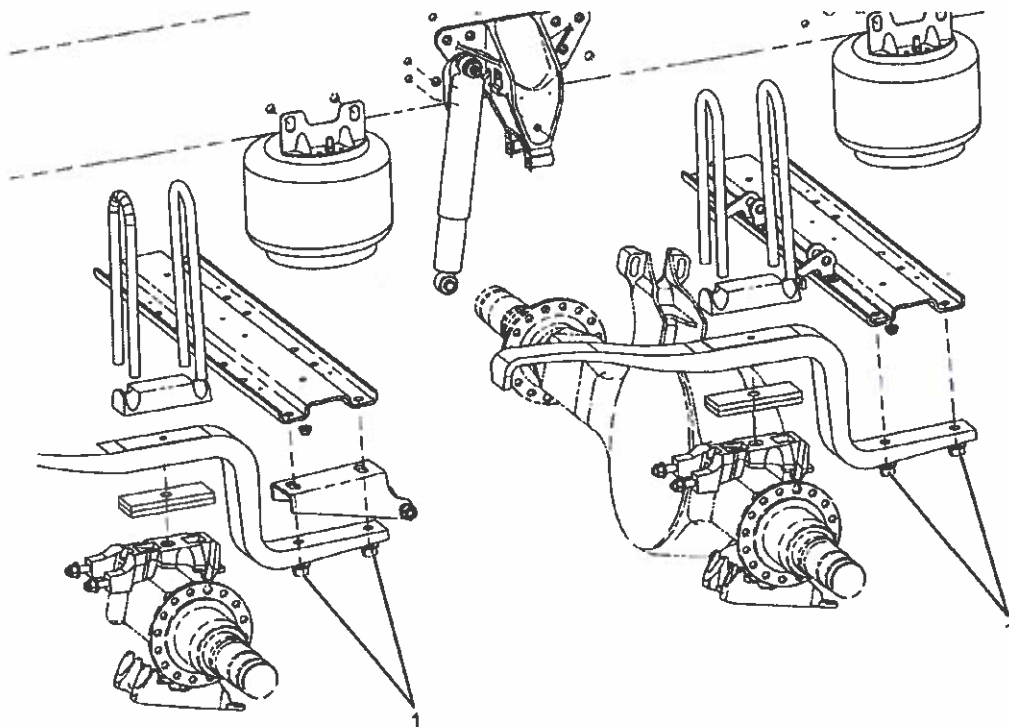
Figure 2. HAS Cross Brace

1. Nut (4)

12. Access four nuts (Figure 2, Item 1) securing rear axle(s) to cross brace.

NOTE: After installation of each nut, ensure at least one thread is protruding past the top edge of the nut.

13. Remove and replace nuts one at a time. Using a torque wrench, tighten nuts to 330-370 lb-ft (450-500 N·m).

14. Repeat Steps 12 - 13 for opposite side.
