# SERVICE PROCEDURE

**SUBJECT:** SAFETY RECALL 22524 Variation 22546  
Hex Flange Lock Nut on certain International® HV™  
Series trucks built 01/18/2022 thru 08/16/2022.

### VEHICLE RECALL 22546

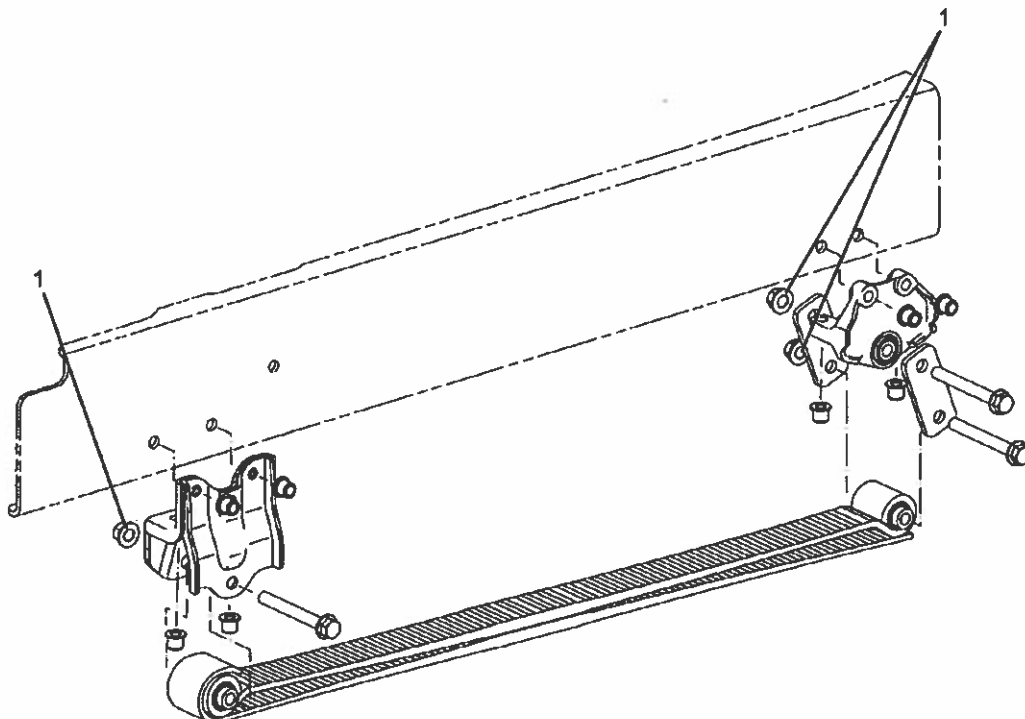
**Figure 1. Front Steer Axle Shackle (Driver-side)**

A specific hex flange lock nut used in several, but not all, steering and / or suspension locations may have not been properly formed and heat treated to Navistar's specifications and can result in a loss of joint tension as the vehicle ages. A loss of joint tension in these joints may affect vehicle handling and could contribute to a vehicle crash.

1. Nut (3)

7. Access front steer axle shackle nuts (Figure 1, Item 1) securing front steer axle shackle.

**NOTE:** After installation of each nut, ensure at least one thread is protruding past the top edge of the nut.

8. Remove and replace nuts. Using a torque wrench and backup wrench positioned on bolt, tighten three nuts to 330 - 370 lb-ft (450 - 500 N·m).
9. Repeat Steps 7-8 for opposite side.

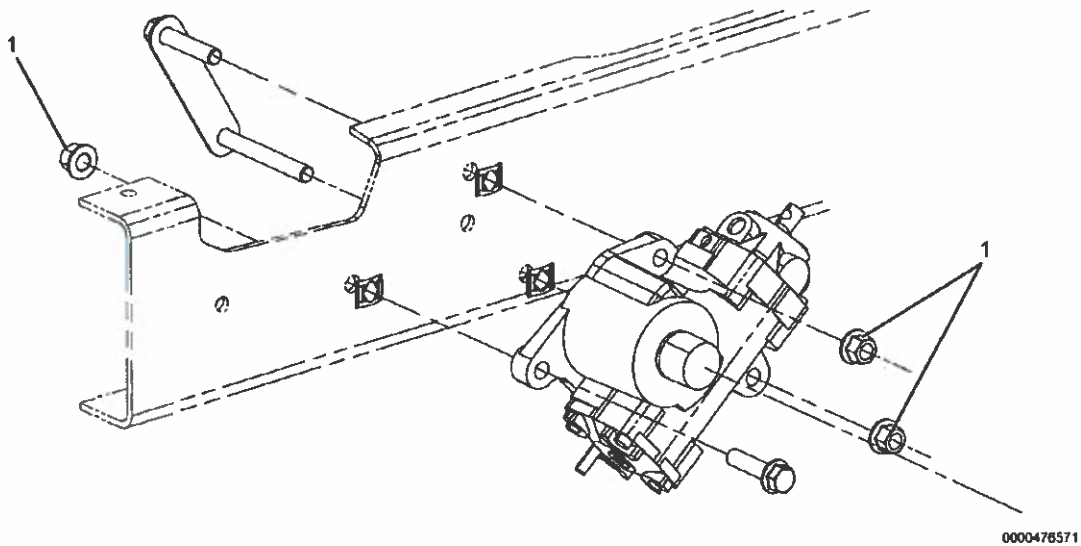
**Figure 2. Shepard Main Steering Gear Mounting Nuts (Driver-side)**

1. Nut (3)

10. Access main steering gear mounting nuts (Figure 2, Item 1).

11. Remove only one mounting nut at a time. Discard nut.

**NOTE: After installation of each nut, ensure at least one thread is protruding past the top edge of the nut.**

12. Install new mounting nut.

13. Using a torque wrench and backup wrench positioned on bolt, tighten mounting nut to 330 - 370 lb-ft (450 - 500 N·m).

14. Repeat Steps 11-13 for additional mounting nuts.
