SERVICE PROCEDURE

22525 / 22558
JANUARY, 2023

**SUBJECT: SAFETY RECALL 22525 Variation 22558
Hex Flange Lock Nut on certain IC Bus® RE buses
built 02/25/2022 thru 08/15/2022.**

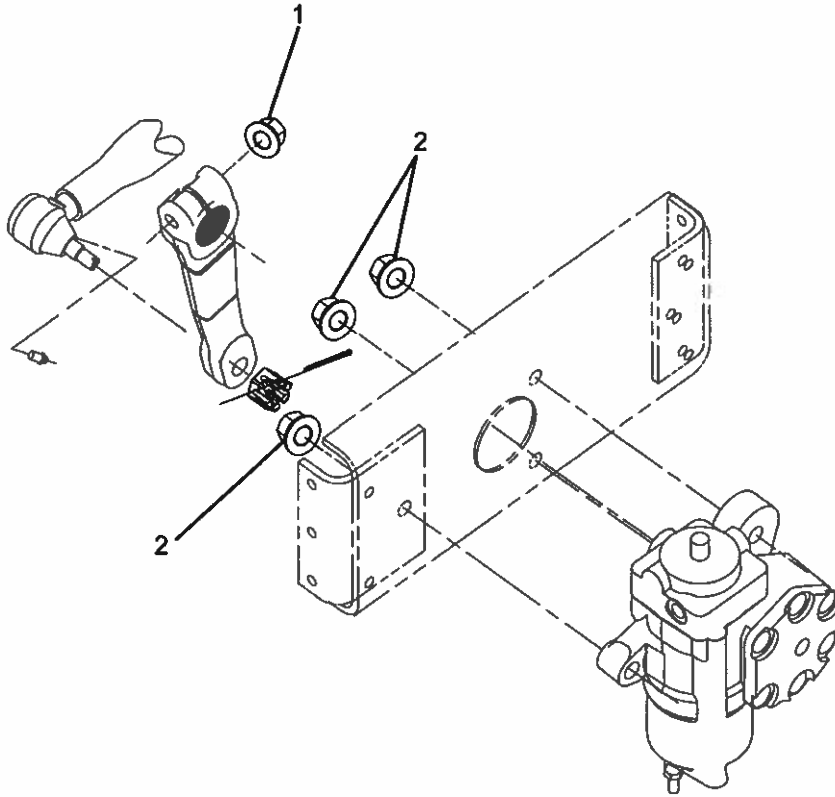
Figure 1. TRW Pitman Arm Nut and Steering Gear Mounting

A specific hex flange lock nut used in several, but not all, steering and / or suspension locations may have not been properly formed and heat treated to Navistar's specifications and can result in a loss of joint tension as the vehicle ages. A loss of joint tension in these joints may affect vehicle handling and could contribute to a vehicle crash.

1. Pitman arm nut
2. Steering gear nut (3)

6. Access Pitman arm nut (Figure 1, Item 1) securing pinch bolt.

NOTE: After installation of each nut, ensure at least one thread is protruding past the top edge of the nut.

7. Remove and replace nut. Using a torque wrench and backup wrench positioned on bolt, tighten nut to 330 - 370 lb-ft (450 - 500 N·m).
8. Access three steering gear mounting nuts (Figure 1, Item 2).

9. Remove and replace nuts one at a time. Using a torque wrench and backup wrench positioned on bolt, tighten nut to 330 - 370 lb-ft (450 - 500 N·m).
10. Raise vehicle, remove jack stands, and lower vehicle.
11. Remove wheel chocks.
